# PEDESTRIAN SAFETY AUDIT REPORT

SR 424/Edgewater Drive from  
SR 423/Lee Road to SR 434/Forest City Road

October 2012

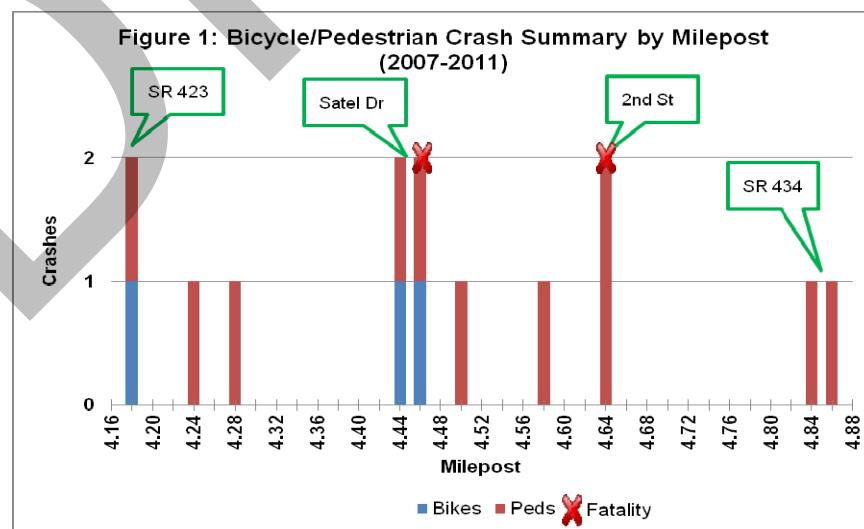
The crashes are summarized by milepost in Figure 1. As illustrated in Figure 1, eight of the 14 crashes occurred mid-block between SR 423/Lee Road and SR 434/Forrest City Road. Of the two crashes that occurred at the SR 423/Lee Road intersection, one involved a bicycle. One of the two crashes that occurred at SR 434 involved a motorized wheelchair. The crash diagram, along with other pertinent crash data and intersection signal timing data, is provided in the Appendix.

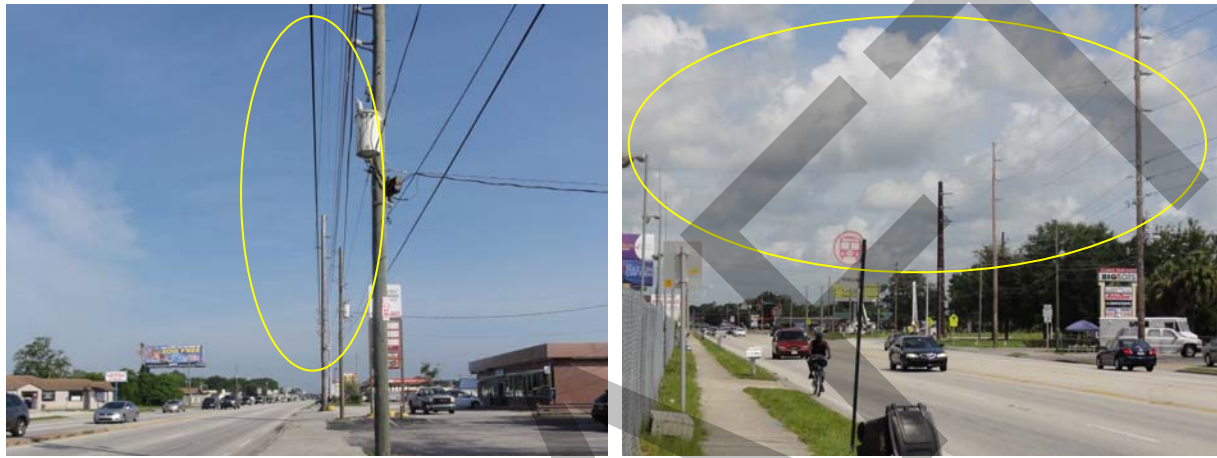
### Issue: Absence of Roadway Lighting

The study corridor does not have street lighting. The 2010 Highway Safety Manual, 1<sup>st</sup> Edition (HSM), provides an equation for crash modification factors (CMF) of roadways with street lighting. The CMF equation is:

Six of the 14 total crashes occurred at night ( $p_{nr} = 6/14 = 0.429$ ). All of the six nighttime crashes involved a fatality or injury ( $p_{inr} = 6/6 = 1.000$ ). None of the six nighttime crashes involved property damage only ( $p_{pnr} = 0/6 = 0.000$ ). Therefore, per the 2010 HSM, the crash modification factor (CMF) associated with implementing street lighting on this roadway would be 0.88. This indicates a 12-percent reduction in total crashes expected along the corridor.

Install street lighting along the corridor.

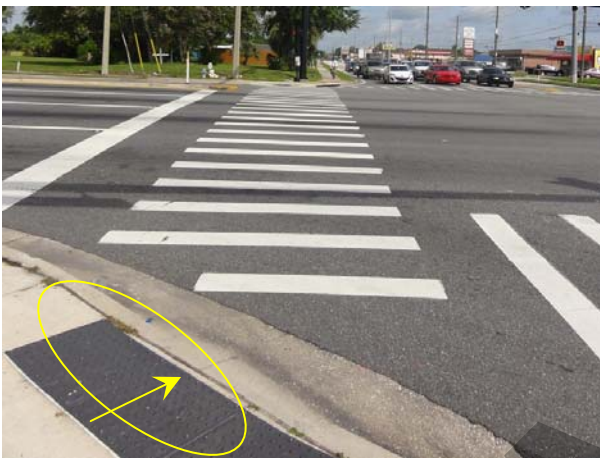
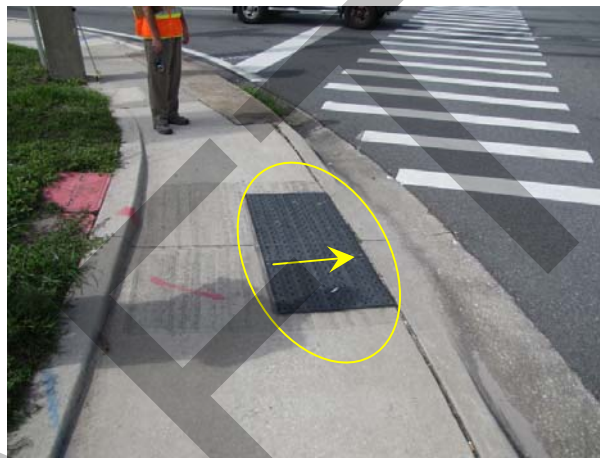
**Issue: Detectable Warning Surface Orientation**

Where detectable warning surfaces exist, the majority are improperly oriented to lead pedestrians into the crosswalk.

If / when major construction or expansion occurs, orient detectable warning surfaces with direction of crosswalk.

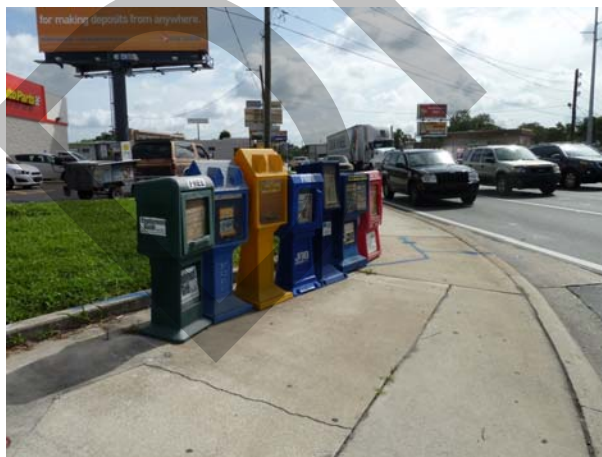
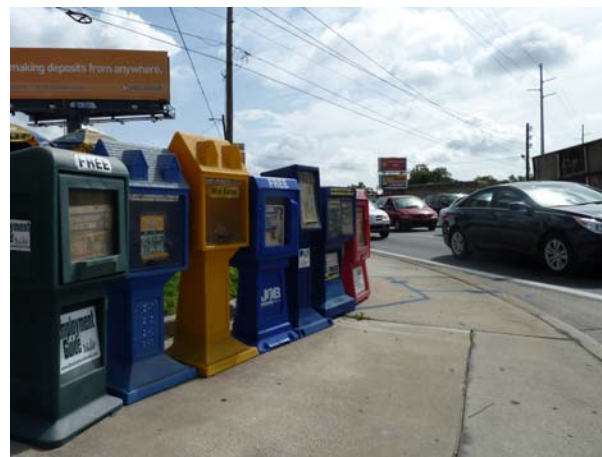
**Issue: Periodical Publication Distribution Boxes Obstructing View of Wheelchairs**

The periodical publication distribution boxes on the northeast corner of the intersection obstruct motorist's view of pedestrians and wheelchairs.

Relocate or remove periodical publication distribution boxes.

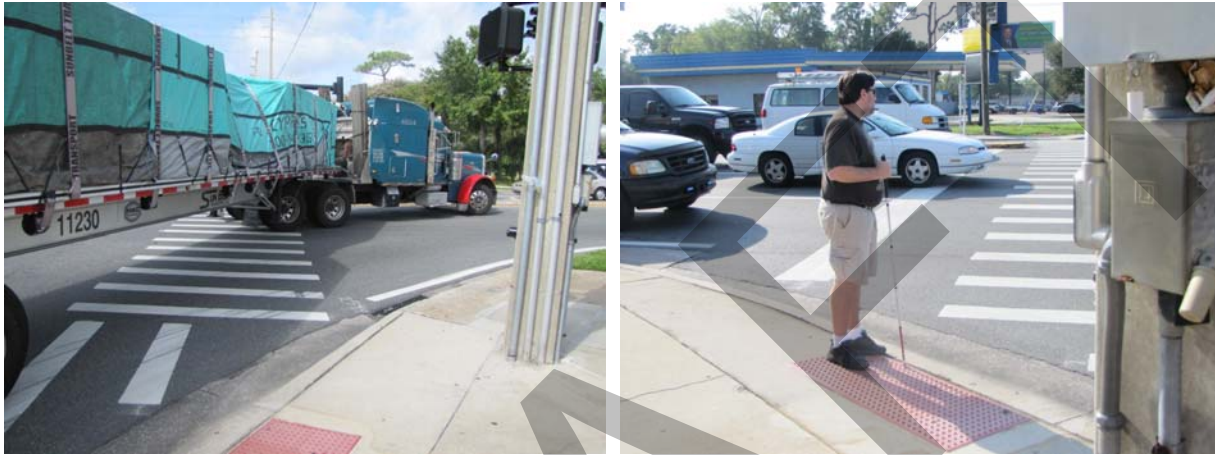
**Issue:** High WB right-turn Volume Not Yielding to Pedestrians in Crosswalk

The Pedestrian RSA team noted a high volume of westbound right-turning vehicles not yielding to pedestrians crossing the northern leg of the intersection. The pedestrian shown in the photo above is visually impaired.

Consider the installation of "Yield to Pedestrian" signage to raise awareness at this intersection. Internally illuminated signage that is activated during appropriate pedestrian phases is recommended. Signs should be placed according to future study considering turning volumes and enforcement.

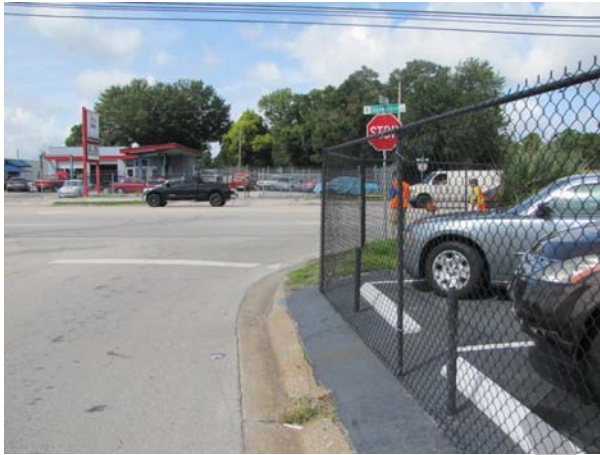
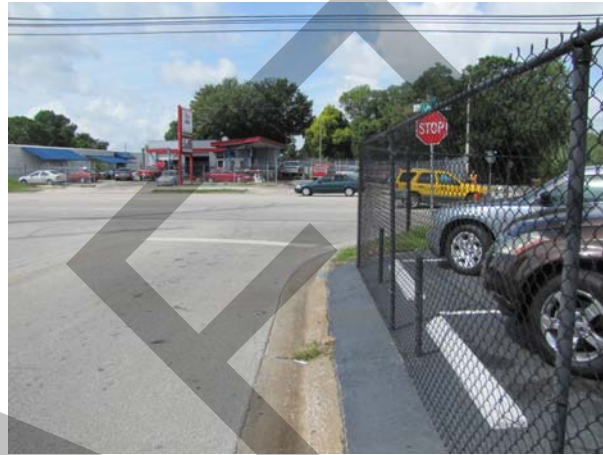
**Issue: Fencing Obstructing Motorist View of Sidewalk Users**

At the intersection of SR 424/Edgewater Drive & Satel Drive there was fencing recently installed less than two feet behind the curb line on Satel Drive. The fencing, accompanied by the vehicles parked in the lot that is protected by the fencing, obstruct a westbound approaching motorist's view of the sidewalk along the east side of SR 424/Edgewater Drive. This obstructed view may have contributed to a crash with a bicyclist traveling southbound on the sidewalk and a motorist traveling westbound at this location in November 2011.

The original recommendation for this safety issue was to check the sight triangle at this intersection and zoning compliance of fence installation. During the time that this document was under production, the fence was relocated to provide added sight distance at the intersection. Pictures of the relocated fence are provided below:

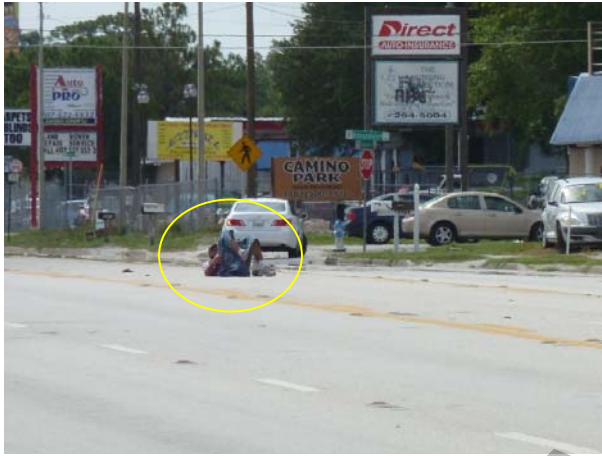
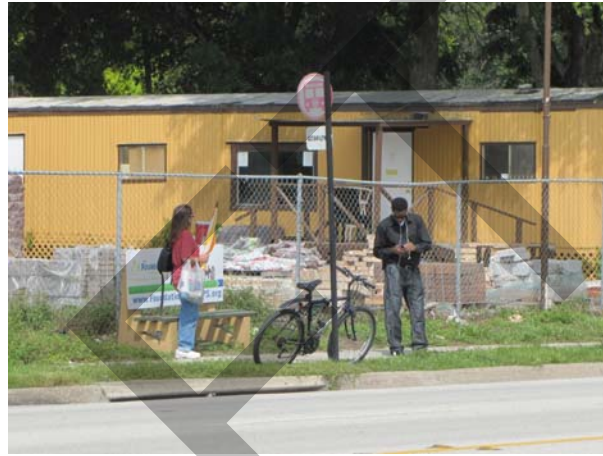
**Issue: Mid-Block Crash History**

As depicted in Figure 1, over one third of the pedestrian and bicycle crashes along the study corridor occurred between Milepost 4.440 and 4.520, near Satel Drive and Aloha Street. Several factors contribute to the higher pedestrian activity in the area and, consequently, the concentration of crashes. This particular area has a residential development located to the west of SR 424 and a restaurant/nightclub/bar on the east of SR 424. In addition to the interaction between the residential and restaurant land uses, a transit stop is located approximately midway between Aloha Street and Annandale Avenue. The Pedestrian RSA team also observed a pedestrian stumble and fall within the two-way left-turn lane. The pedestrian then laid down in the two-way left-turn lane until passing motorists and law enforcement stopped and helped him to safety.

Consider the installation of a median island that could serve as a pedestrian refuge near Lynx stop 5066, approximately 200 feet south of Satel Drive. If the median island is constructed as part of a mid-block crossing, then Chapter 3B18 of the 2009 Manual of Uniform Traffic Control Devices (MUTCD) should be consulted in regard to whether crosswalk striping should be provided. Additionally, Section 3.8 of the FDOT Traffic Engineering Manual should be consulted to aid in identifying applicable crosswalk treatments for consideration.

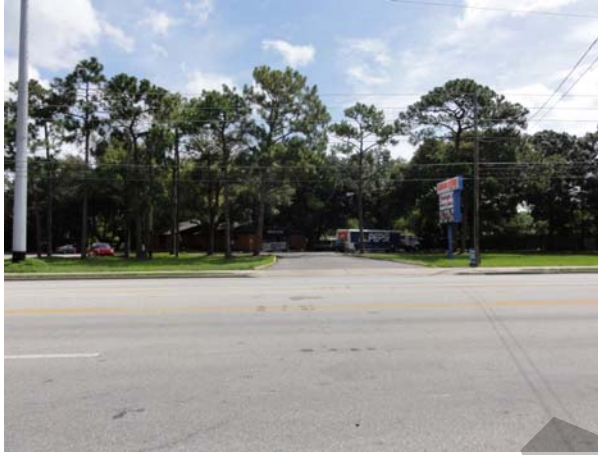
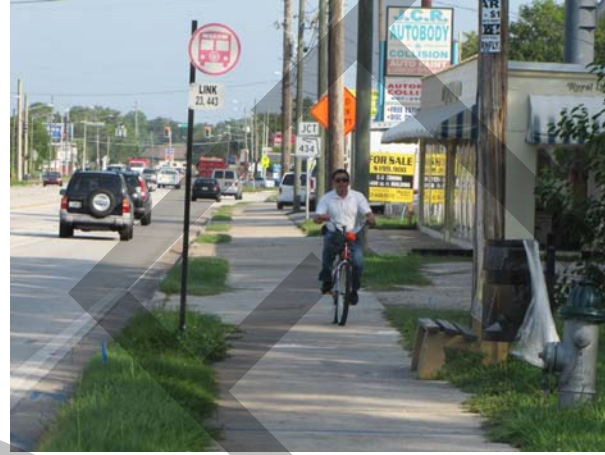
**Issue: Mid-Block Crash History**

As depicted in Figure 1, two crashes occurred near 2<sup>nd</sup> Street. One of the two crashes occurred in low light conditions. The commercial land uses on the east side of SR 424 near this location are set back further from the roadway than in other places along the corridor resulting in the lower availability of ambient lighting. There are also two Lynx transit stops near this location which contribute to a higher level of mid-block crossing at this location.

Consider the consolidating transit stops at this location such that they are more directly across from each other if Lynx ridership data indicates high transit boardings and alightings at this location. A potential location to consider for the transit stops is just south of 2<sup>nd</sup> Street. Consider installation of a median island on SR 424 on the north side of 2<sup>nd</sup> Street. If the median island is constructed as part of a mid-block crossing, then Chapter 3B18 of the 2009 Manual of Uniform Traffic Control Devices (MUTCD) should be consulted in regard to whether crosswalk striping should be provided. Additionally, Section 3.8 of the FDOT Traffic Engineering Manual should be consulted to aid in identifying applicable crosswalk treatments for consideration.

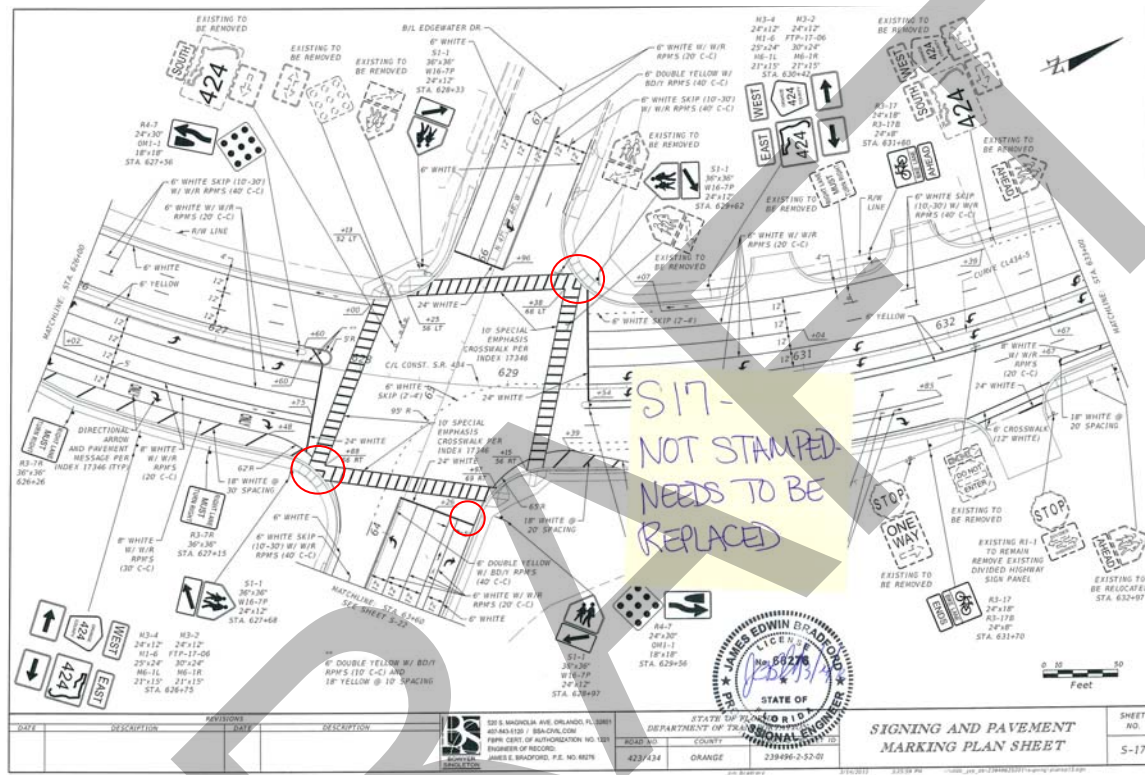
**Issue: Potential Design-Plan Issues**

This intersection is currently under construction to facilitate the Forest City Road extension. The original design showed crosswalks intersecting within the intersection and a single ADA ramp for both intersecting crosswalks. The use of a single ADA ramp for multiple crosswalks imposes difficulty in aligning detectable warning surfaces with the crosswalk direction.

Additionally, the Forest City Road approaches were originally designed with a single stop bar location for all approach lanes. Due to the skew of this intersection, the single stop bar could cause some vehicles to stop further from the crosswalk than others. This introduces the potential for vehicles to disregard the stop bar and potentially block the crosswalk.

Consider providing two separate ADA ramps on each corner serving two crosswalks. Place detectable warning surfaces in line with the crosswalk direction.

Consider moving selected stop bars closer to the crosswalks to create a staggered stop bar that allows for enhanced vehicular visibility. Per FDOT Standard Index No. 17346, stop bars shall be installed no less than four feet from the crosswalk.
