QUALITATIVE ASSESSMENT OF INTERSECTION OPERATIONS

State Road 40 at Interstate 95 Southbound Ramps

Section 79100
M.P. 26.292
Volusia County

January 2021

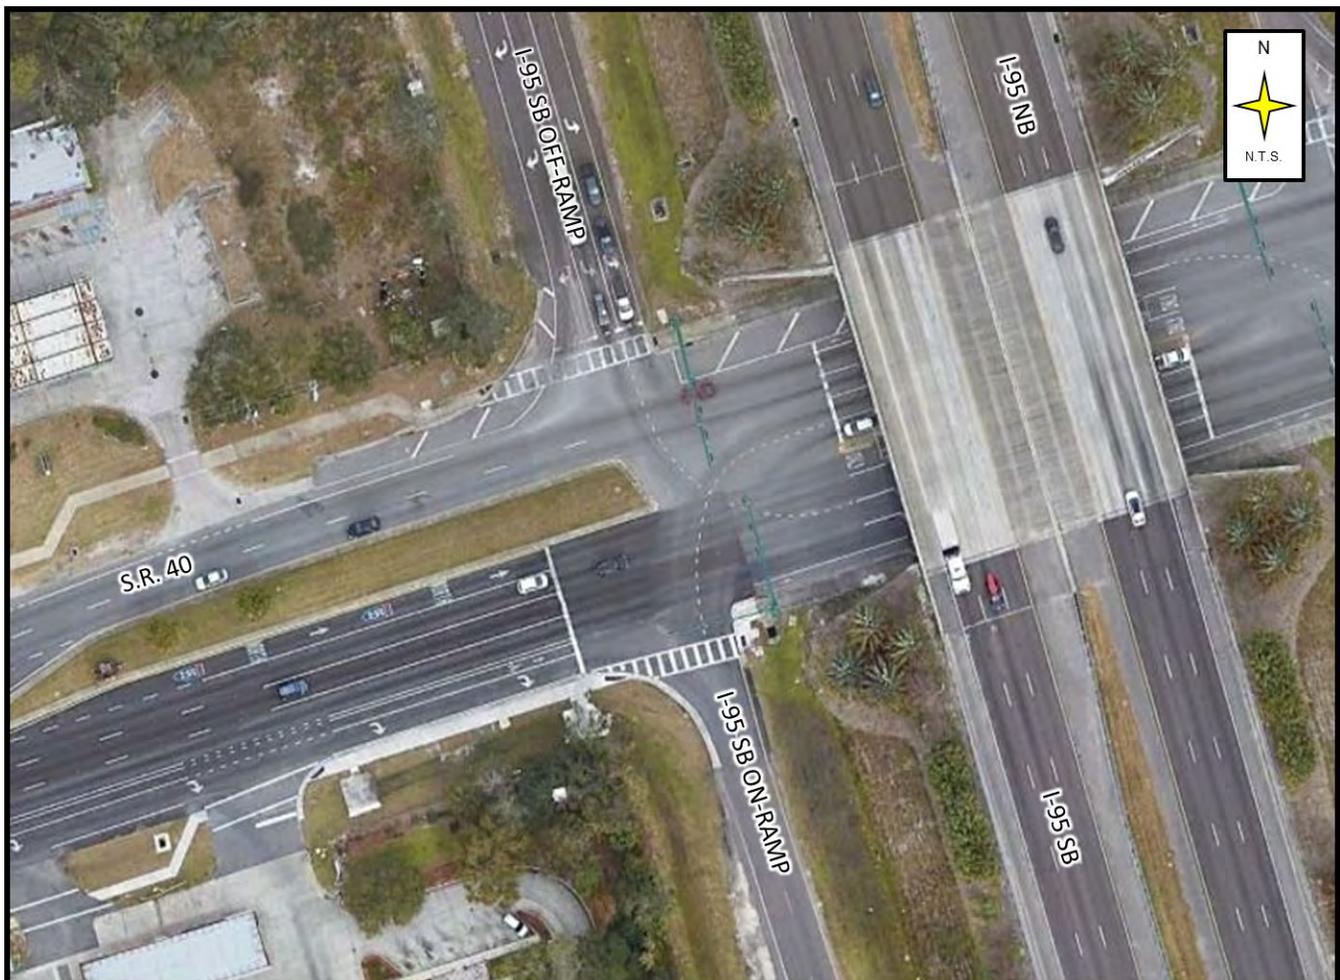
Figure 2
General Location Aerial
S.R. 40 at I-95 Southbound Ramps

S.R. 40 is an east/west arterial that extends east from Marion County, through the study intersection, to S.R. A1A in Ormond Beach. At the study intersection, S.R. 40 is a five-lane divided arterial with bike lanes and curb and gutter. I-95 is a north/south interstate highway that extends from the Volusia/Flagler County line to the Flagler/St. Johns County line. At the study interchange, the southbound off-ramp (Exit 268) is the west ramp terminal at the diamond interchange, which allows southbound I-95 traffic to access S.R. 40, and S.R. 40 traffic to access southbound I-95. The intersection of S.R. 40 at the I-95 Southbound Ramps is a signalized intersection. A location aerial is shown below in **Figure 2**.

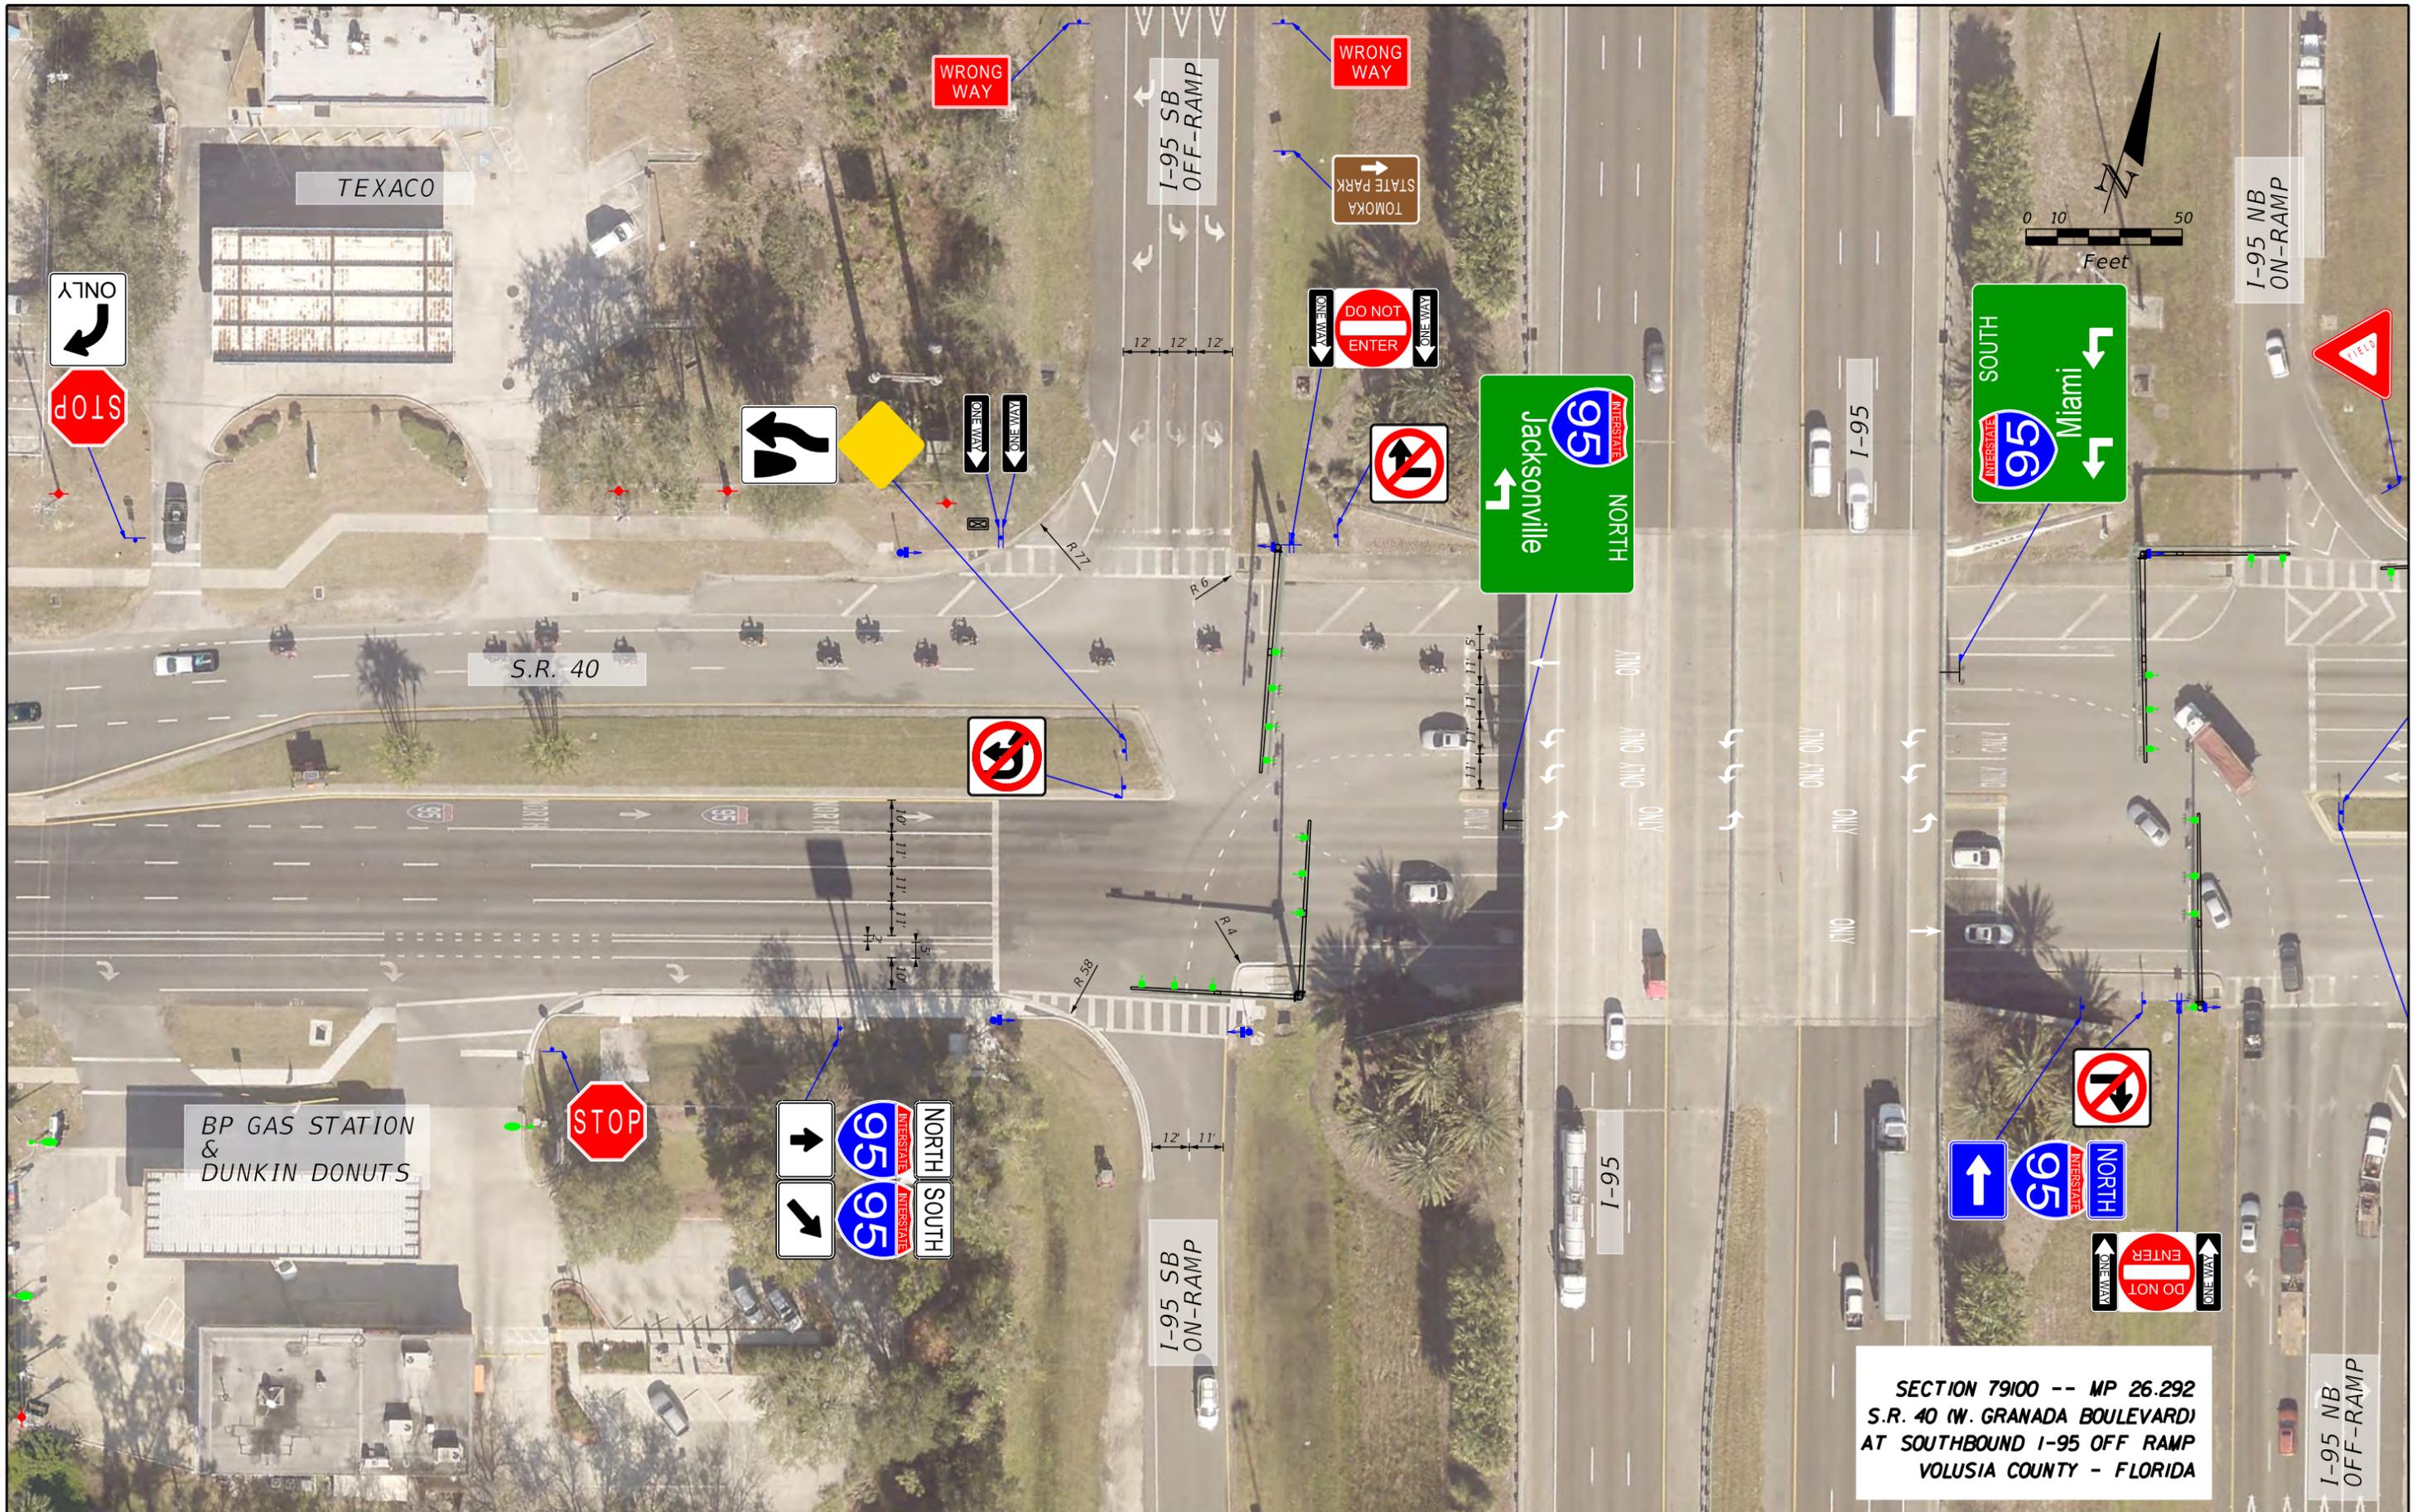
FIGURE 3
 EXISTING CONDITION DIAGRAM

Table 1 on the following page summarizes the existing conditions for the study location. An existing condition diagram is provided as **Figure 3** and photographs of the study intersection are included within this study. A straight-line diagram is also included in the **Appendix**.

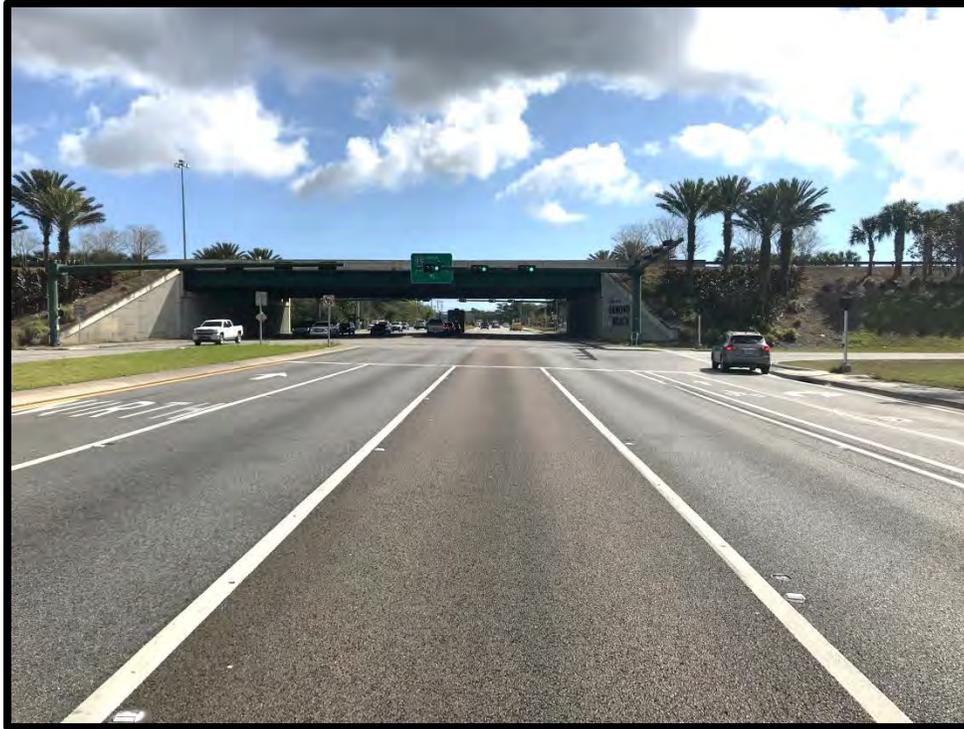
Looking East Towards Intersection

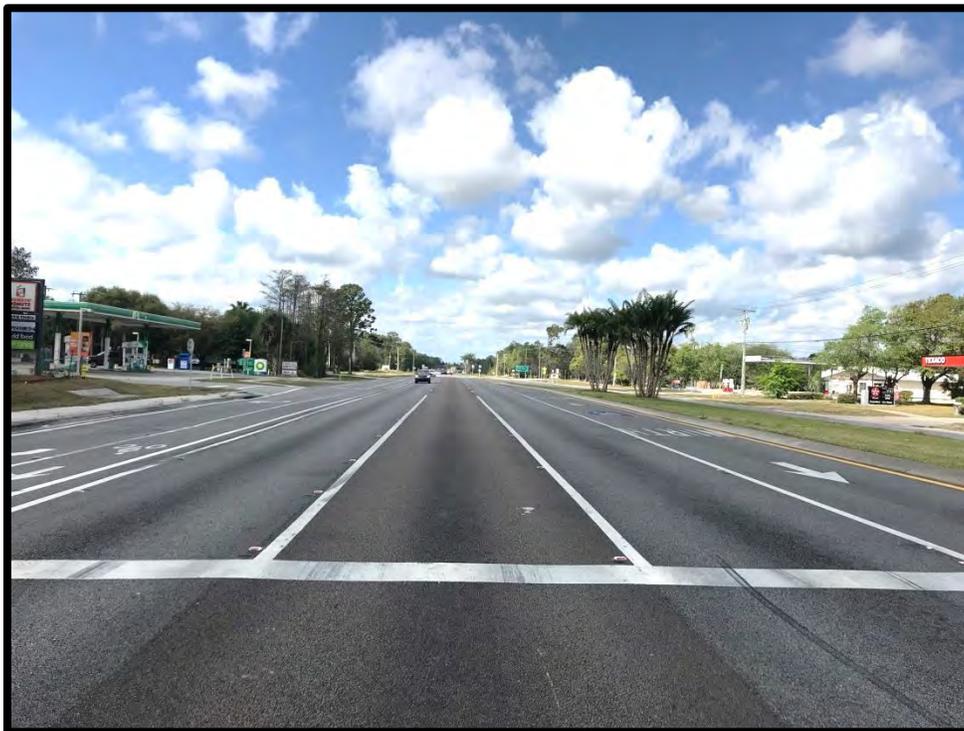
Looking West Away from Intersection

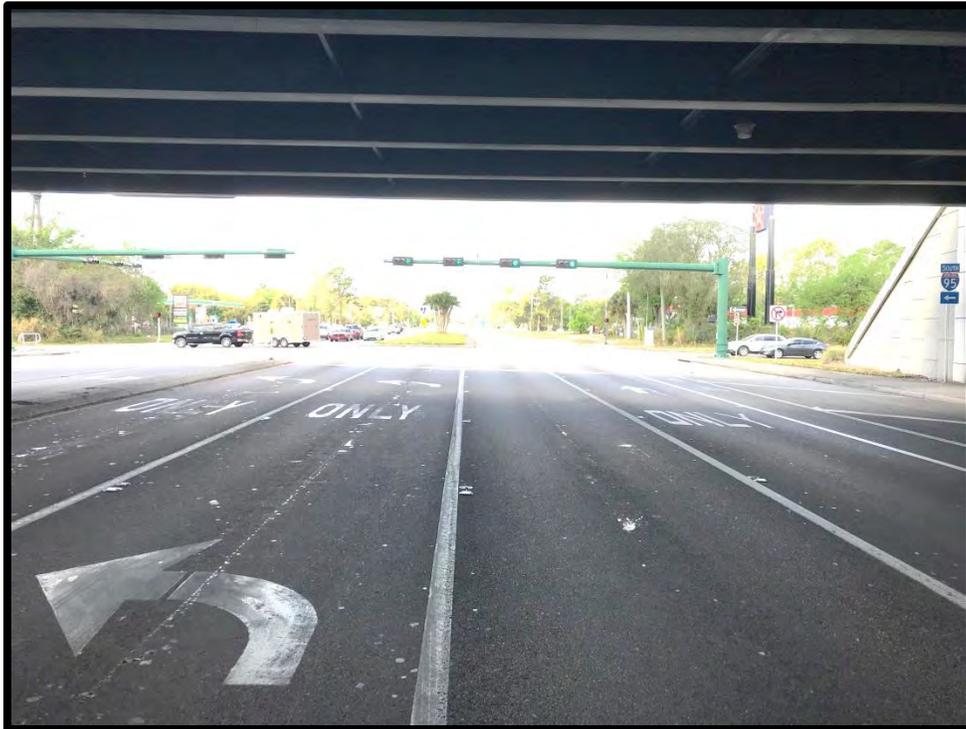
Looking West Towards Intersection

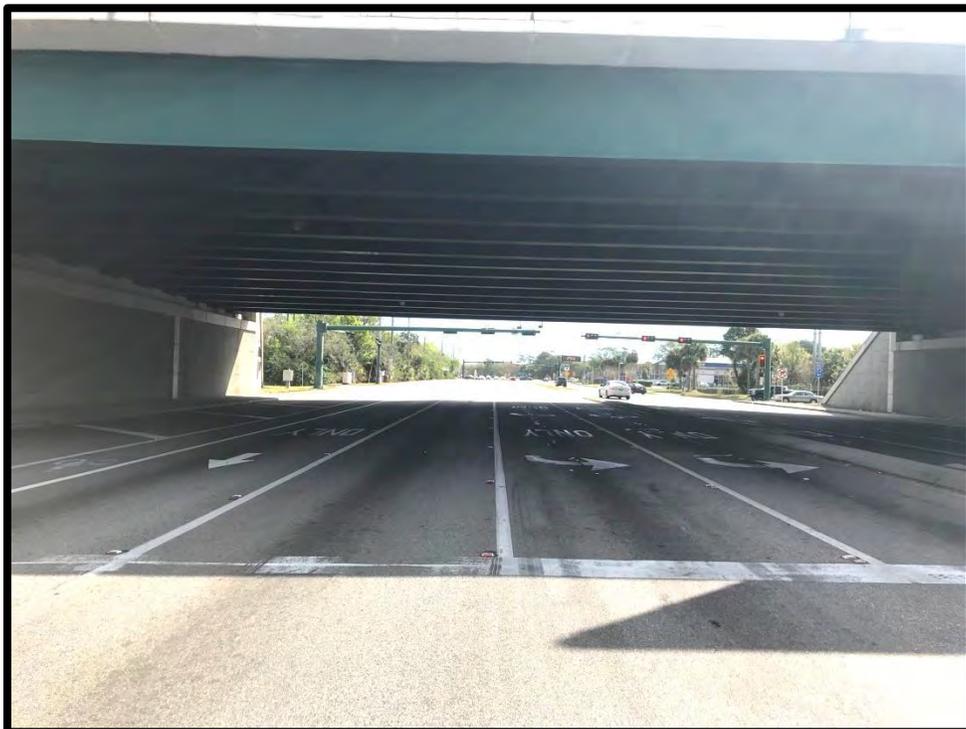
Looking East Away from Intersection

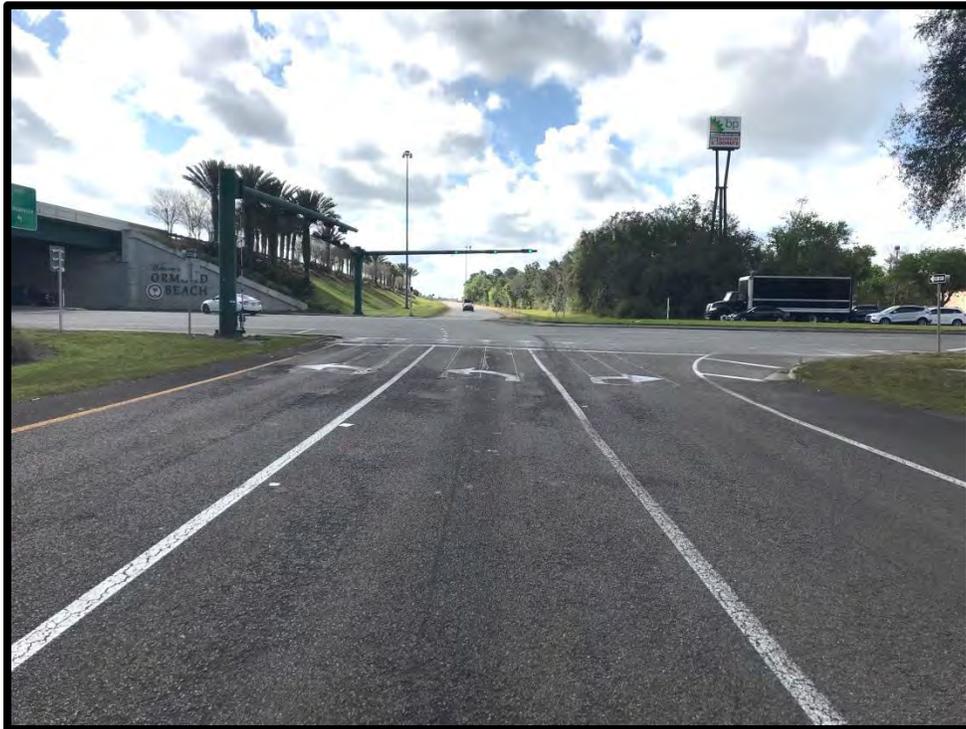
Looking South Towards Intersection

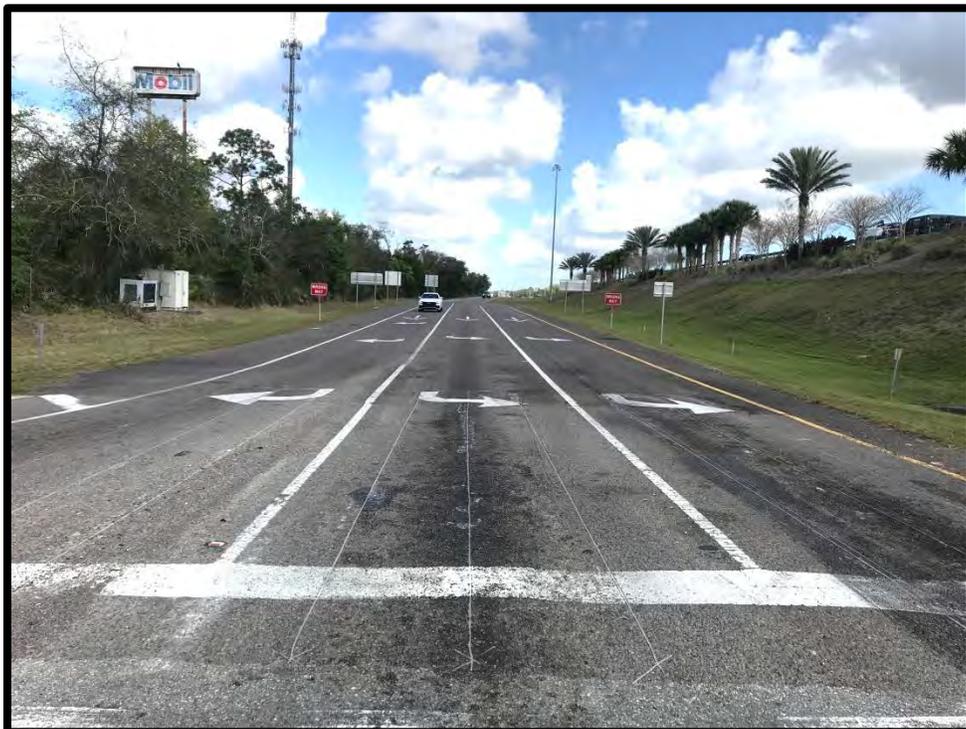
Looking North Away from Intersection

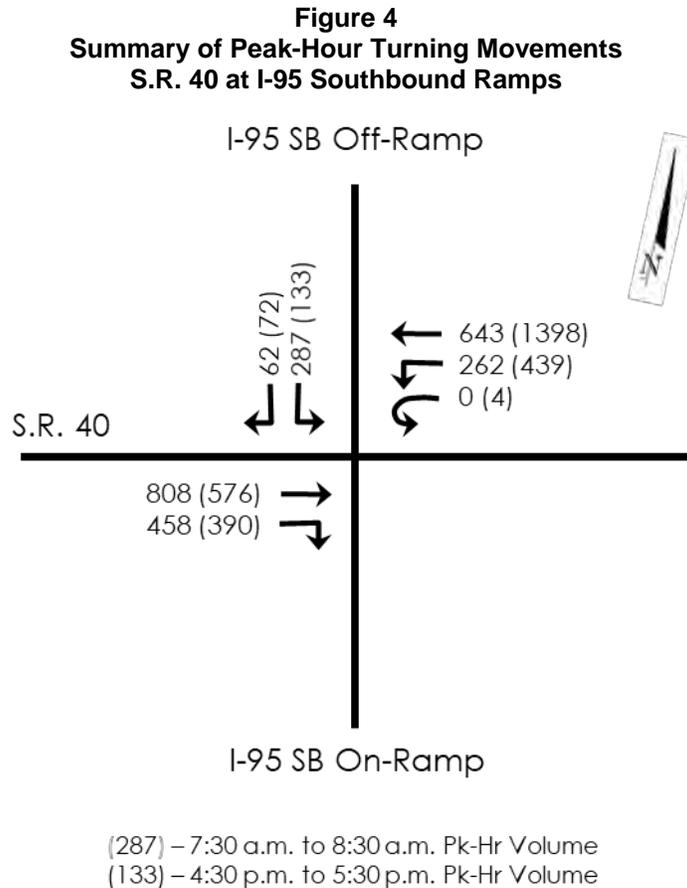
- The morning peak hour at the intersection occurred from 7:30 to 8:30 a.m. while the afternoon peak hour occurred from 4:30 to 5:30 p.m. As summarized below in **Figure 4**, 2,520 and 3,008 vehicles were counted entering the intersection during the morning and afternoon peak hours, respectively.

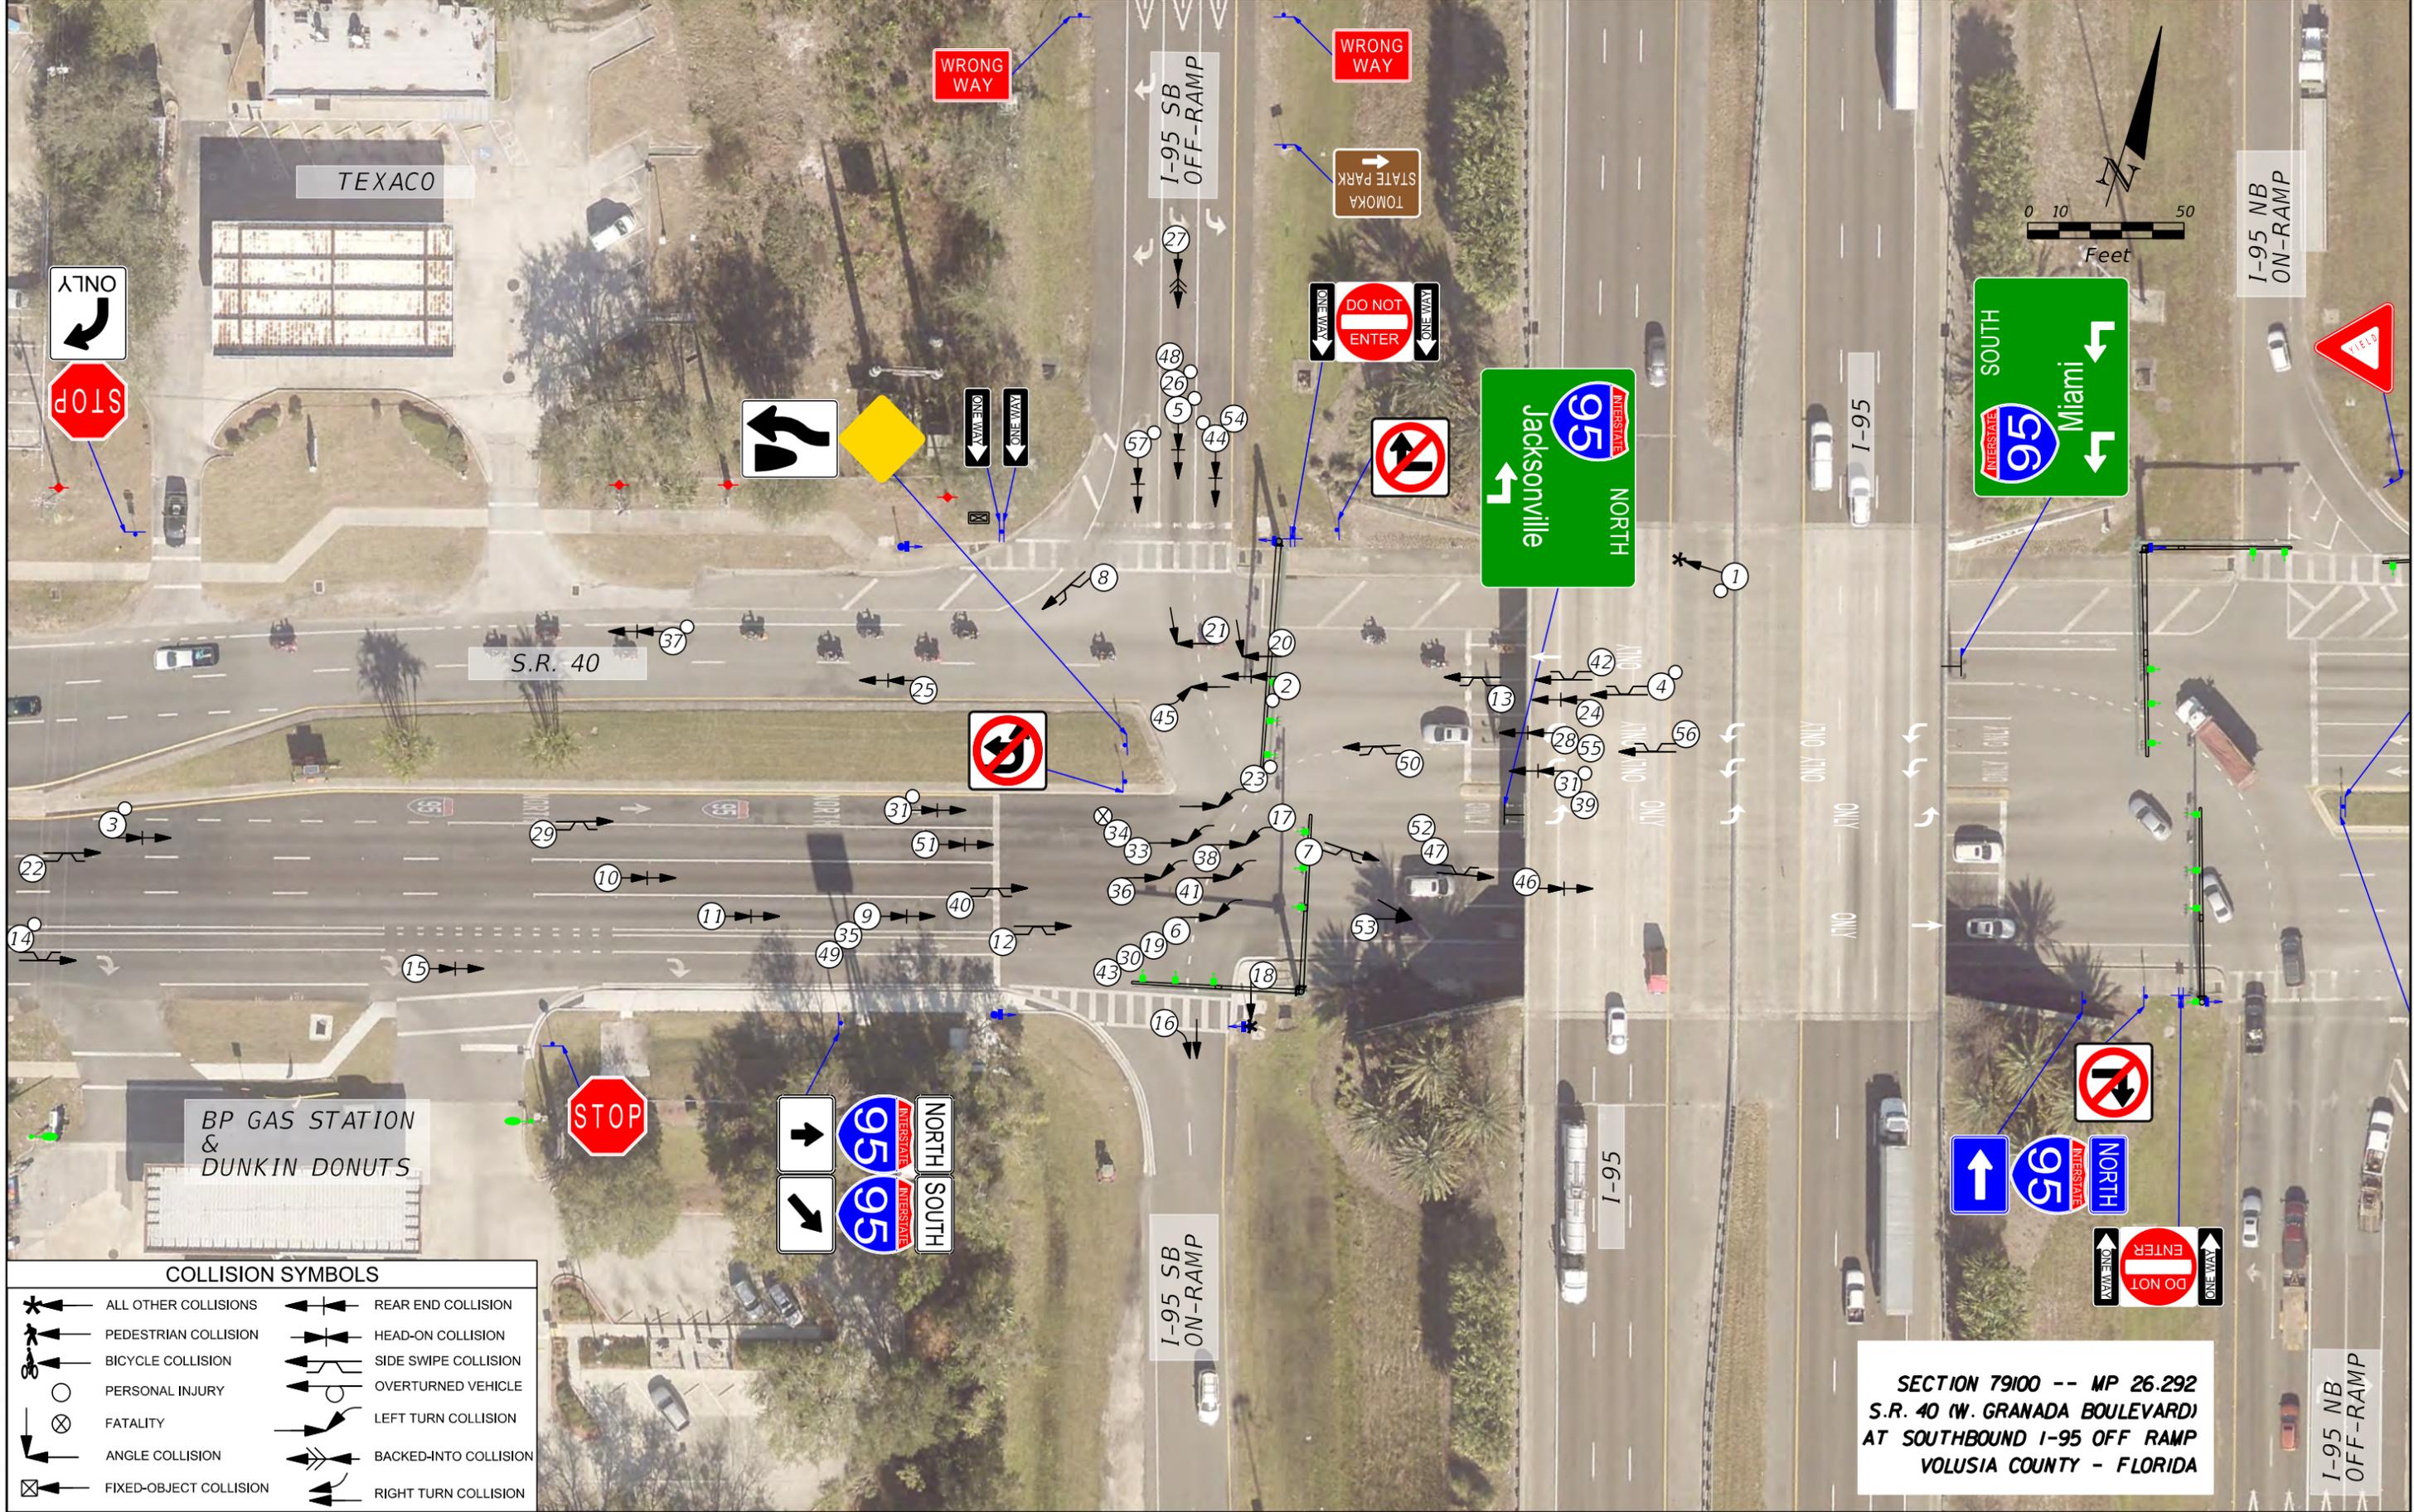
FIGURE 5
 COLLISION DIAGRAM
 (2/1/2017 - 1/31/2020)

A detailed collision summary is provided on the following page in **Table 2**. A collision diagram is provided as **Figure 5**.

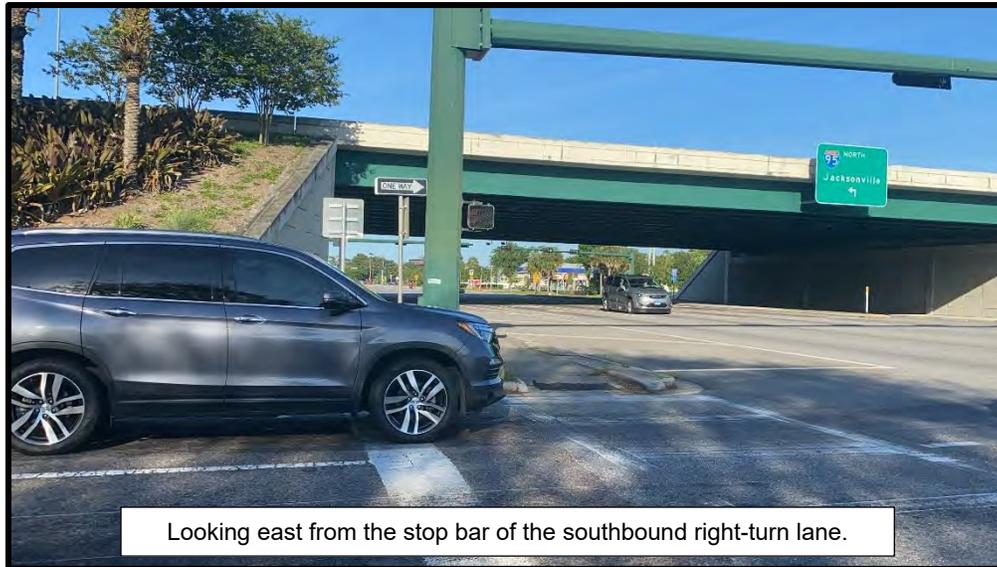
- From the southbound stop bar, visibility to the east can be restricted by the signal mast arm on the northeast corner (see photo on following page). The majority of southbound right-turning drivers were observed stopping on the crosswalk or beyond to get a better view of oncoming westbound through vehicles.

Looking east from the stop bar of the southbound right-turn lane.

- No crashes were reported that involved a southbound right-turning driver failing to yield to a westbound through vehicle. Due to the lower volume of right-turns and the observed efficiency with the RTOR movements, **it is recommended southbound RTOR continue to be permitted at the intersection.**

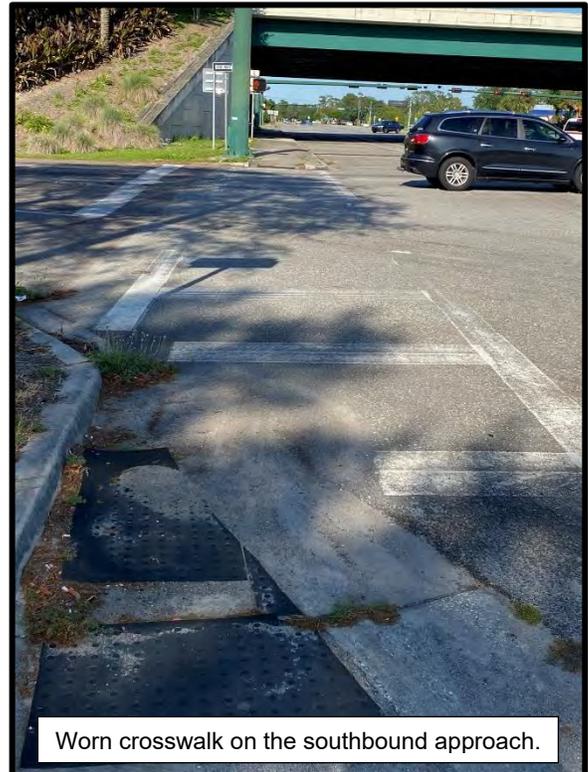
- The signs, pavement markings and pavement conditions appeared to be in good condition with the exception of the following:
 - The crosswalk on the southbound approach and the stop bar on the westbound approach are faded. **It is recommended the crosswalk and stop bar be restriped.**
 - The tactile mats on all four corners are damaged. **It is recommended the tactile mats be replaced.**

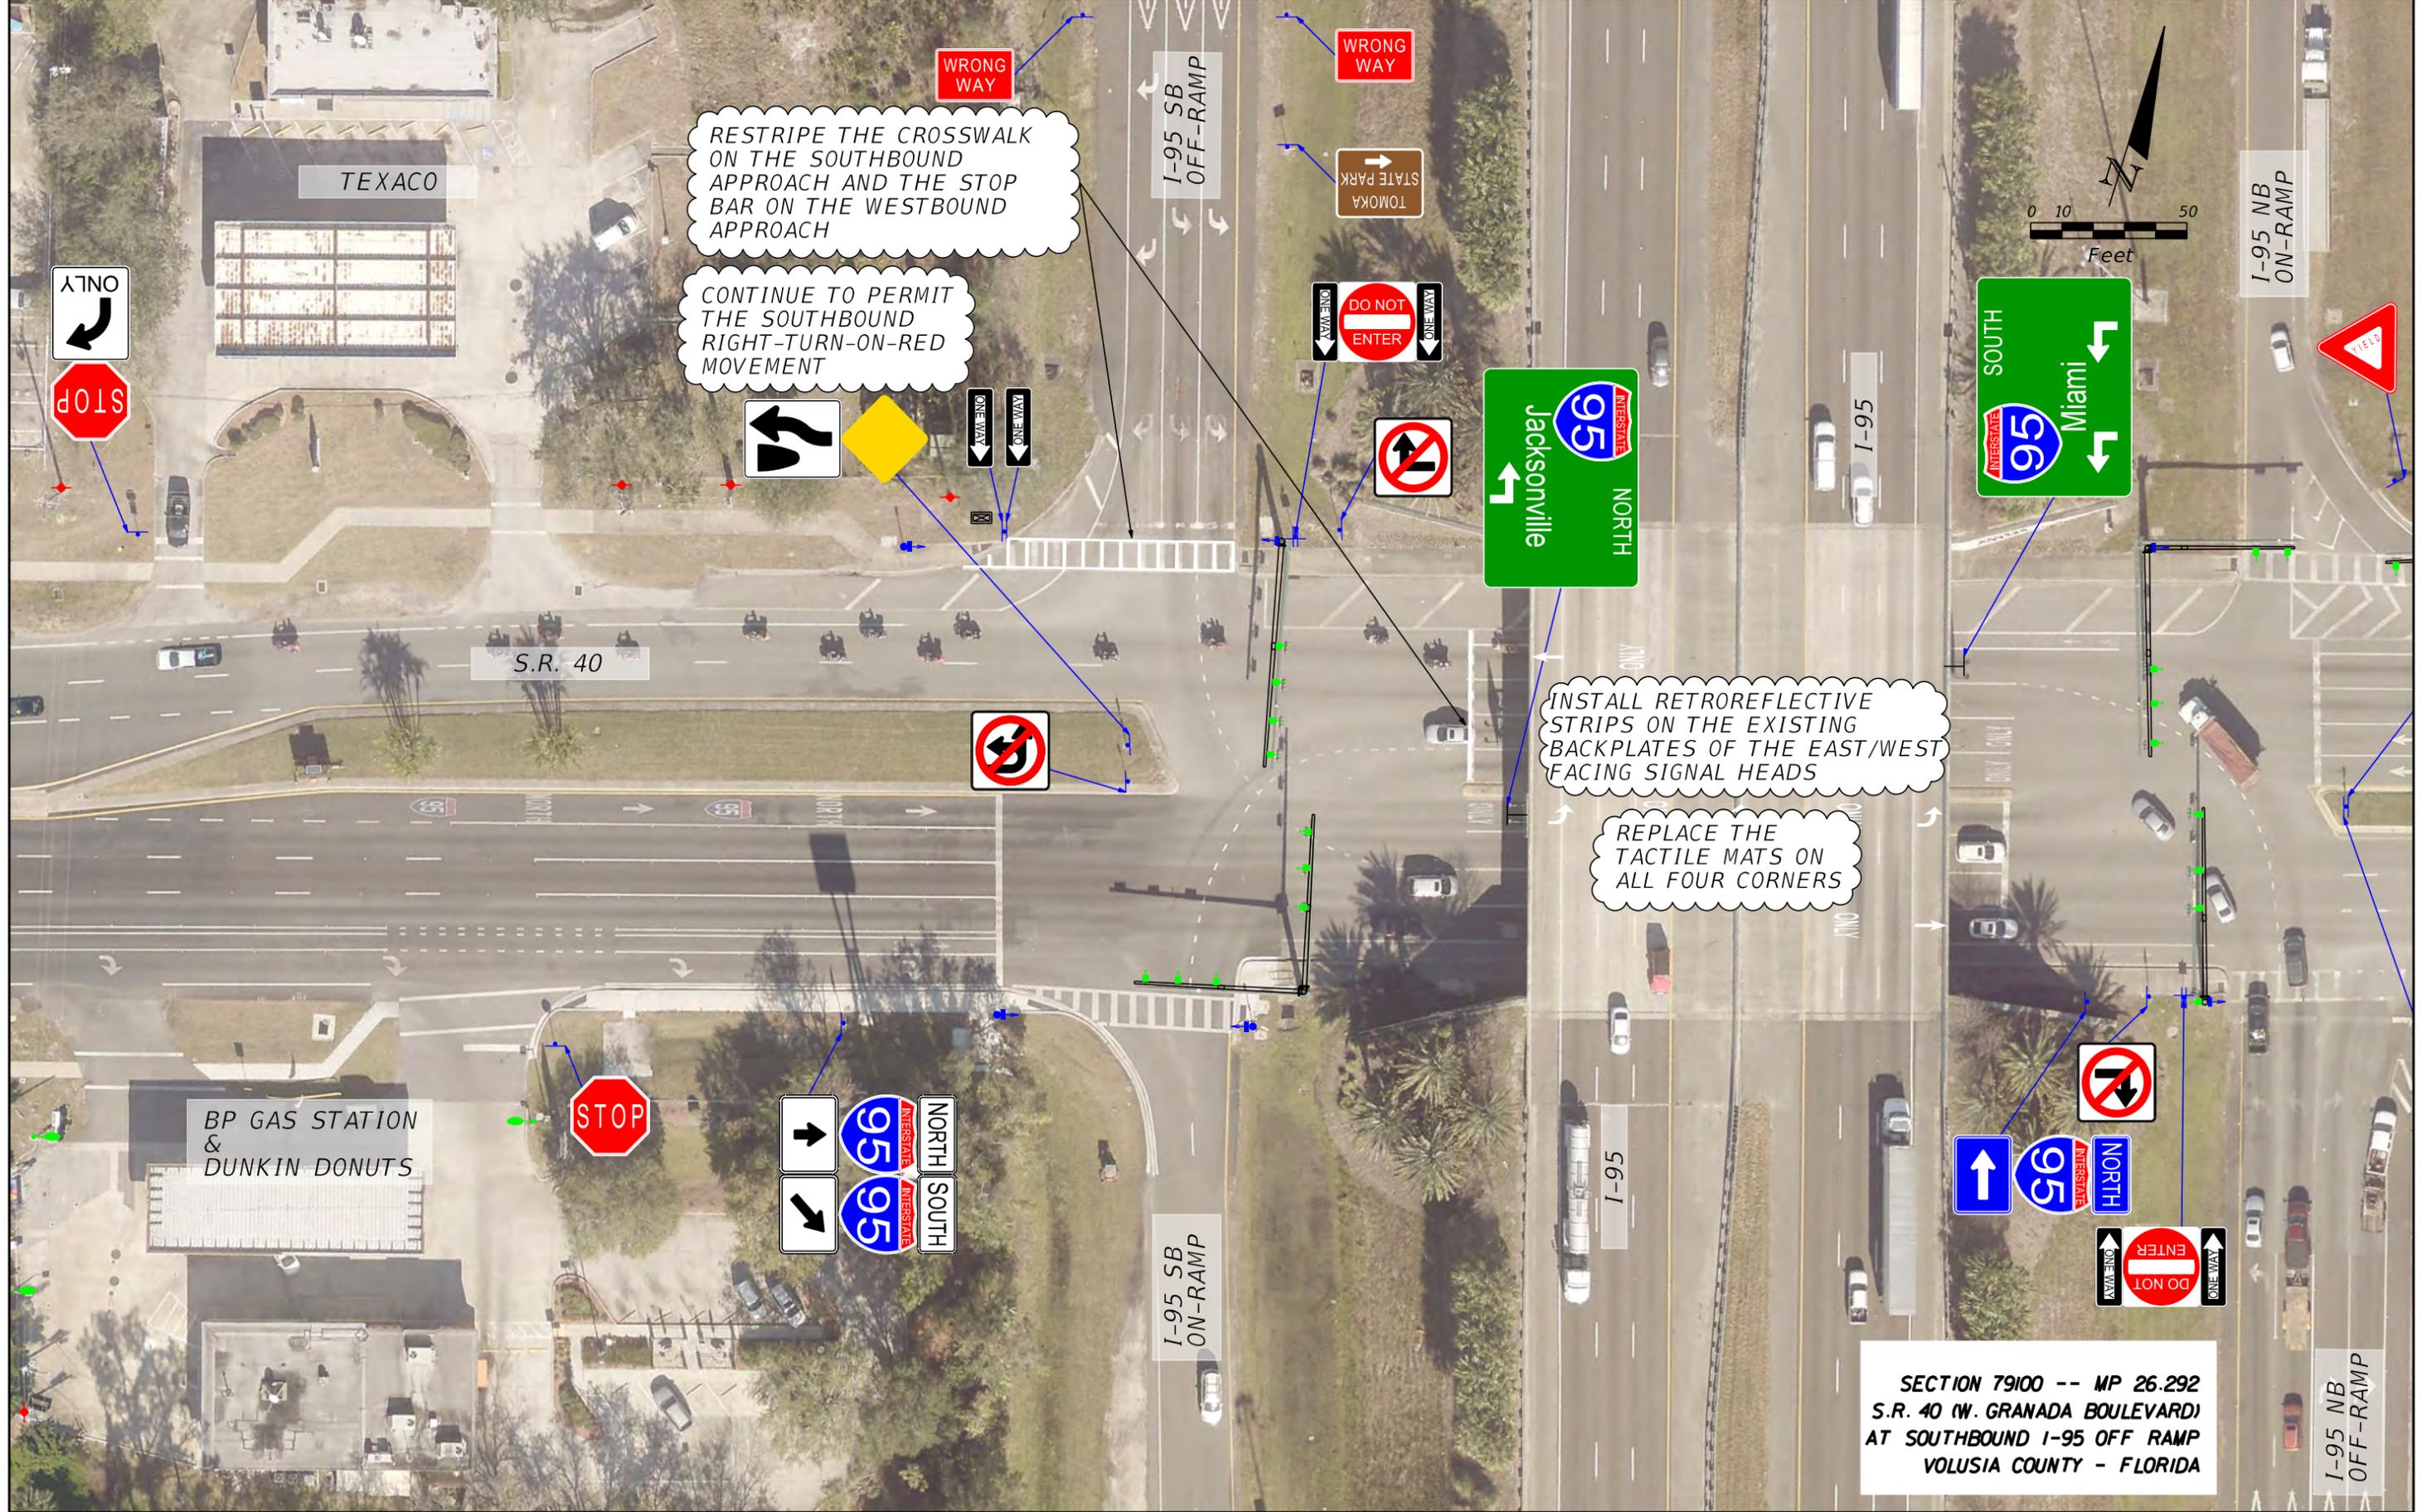
FIGURE 6
IMPROVEMENT DIAGRAM

RESTRIPE THE CROSSWALK ON THE SOUTHBOUND APPROACH AND THE STOP BAR ON THE WESTBOUND APPROACH

CONTINUE TO PERMIT THE SOUTHBOUND RIGHT-TURN-ON-RED MOVEMENT

INSTALL RETROREFLECTIVE STRIPS ON THE EXISTING BACKPLATES OF THE EXISTING EAST/WEST FACING SIGNAL HEADS

REPLACE THE TACTILE MATS ON ALL FOUR CORNERS

- Continue to permit the southbound right-turn-on-red movement.
- Install retroreflective strips on the existing backplates of the east/west facing signal heads.
- Restripe the crosswalk on the southbound approach and the stop bar on the westbound approach.
- Replace the tactile mats on all four corners.
