# CONTAMINATION SCREENING EVALUATION REPORT

## **S.R. 401 Bridge Replacement PD&E Study**

Brevard County, Florida

Financial Project Identification (FPID) Number: 444787-1-22-01  
ETDM Number: 14397

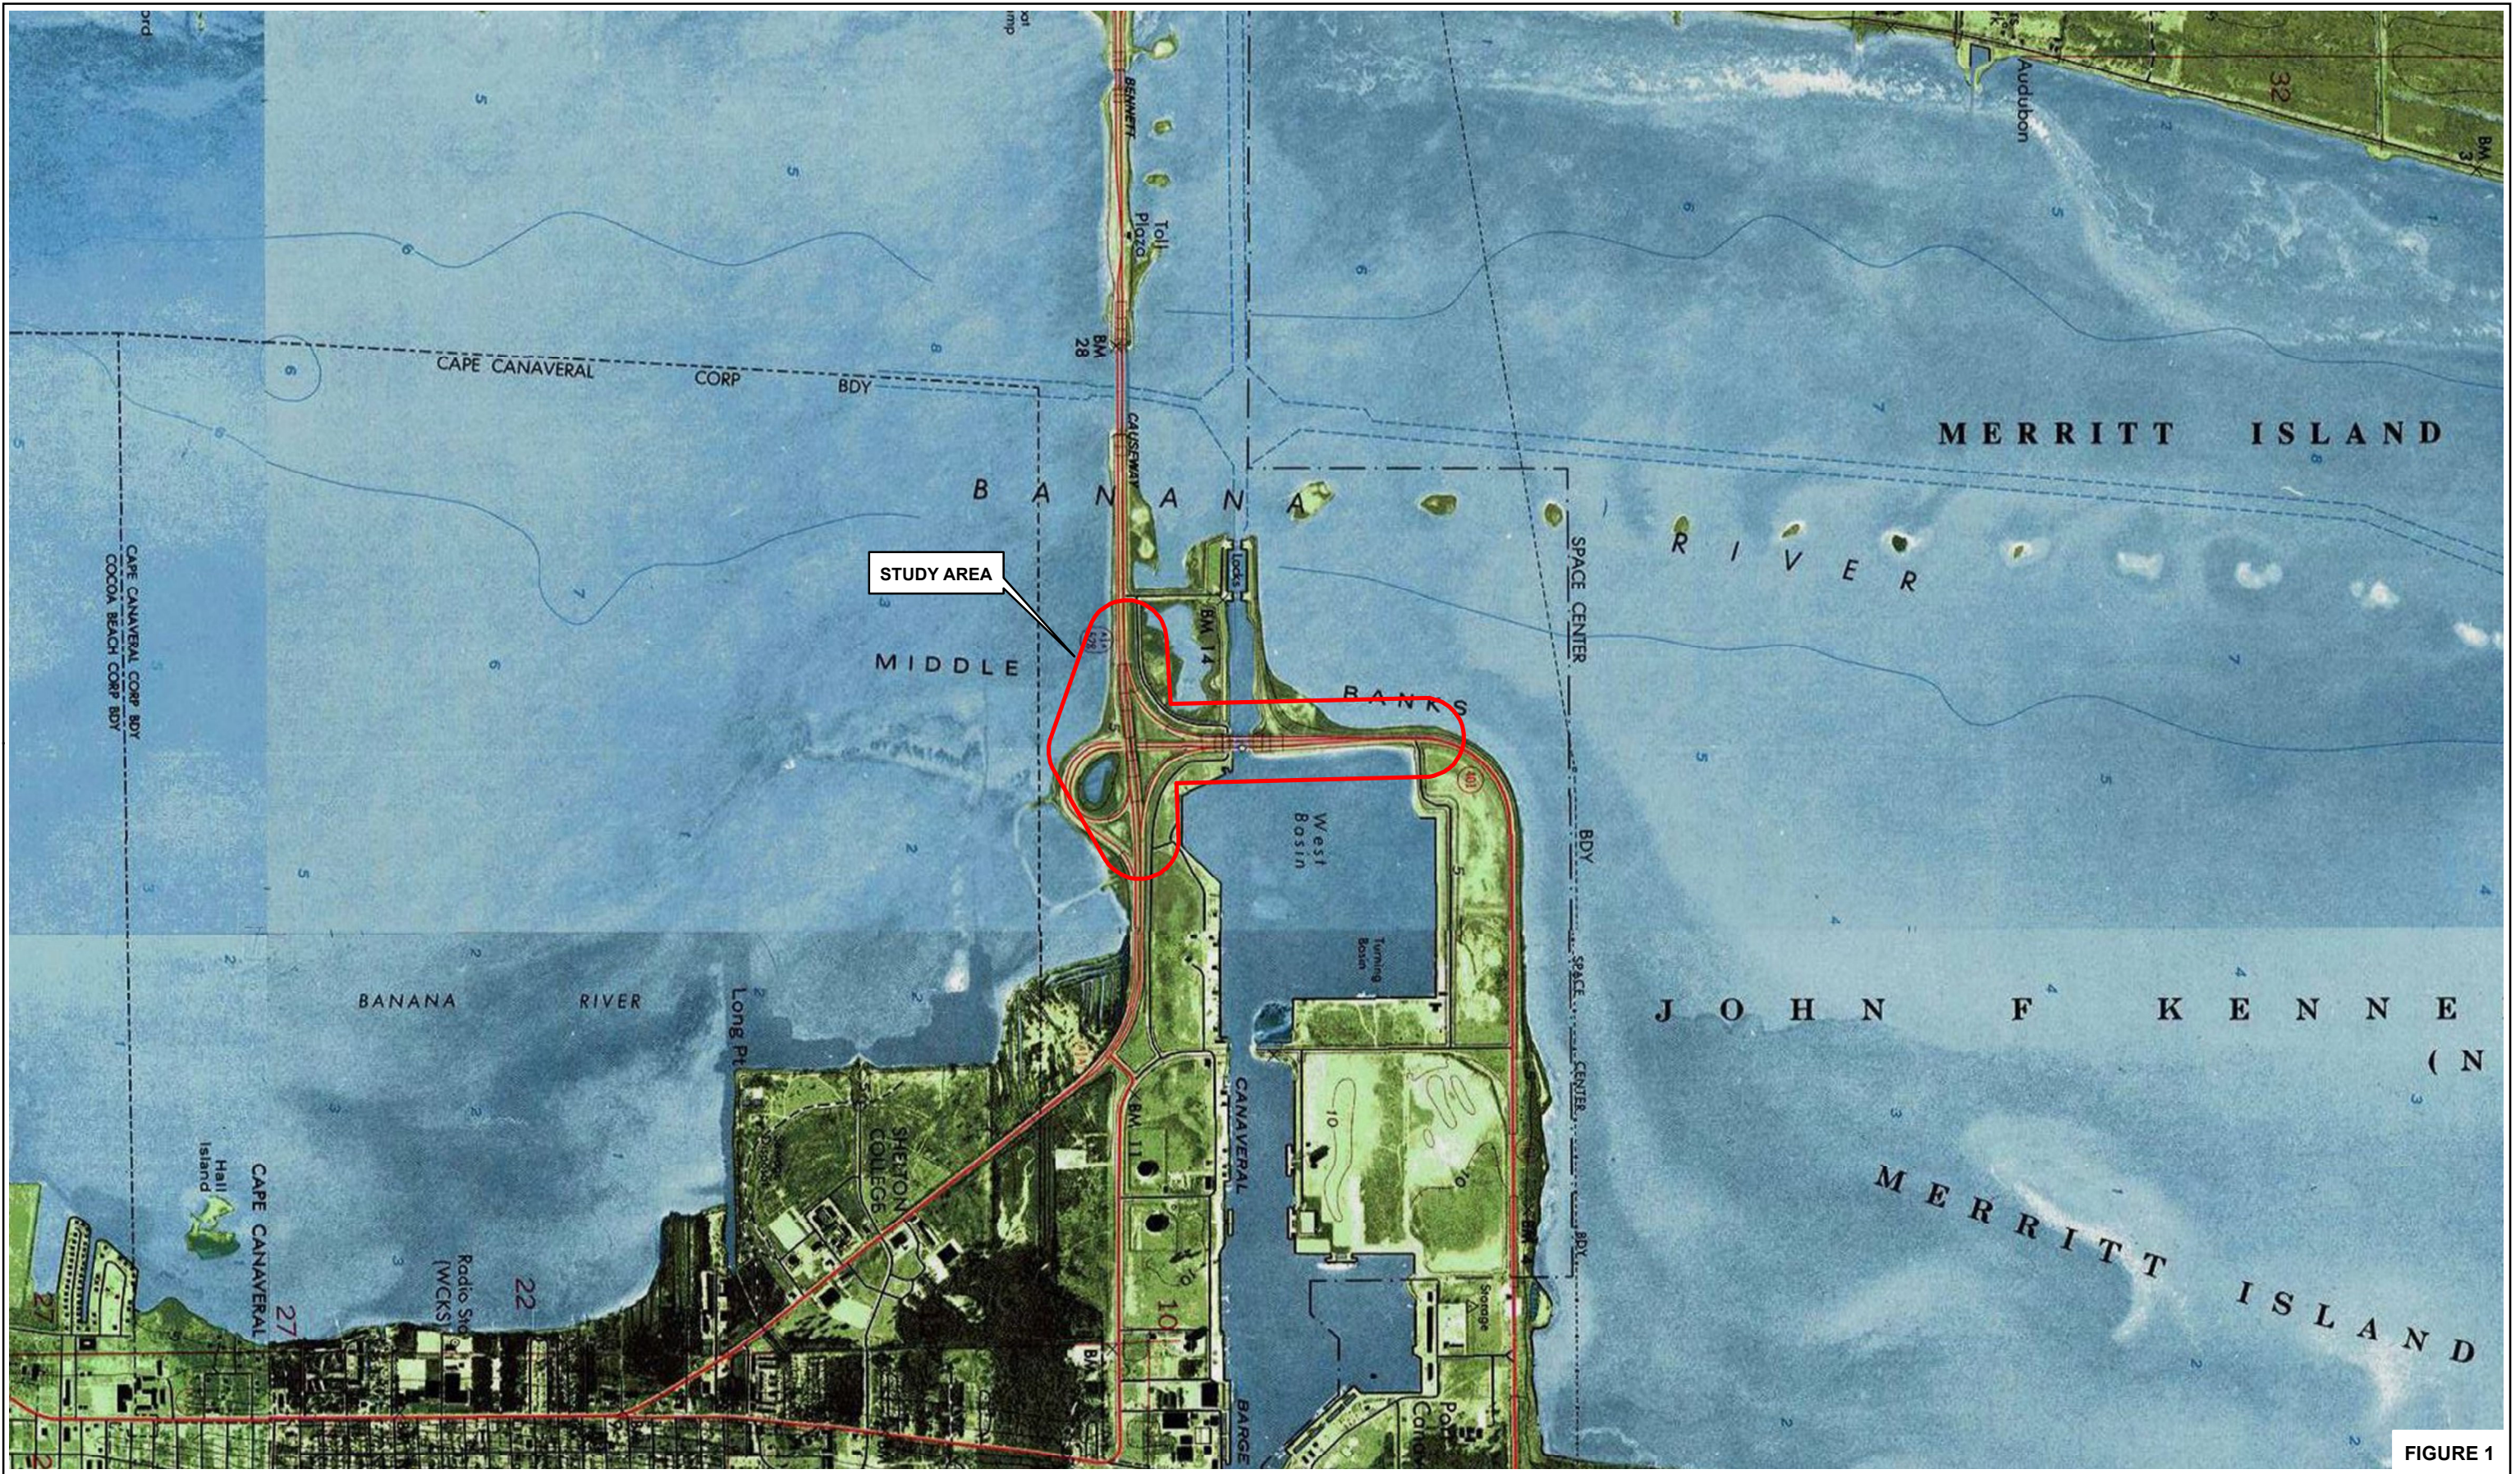
FIGURE 1

The study area has been transposed onto the United States Geological Survey (USGS) Courtenay, Florida Quadrangle Map, as shown on **Figure 1**. The USGS Quadrangle maps indicate that the natural topography of the study ranges between +0 and +5 feet above the National Geodetic Vertical Datum (NGVD). The study area includes, and slopes gently towards, Port Canaveral and the Banana River.

No landfills, borrow pits, quarries, or other conditions are depicted that would represent potential contamination concerns on, or in the immediate vicinity of, the study area.

USGS Courtenay, FL. Quadrangle Map		RICHARD P. McCORMICK, P.G. P.G. LICENSE NUMBER 2096 GEOTECHNICAL AND ENVIRONMENTAL CONSULTANTS, INC. 919 LAKE BALDWIN LANE ORLANDO, FL 32814			STATE OF FLORIDA DEPARTMENT OF TRANSPORTATION			SHEET NO.
		ROAD NO.	COUNTY	FINANCIAL PROJECT ID	USGS QUADRANGLE MAP			
		SR 401	BREVARD	444787-1-22-01

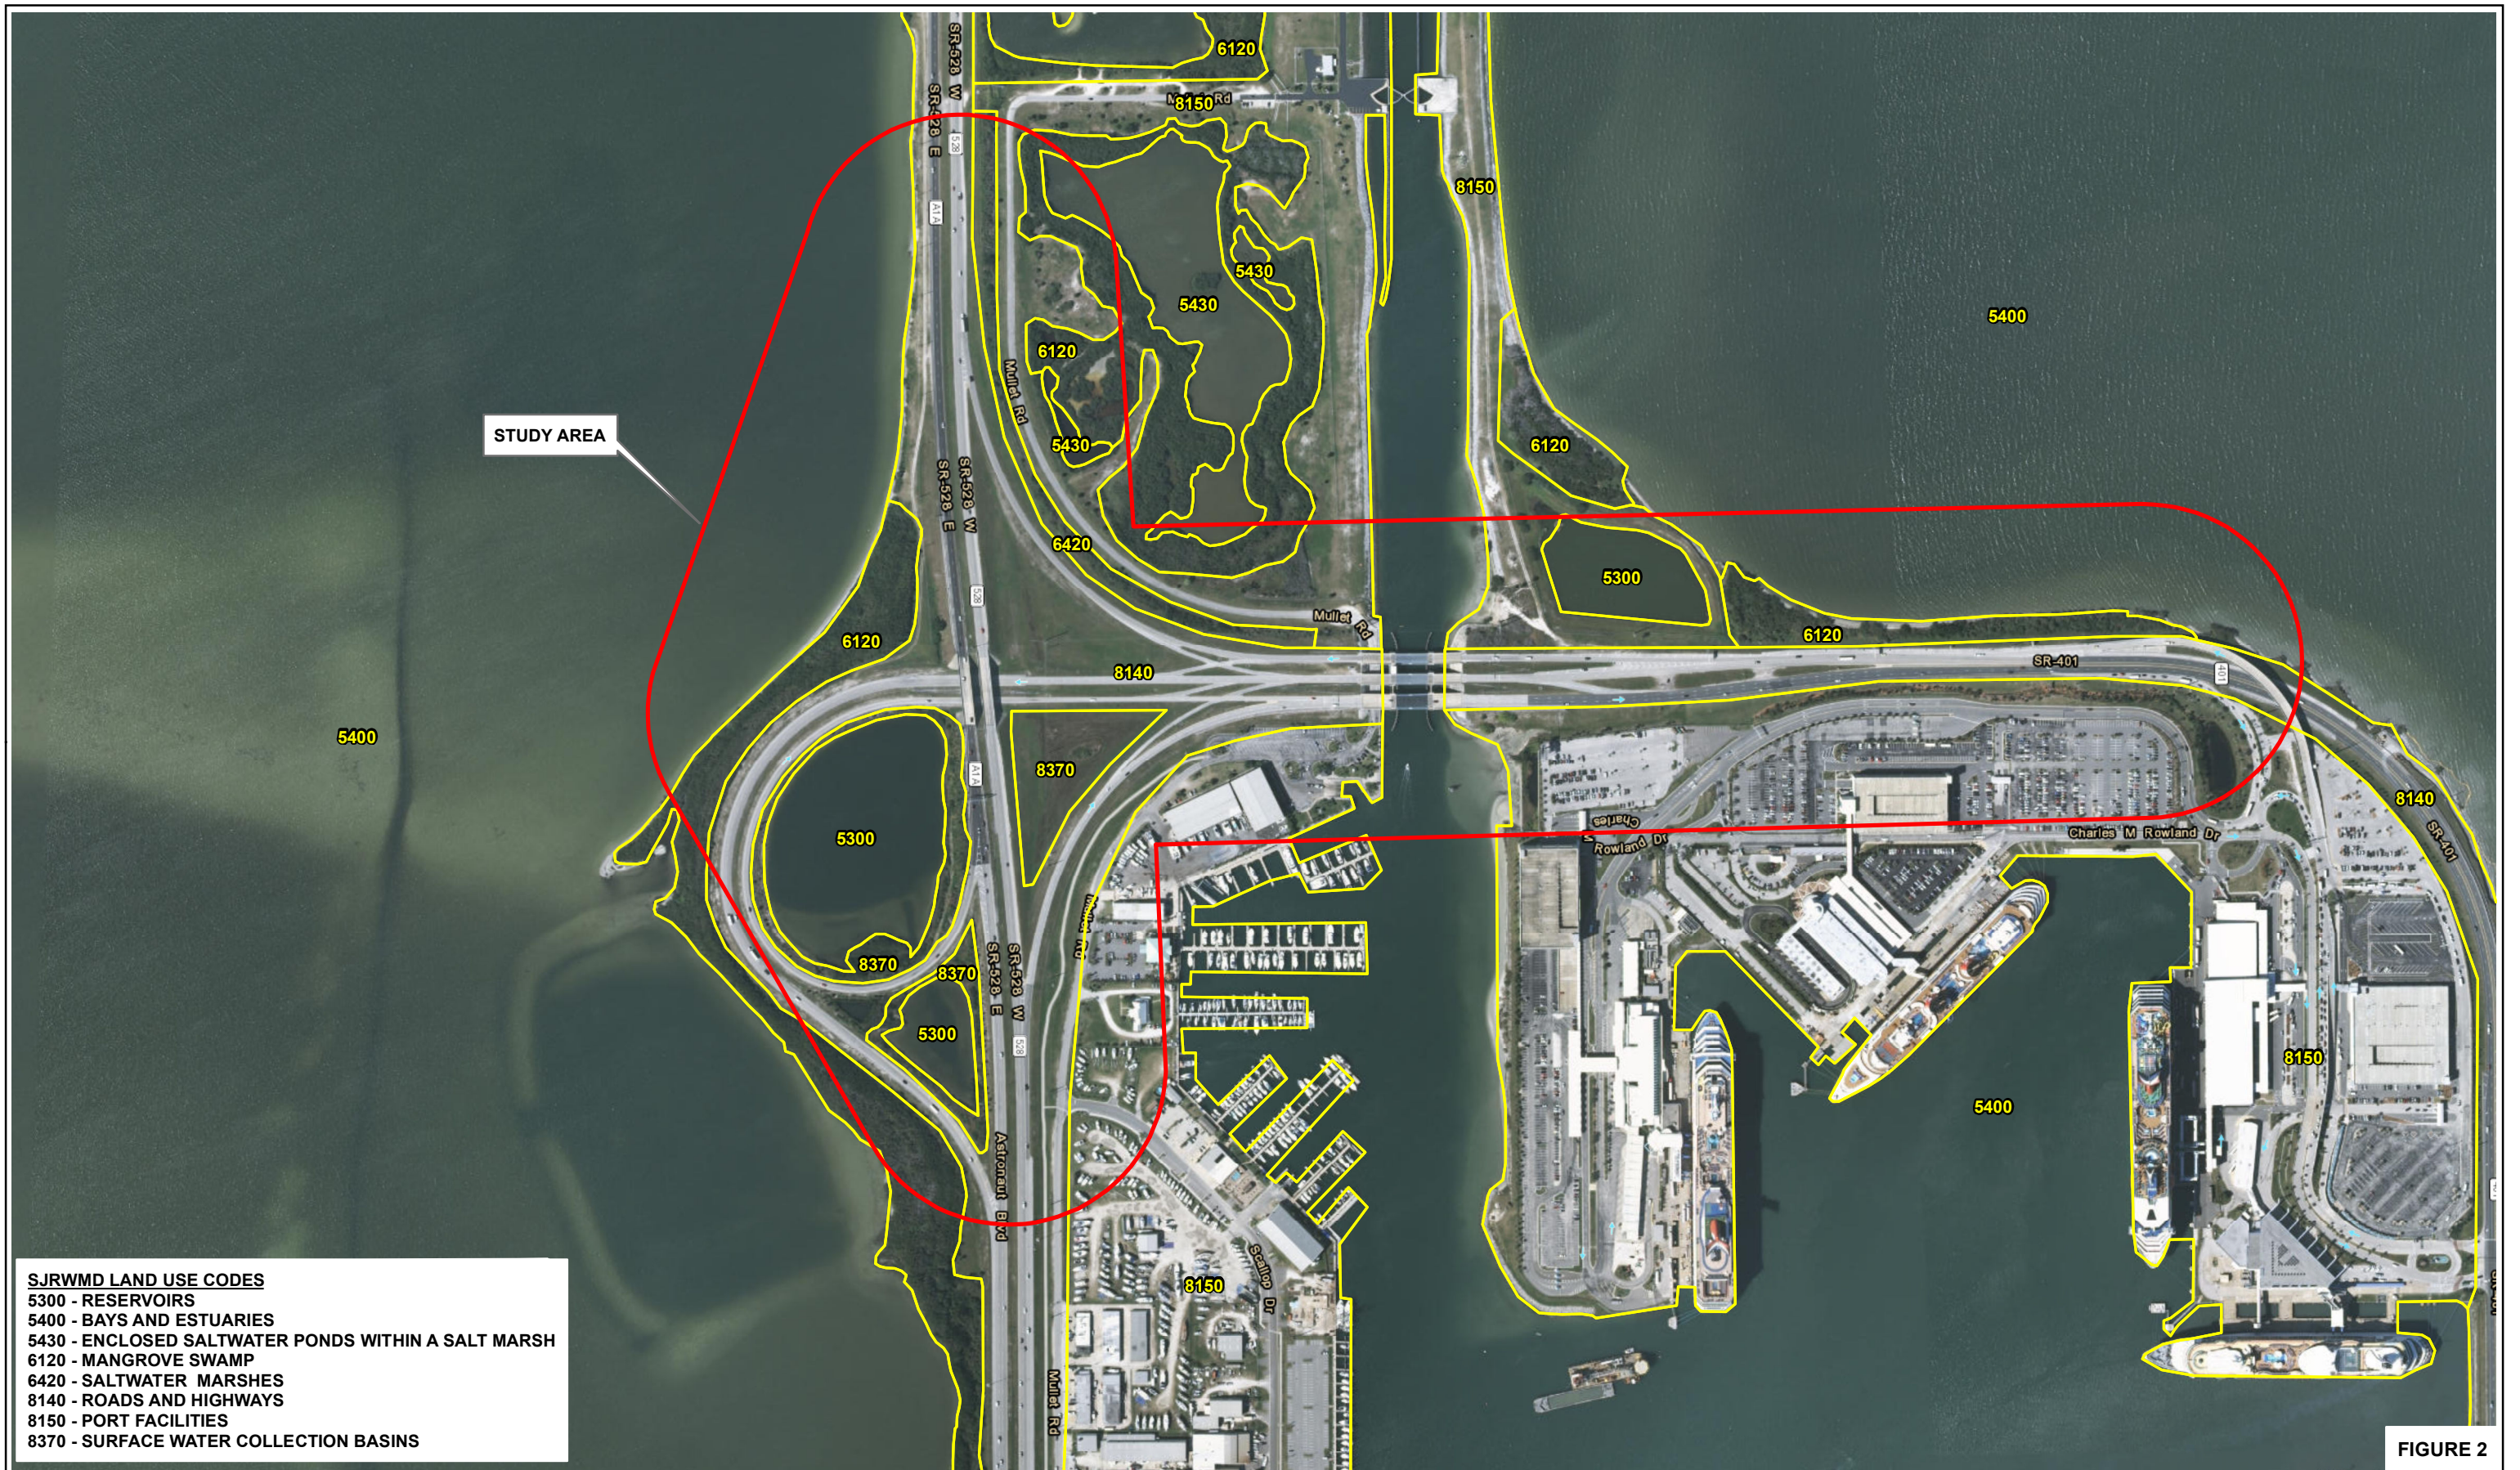
LAND USE MAP

The current land uses within the study area are shown on the St Johns River Water Management District (SJRWMD) Map on **Figure 2** and are summarized as follows:

- Reservoirs
- Bays and Estuaries
- Mangrove Swamp
- Enclosed saltwater ponds within a salt marsh
- Saltwater marshes
- Roads and highways
- Port facilities
- Surface water collection basins

- SJRWMD LAND USE CODES**
- 5300 - RESERVOIRS
  - 5400 - BAYS AND ESTUARIES
  - 5430 - ENCLOSED SALTWATER PONDS WITHIN A SALT MARSH
  - 6120 - MANGROVE SWAMP
  - 6420 - SALTWATER MARSHES
  - 8140 - ROADS AND HIGHWAYS
  - 8150 - PORT FACILITIES
  - 8370 - SURFACE WATER COLLECTION BASINS

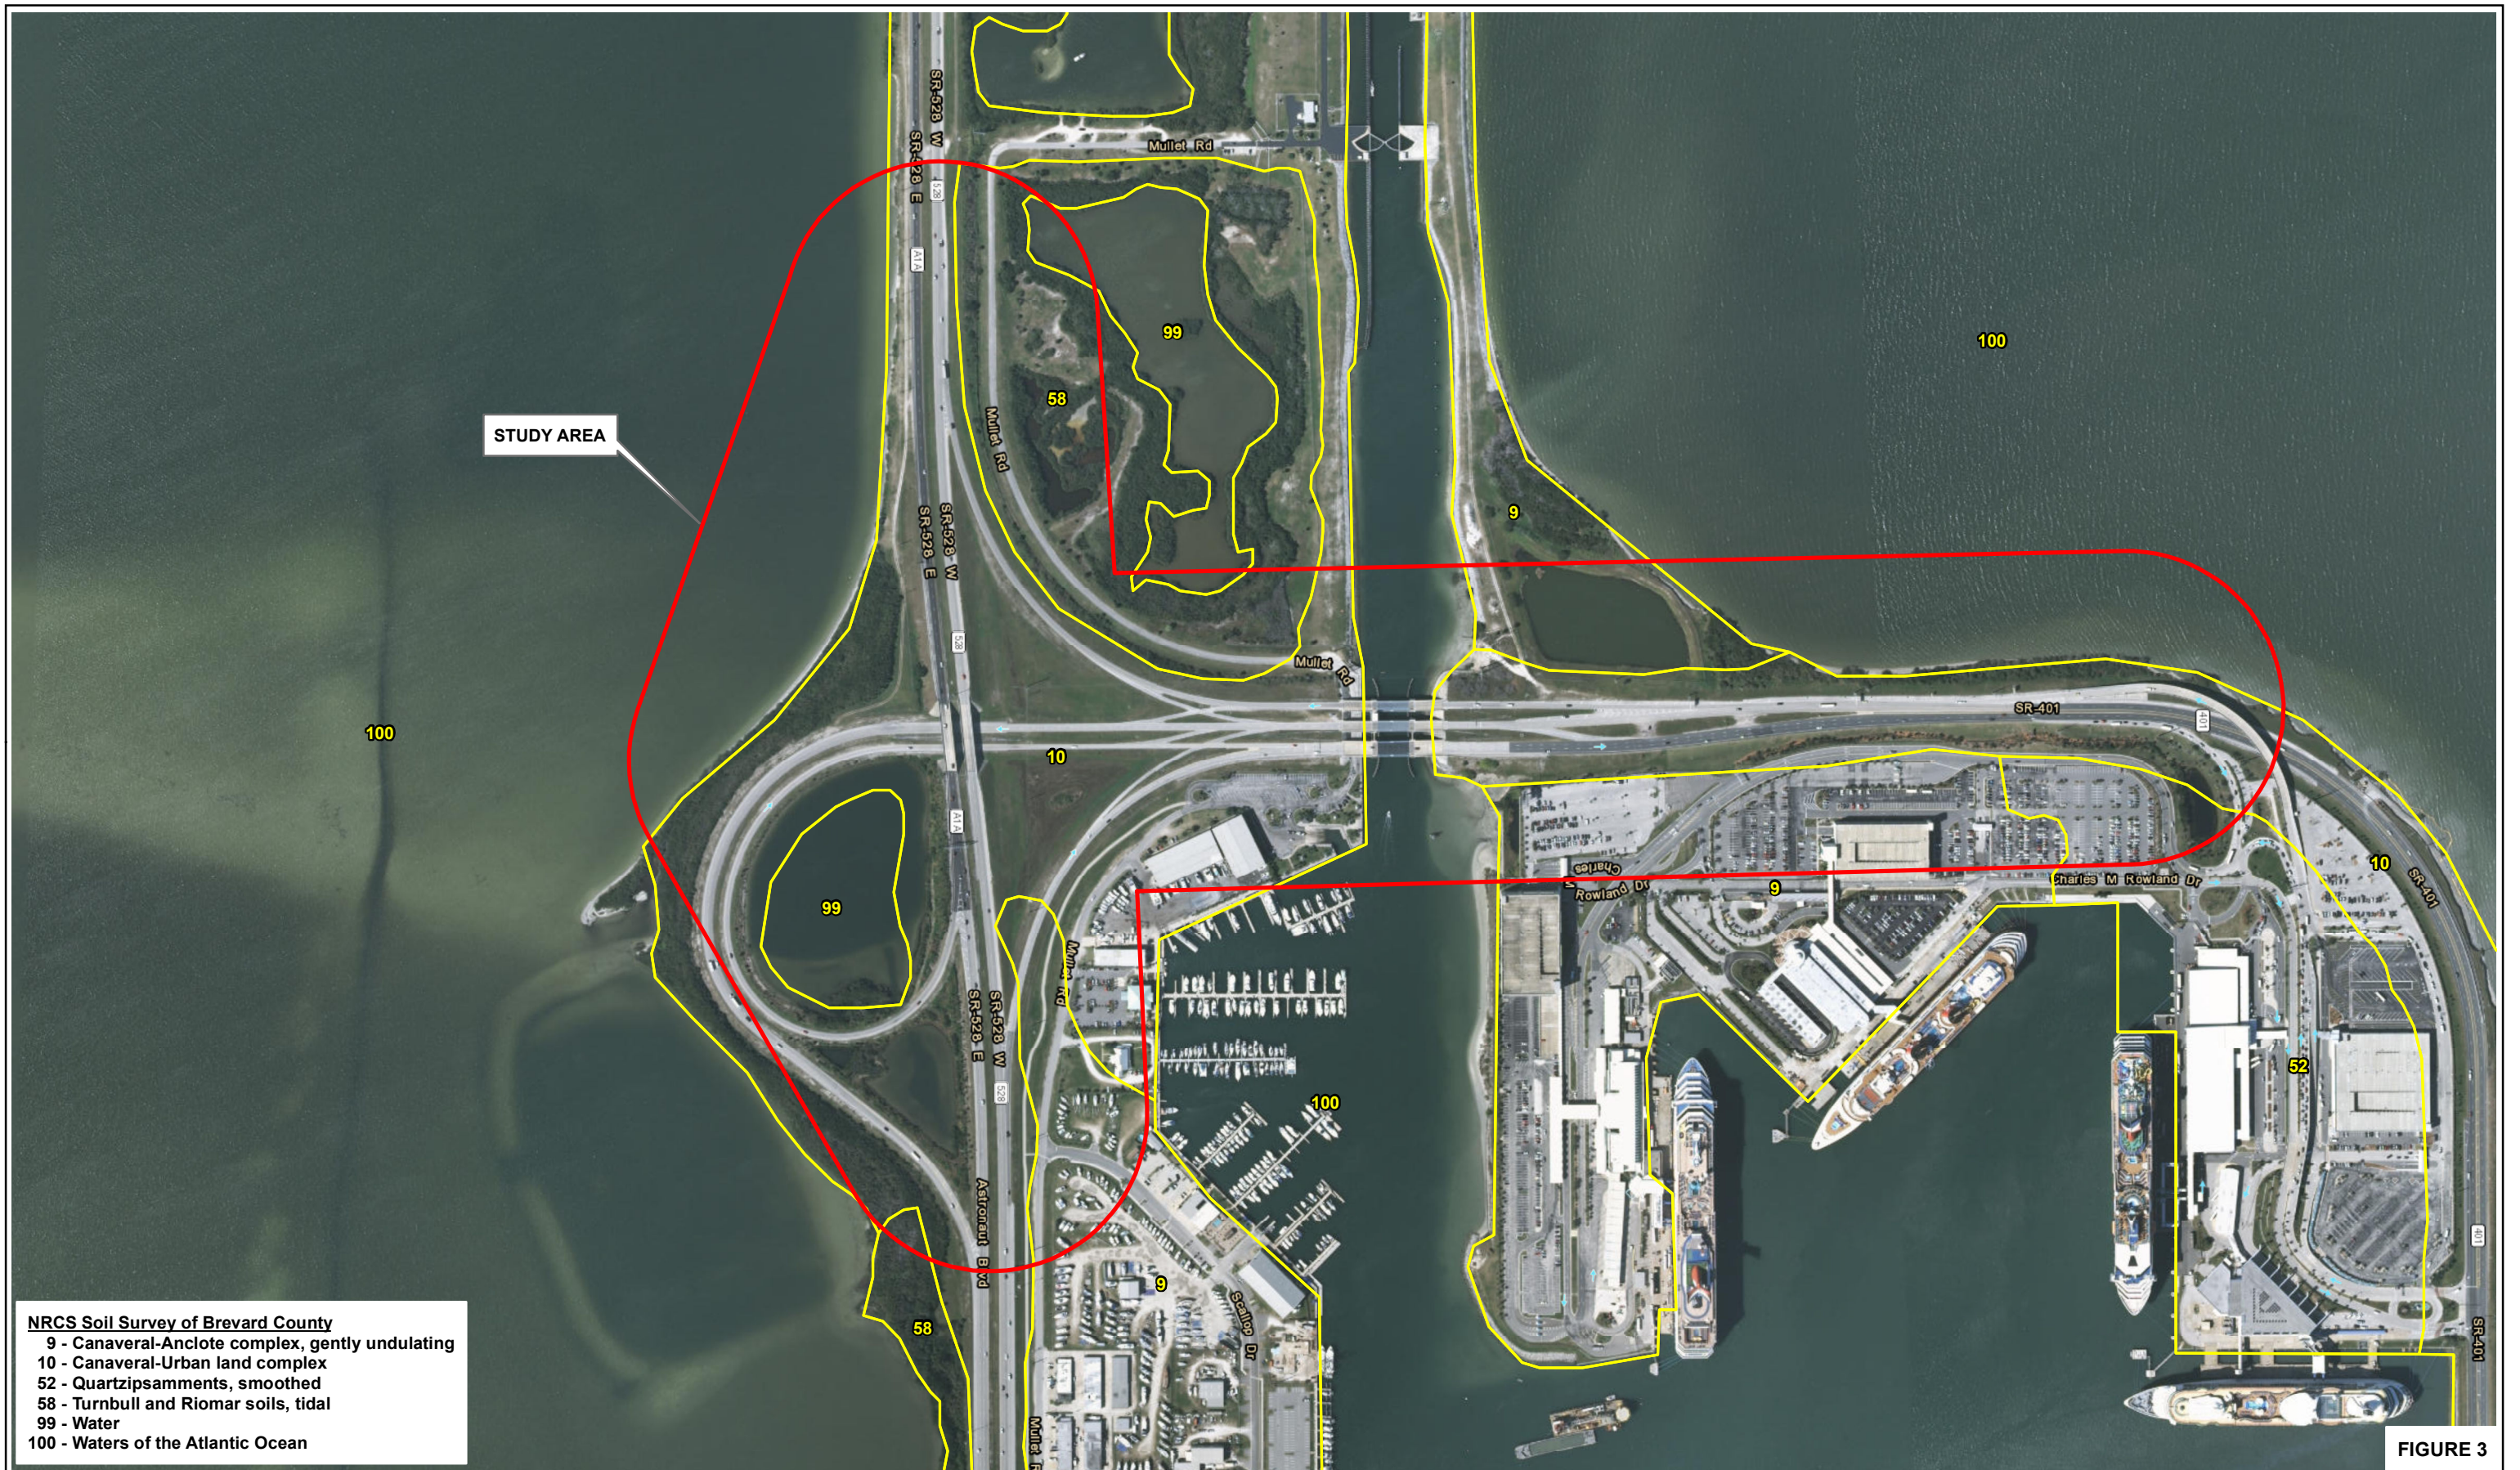
**FIGURE 3**

The National Resources Conservation Service (NRCS) Soil Survey for Brevard County, Florida was reviewed for information regarding near-surface soil conditions within the project limits, as shown on **Figure 3**. The following soil types were identified within the study area:

Unit No.	Soil Name	Unit No.	Soil Name
9	Canaveral-Anclote complex, gently undulating	10	Canaveral-Urban land complex
52	Quartzipsamments, smoothed	58	Turnbull & Riomar soils, tidal
99	Water	100	Waters of the Atlantic Ocean

Quartzipsamments, smoothed (Soil Type No. 52) are nearly level to steep sands that have been reworked and shaped by earthmoving equipment. These soils are commonly found near urban areas, highways and in ponds and sloughs that have been filled to the surrounding ground level.

**NRCS Soil Survey of Brevard County**  
 9 - Canaveral-Anclote complex, gently undulating  
 10 - Canaveral-Urban land complex  
 52 - Quartzipsamments, smoothed  
 58 - Turnbull and Riomar soils, tidal  
 99 - Water  
 100 - Waters of the Atlantic Ocean

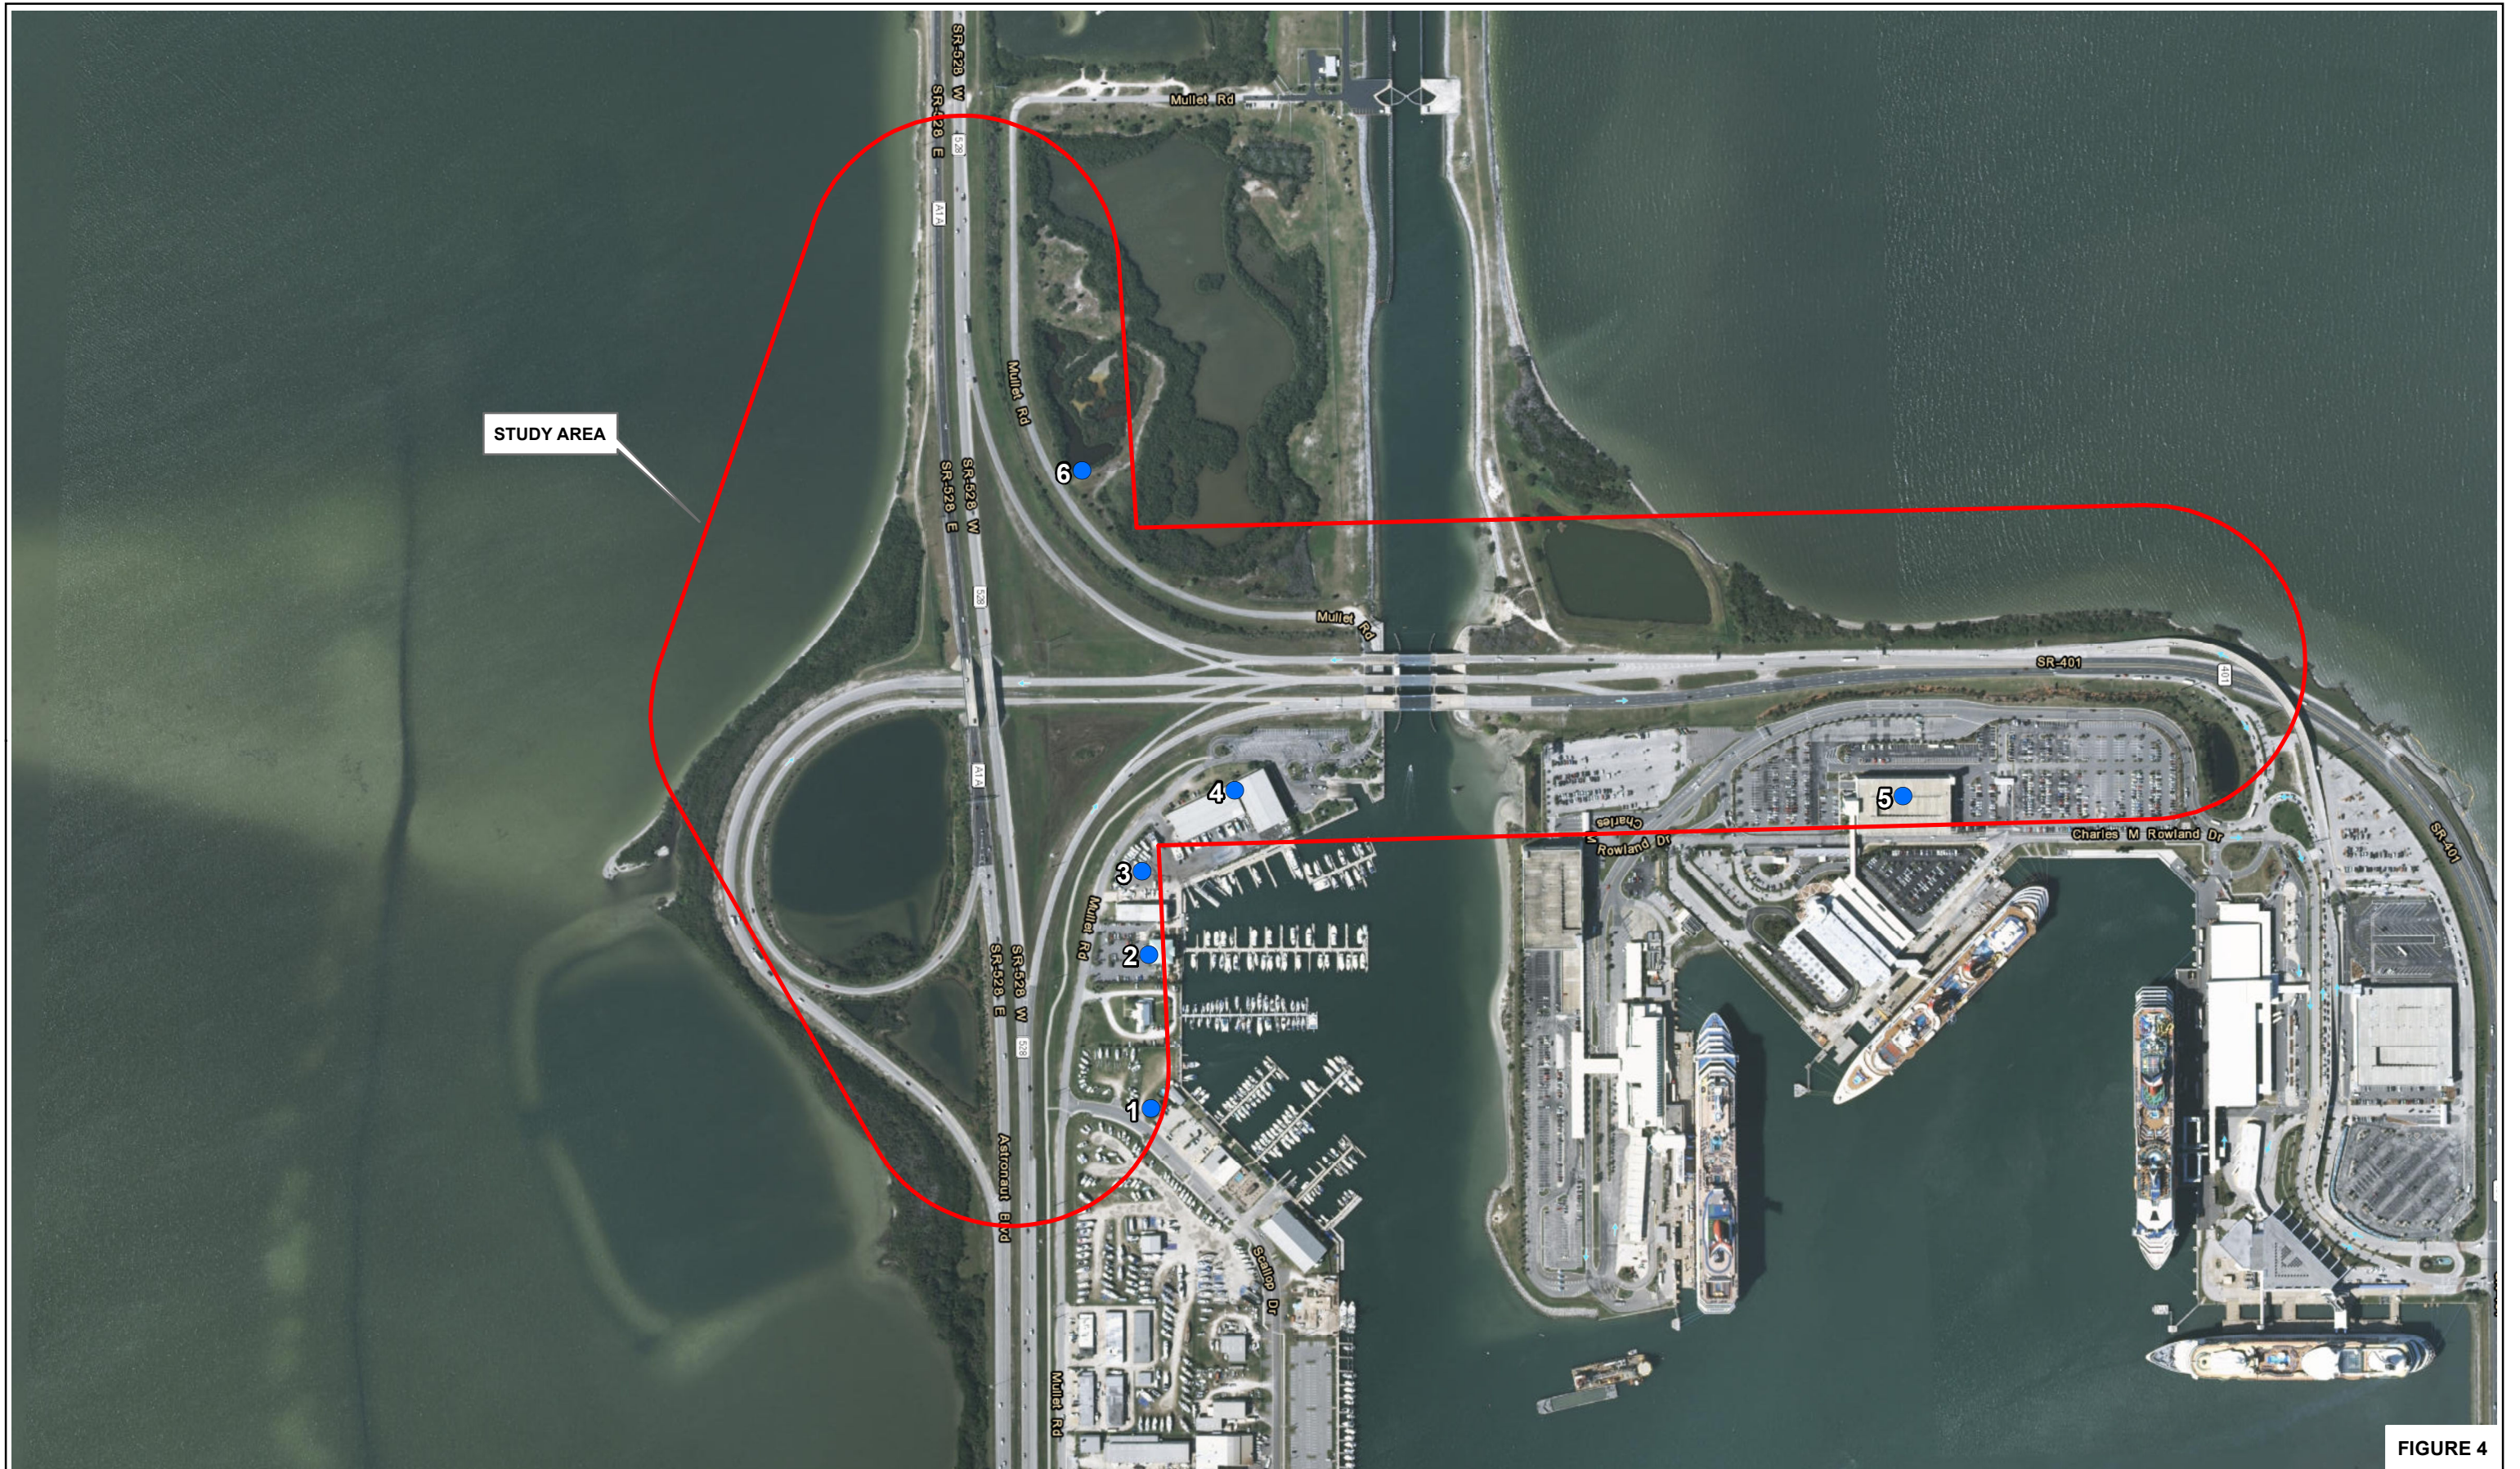
FIGURE 4

As a result of this evaluation, we have assigned Contamination Risk Ratings (CRR) to six sites. The site locations are shown on **Figure 4** and the contamination status of each site is summarized in **Table 1**.

- SITE WITH HIGH RISK RATING
- SITE WITH MEDIUM RISK RATING
- SITE WITH LOW RISK RATING
- SITE WITH NO RISK RATING

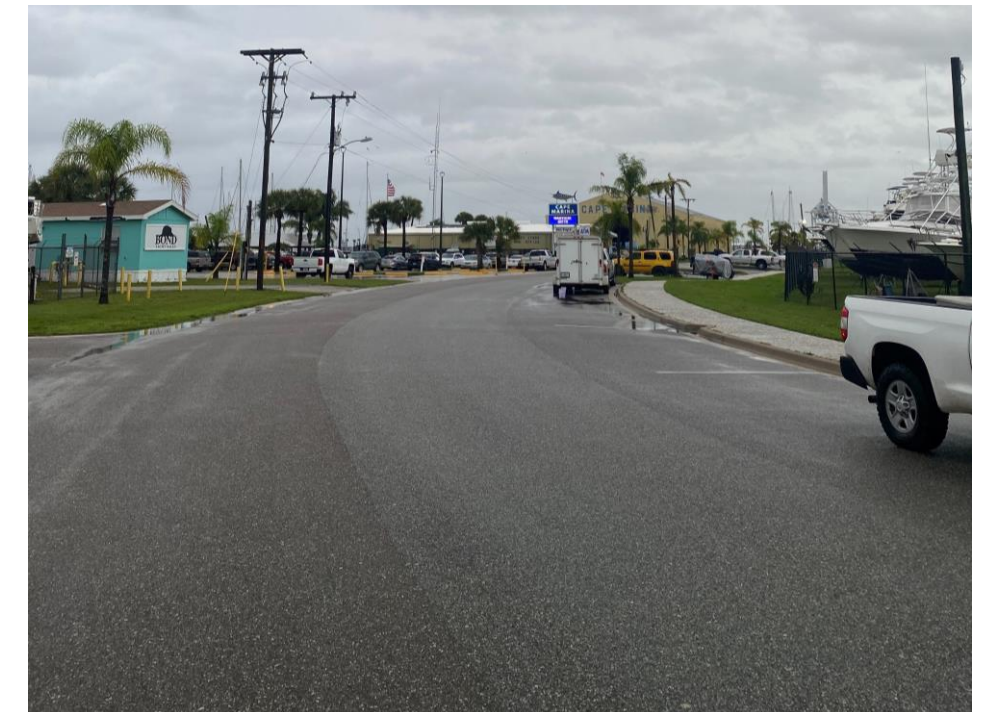
Site No:	<b>1</b>		Risk Potential:	<b>LOW</b>	
Site Name	<b>Cape Marina Services</b>				
Site Address	800 Scallop Drive				
Site Location	Northeast corner of the SR 528 and SR 401 interchange				
Distance/Direction	>450 feet north and northeast of the SR 528 westbound to SR 401 northbound offramp				
Facility ID Nos:	FLR000005850, 8500921				
Database Listings/Sources:	AST, NPDES, RCRA SQG				
Historical Land Use	Marina				
Current Land Use	Marina, Fueling Dock and Boat Repair				
Contaminants	Petroleum Products and Hazardous Materials				
TANKS	U/A	Capacity (gal)	Content	Installed	Removed
1	A	10,000	Unleaded Gas	3/2005	In Use
1	A	20,000	Vehicular Diesel	3/2005	In Use
1	A	20,000	Unleaded Gas	6/1976	2004/2005
Discharge Date	N/A		Cleanup Date:	N/A	
Documented/ Known Impacts:	NO		NO

**PUBLIC RECORDS:** The public records document a 10,000-gallon aboveground gasoline tank that was present from 1976 through about 2005 when it was replaced with aboveground 10,000-gallon gasoline and 20,000-gallon diesel tanks. The 1976 tank was about 900 feet from the SR 401 northbound onramp and the newer tanks are about 1,250 feet from the onramp. No spills, discharges or contamination impacts are documented relative to these tanks.

The only hazardous waste information was relative to a citizen complaint regarding improperly disposed sand blasting media. No contamination is documented relative to the site's hazardous waste status.

**CONCLUSIONS:** This site is a boat yard and marina that fuels boats and generates some hazardous material from boat painting and repairs. No contamination impacts are documented for this location.

Based on the lack of documented contamination impacts, and the distance from the proposed SR 401 improvements, this site has been assigned a Contamination Risk Rating (CRR) of **Low**.

Looking east towards Cape Marina Services. Site is on both sides of photograph/road.

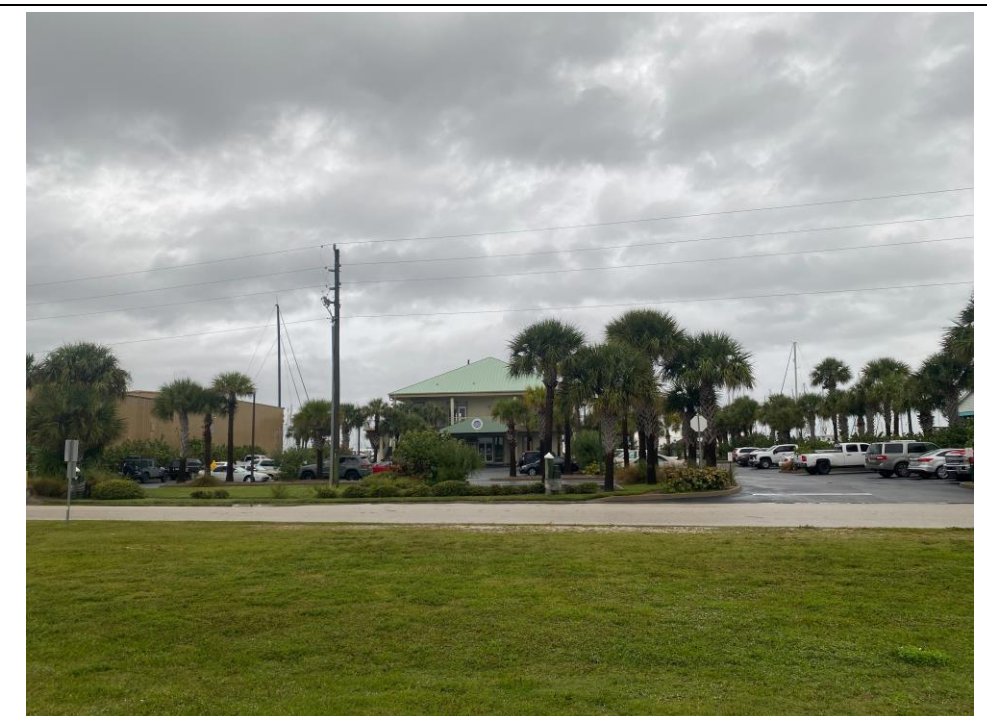
Site No:	<b>2</b>		Risk Potential:	<b>LOW</b>	
Site Name	<b>Ocean Club at Port Canaveral</b>				
Site Address	930 Mullet Road				
Site Location	Northeast corner of the SR 528 and SR 401 interchange				
Distance/Direction	375 feet north of the SR 528 westbound to SR 401 northbound offramp				
Facility ID Nos:	9810255				
Database Listings/Sources:	UST				
Historical Land Use	Marina				
Current Land Use	Marina				
Contaminants	Petroleum Products				
TANKS	U/A	Capacity (gal)	Content	Installed	Removed
1	U	16,000	Vehicular Diesel	12/2007	In Use
1	U	10,000	Unleaded Gas	12/2007	In Use
Discharge Date	N/A		Cleanup Date:	N/A	
Documented/ Known Impacts:	NO		NO

**PUBLIC RECORDS:** The diesel and unleaded gas underground tanks were installed in 2007 and were inspected under the New Port Marina address at 760 Mullet Road, **Site No. 3**. The latest June 2021 inspection indicated that the gasoline fill sump was damaged by a truck parking on it and needed repair. No contamination impacts were reported relative to the damaged sump.

**CONCLUSIONS:** This site is a marina that fuels boats. No contamination impacts are documented for this location.

Based on the lack of documented contamination impacts, and the distance from the proposed SR 401 improvements, this site has been assigned a CRR of **Low**.

Looking north at Ocean Club Port Canaveral.

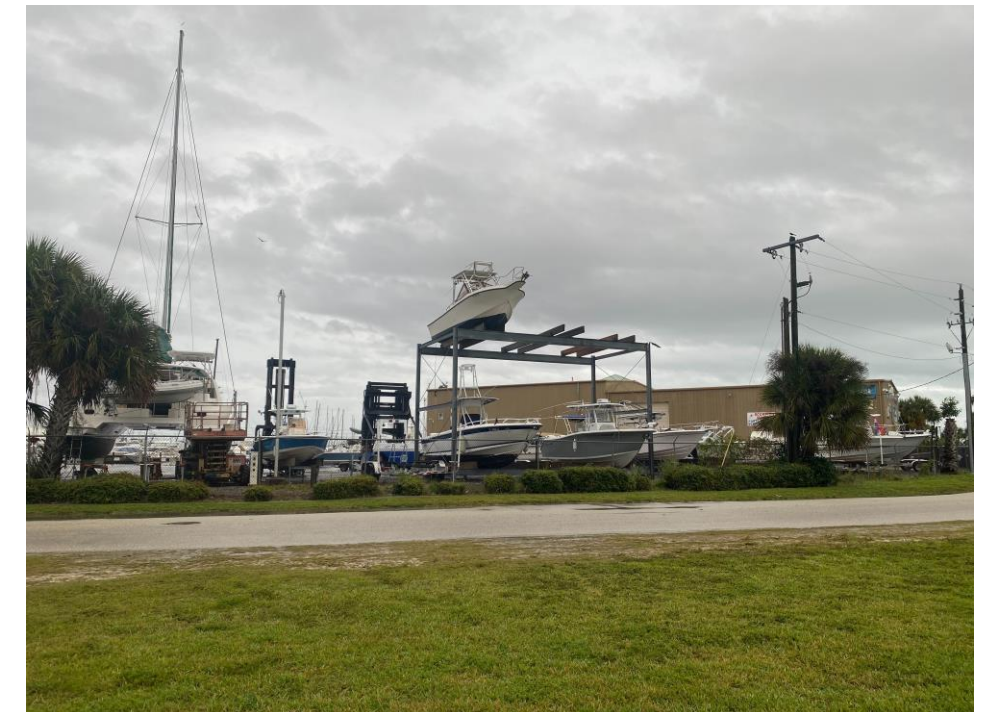
**SITE OBSERVATIONS:** The site is occupied by the Scorpion Marine/Port Canaveral Marine facility that includes sales, repair, and sea wall services.

**CONCLUSIONS:** This is a boat sales and repair marina. No contamination impacts are documented for this location.

Based on the lack of documented contamination impacts, and the distance from the proposed SR 401 improvements, this site has been assigned a CRR of **Low**.

Looking southeast towards the former New Port Marina.

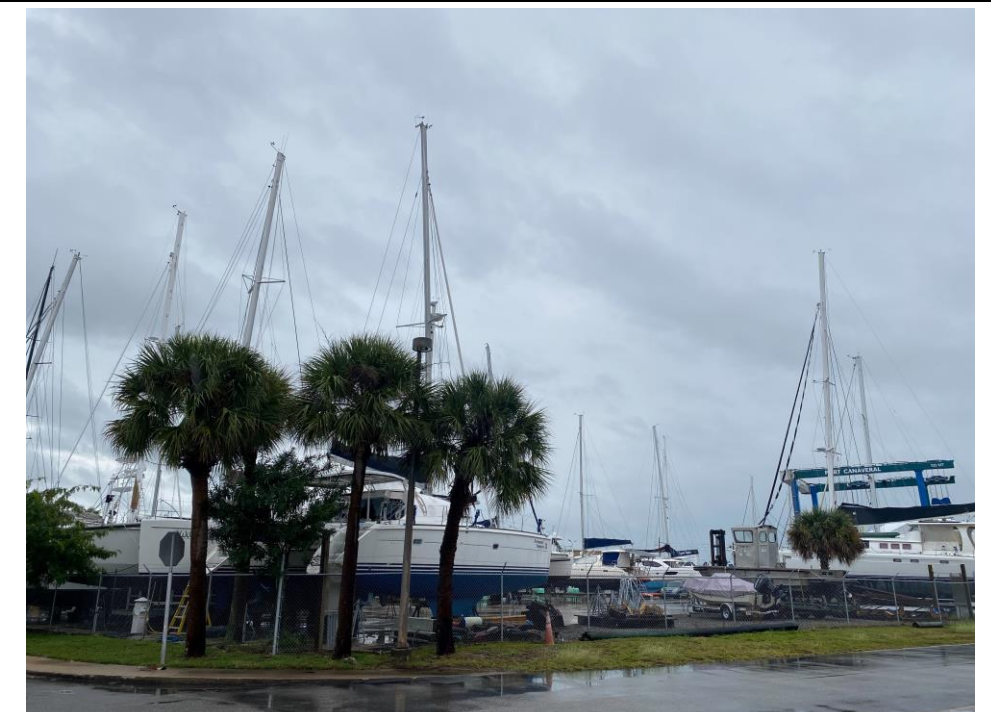
Site No:	<b>4</b>		Risk Potential:	<b>LOW</b>	
Site Name	<b>Unknown Release</b>				
Site Address	990 Mullet Road				
Site Location	Northeast corner of the SR 528 and SR 401 interchange				
Distance/Direction	180 feet east of the SR 528 westbound to SR 401 northbound offramp				
Facility ID Nos:	N/A				
Database Listings/Sources:	2005 CSER				
Historical Land Use	Marina, Boat Repair				
Current Land Use	Marina, Boat Repair				
Contaminants	Petroleum Products				
TANKS	U/A	Capacity (gal)	Content	Installed	Removed
N/A	N/A	N/A	N/A	N/A	N/A
Discharge Date	N/A		Cleanup Date:	N/A	
	Soil		Groundwater		
Documented/ Known Impacts:	NO		NO

**PUBLIC RECORDS:** This listing was found in the CSER for the 2005 SR 528 PD&E Study. This location was listed as having a spill or release. There are no available public records and our conversation with Mr. Bob Musser, Canaveral Port Authority Director of Environmental Plans & Programs, did not reveal any known contamination impacts in the vicinity of the SR 401 bridge.

**CONCLUSIONS:** This is a boat yard. No contamination impacts are documented for this location.

Based on the lack of documented contamination impacts, and the distance from the proposed SR 401 improvements, this site has been assigned a CRR of **Low**.

Looking southeast towards the former building location at 990 Mullet Road.

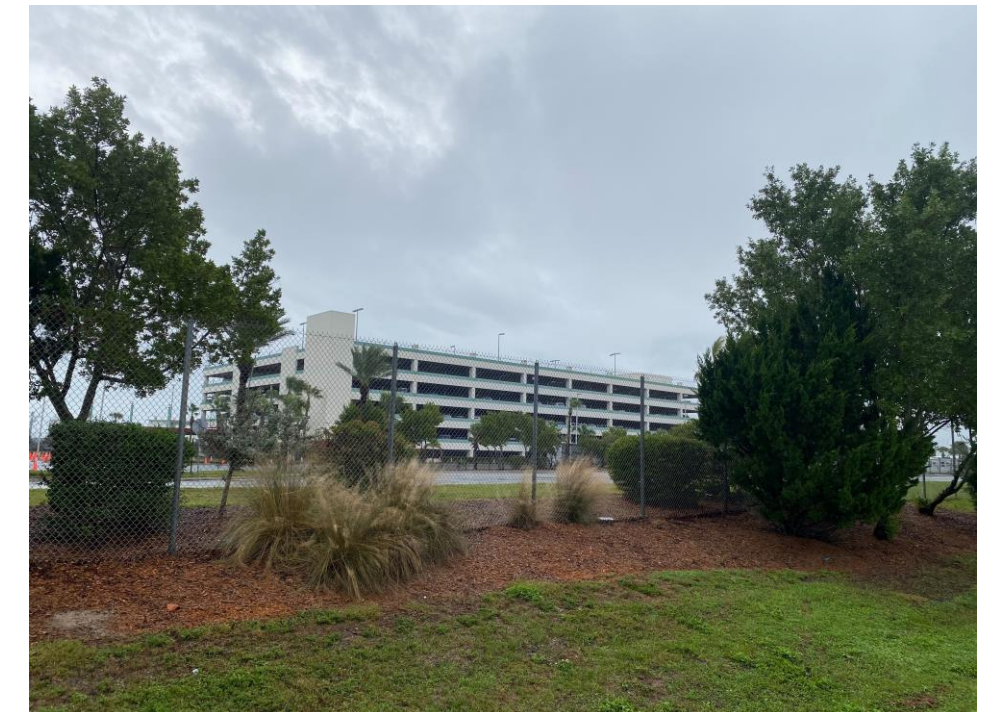
**CONCLUSIONS:** This is an emergency fuel tank for a parking garage generator. No contamination impacts are documented for this location.

Based on the lack of documented contamination impacts, and the distance from the proposed SR 401 improvements, this site has been assigned a CRR of **Low**.

Looking east at the parking garage.

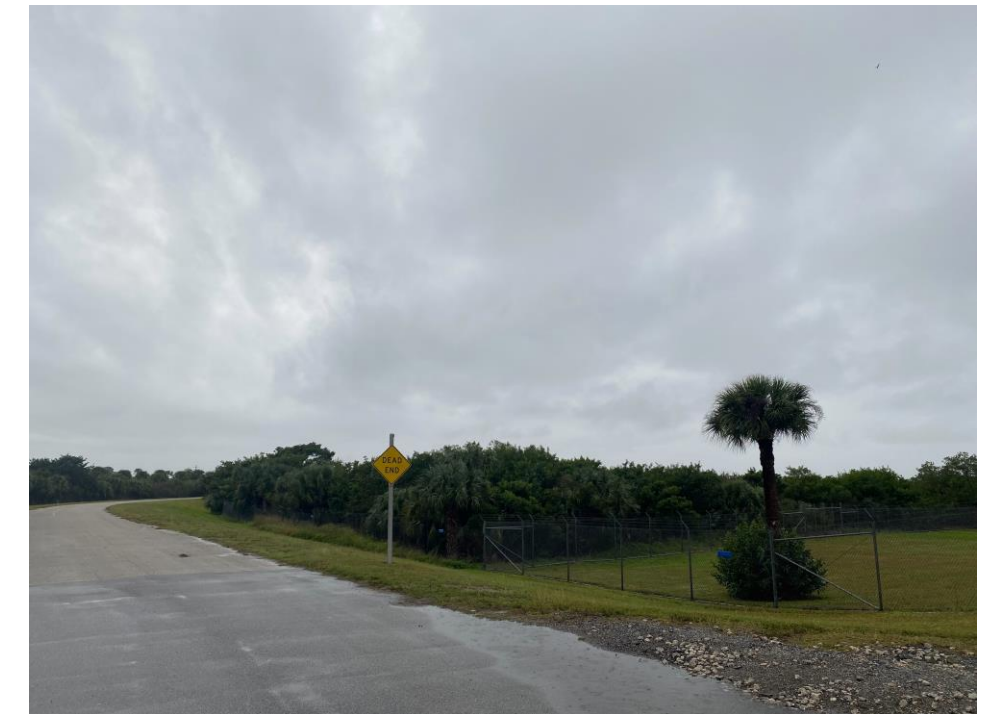
Site No:	<b>6</b>		Risk Potential:	<b>LOW</b>	
Site Name	<b>Canaveral Landfill</b>				
Site Address	Mullet Drive				
Site Location	Northwest corner of the SR 528 and SR 401 interchange				
Distance/Direction	180 feet west of the SR 401 southbound to 528 westbound on ramp				
Facility ID Nos:	8840376				
Database Listings/Sources:	Landfill, Tanks				
Historical Land Use	Banana River				
Current Land Use	Salt Marsh				
Contaminants	Petroleum Products and Hazardous Materials				
<b>TANKS</b>	<b>U/A</b>	<b>Capacity (gal)</b>	<b>Content</b>	<b>Installed</b>	<b>Removed</b>
4	A	150	Lube Oil	Unk.	Unk.
1	A	150	Other Non-Regulated	Unk.	Unk.
Discharge Date	N/A		Cleanup Date:	N/A	
	Soil		Groundwater		
Documented/ Known Impacts:	NO		NO

**SITE OBSERVATIONS:** This is an undeveloped parcel containing a salt marsh.

**CONCLUSIONS:** This location is a salt marsh. A mitigating factor is that the former location of the tanks is outside the Bridge Right-of-Way and is downslope of the project area. Migration of any spills or releases from the tanks would have been toward the northwest and the interior of Site 6, away from the Project. Based on the lack of documented contamination impacts, the distance from the proposed SR 401 improvements, and the migration path of any historical discharges being to the west, away from the Bridge Right-of-Way, this site has been assigned a CRR of **Low**.

Looking southwest at the salt marsh area on the northwest corner of the SR 528 and SR 401 interchange.
