CONTAMINATION SCREENING EVALUATION REPORT UPDATE

Florida Department of Transportation
District 5
SR 35 (US 301) FROM CR 470 TO SR 44
Sumter County, Florida
Financial Project ID No. 430132-1-32-01
GEC Project No. 5213E

June 2024

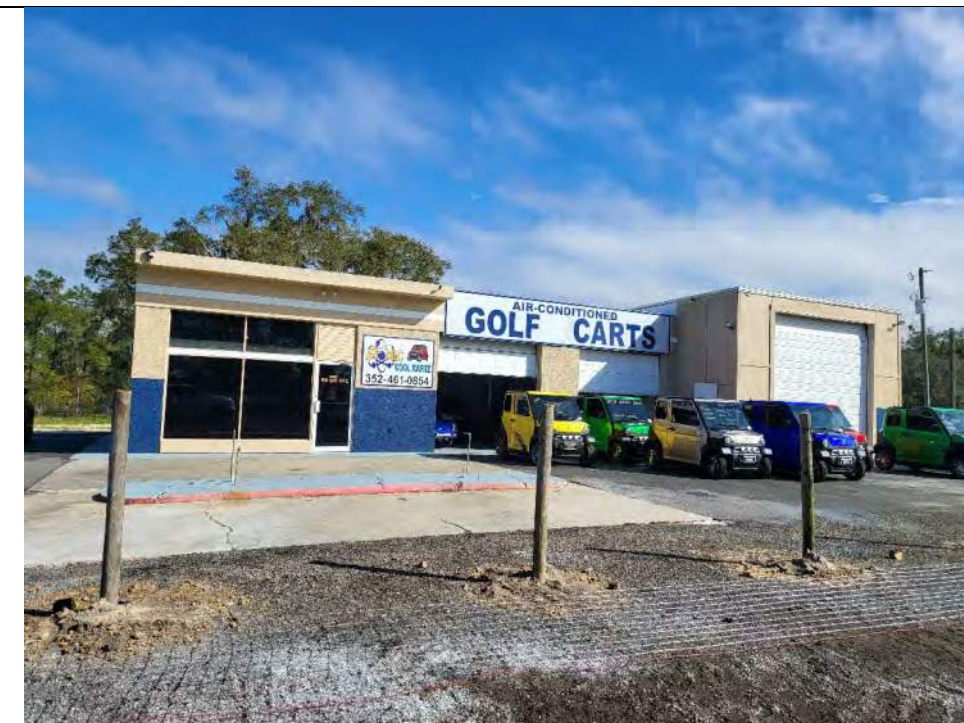
CONCLUSIONS: Due to the potential for petroleum impacts from historical gas station usage, this site has been assigned a Contamination Risk Rating (CRR) of **Medium**.

Looking east at the former gas station. The former fuel pump island is visible on the left in the foreground.

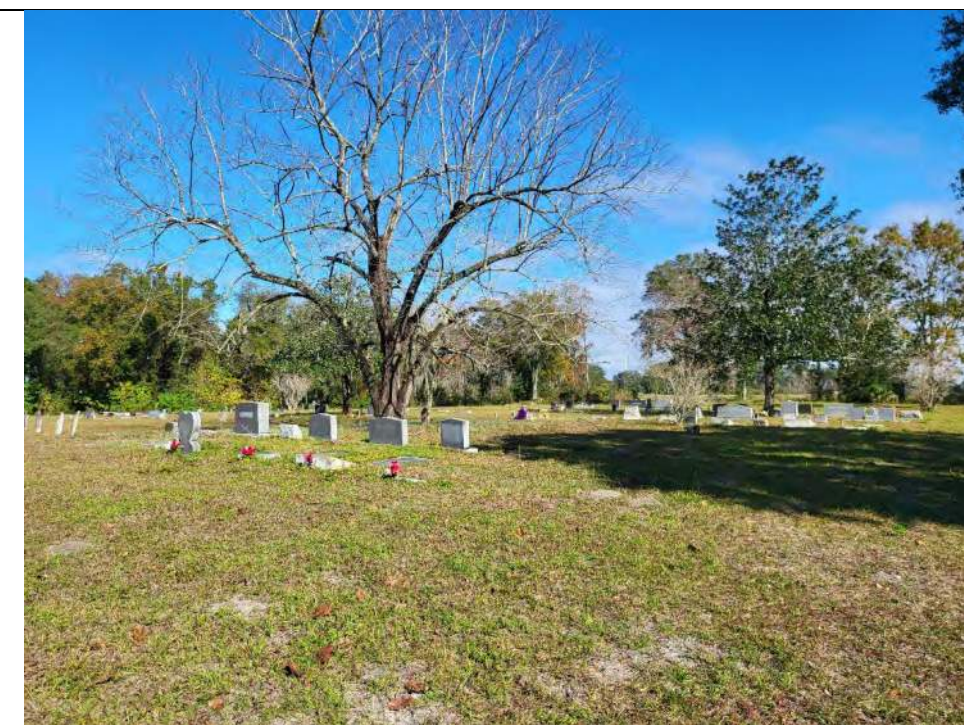
CONCLUSIONS: Due to the potential for hazardous waste impacts from historical cemetery use, this site has been assigned a CRR of **Medium**.

Looking east at the cemetery.

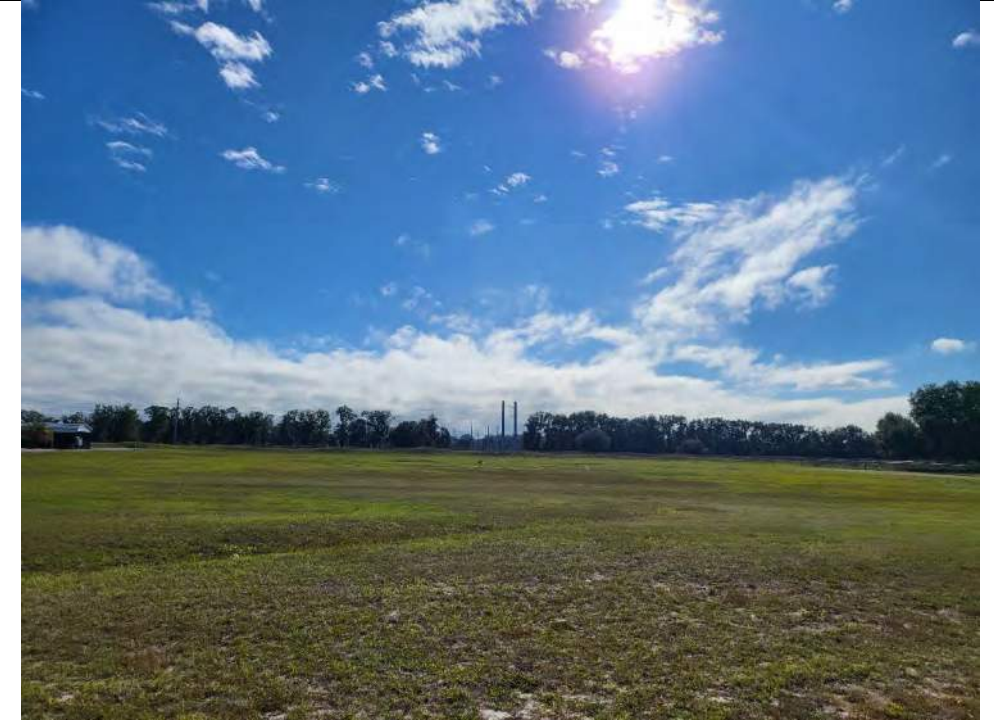
CONCLUSIONS: Due to the potential for arsenic, pesticide, or herbicide impacts from golf course land use, and the distance to SR 35, this site has been assigned a CRR of **Medium**.

Looking south at the golf course.

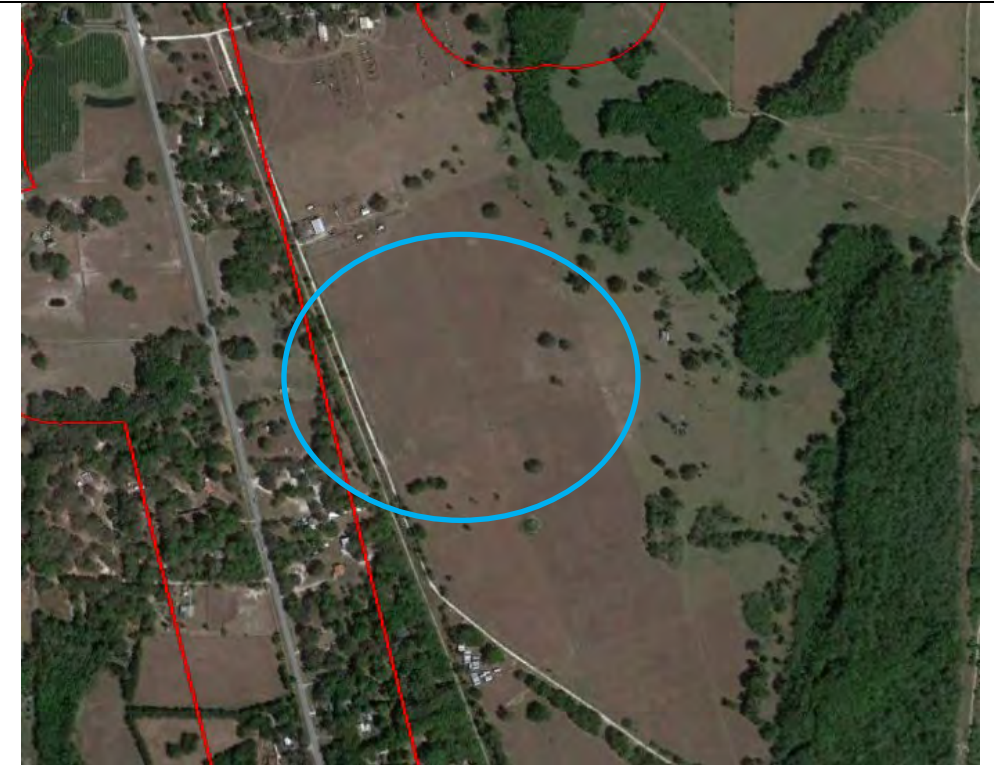
PUBLIC RECORDS: This facility is authorized as a disaster debris management site to accept yard trash and mixed materials, and does not appear to have been utilized. No violations, leaks, or discharges have been recorded at this site.

SITE OBSERVATIONS: The site is a vacant field.

View of the debris management field on the 2023 aerial photograph.

CONCLUSIONS: Due to the lack of recorded contamination impacts, this site has been assigned a CRR of **Low**.

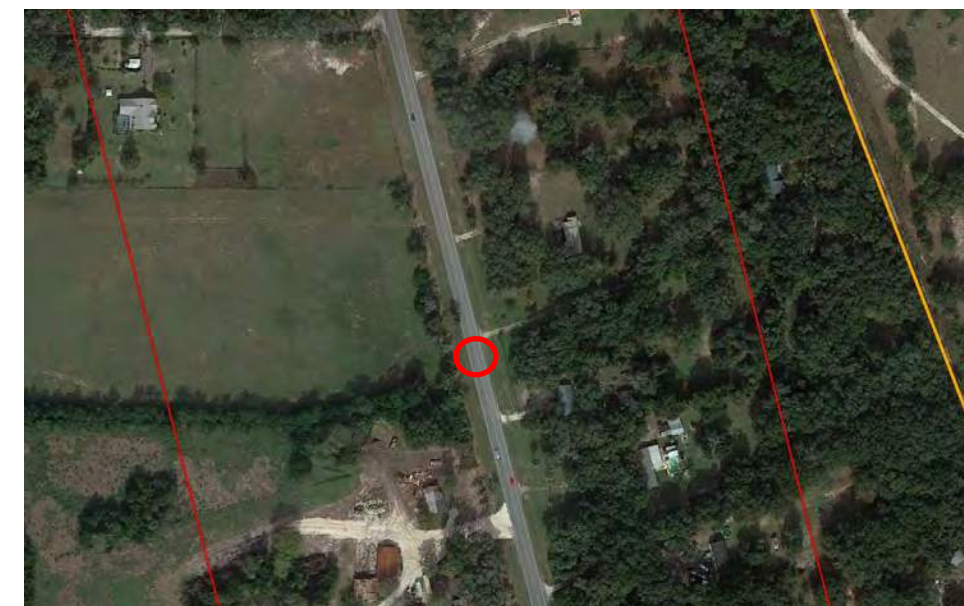
SITE OBSERVATIONS: No evidence of the petroleum spill was observed.

CONCLUSIONS: Due to the possibility of petroleum impacts, this site has been assigned a CRR of **Medium**.

View of the approximate area of the spill on the 2019 aerial photograph.

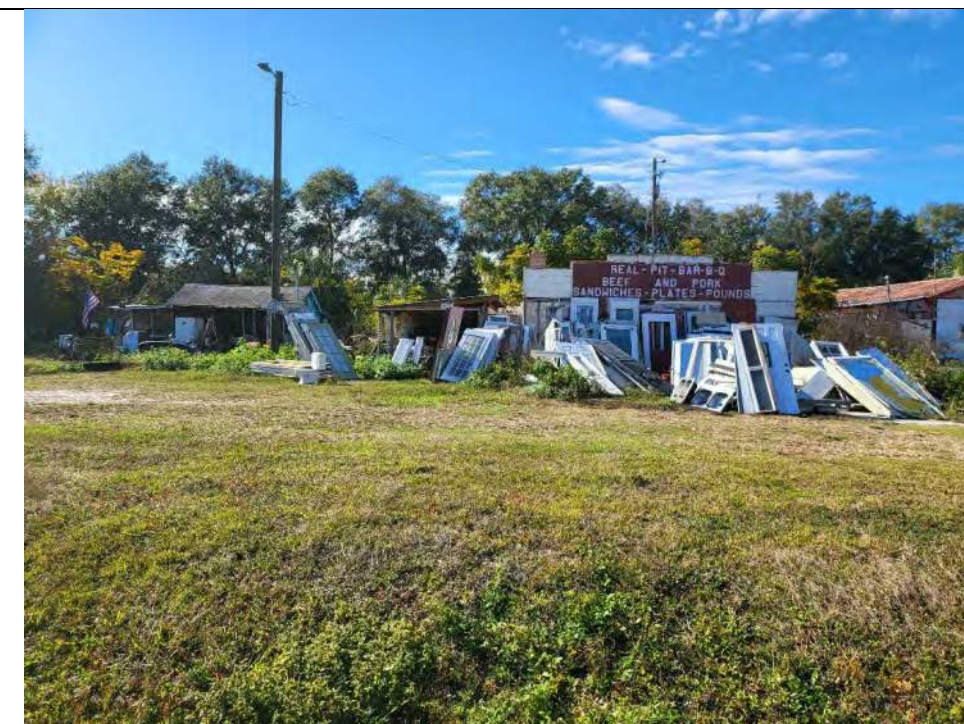
CONCLUSIONS: Due to the potential for petroleum impacts, this site has been assigned a CRR of **Medium**.

Looking west at the potential former gas station building.

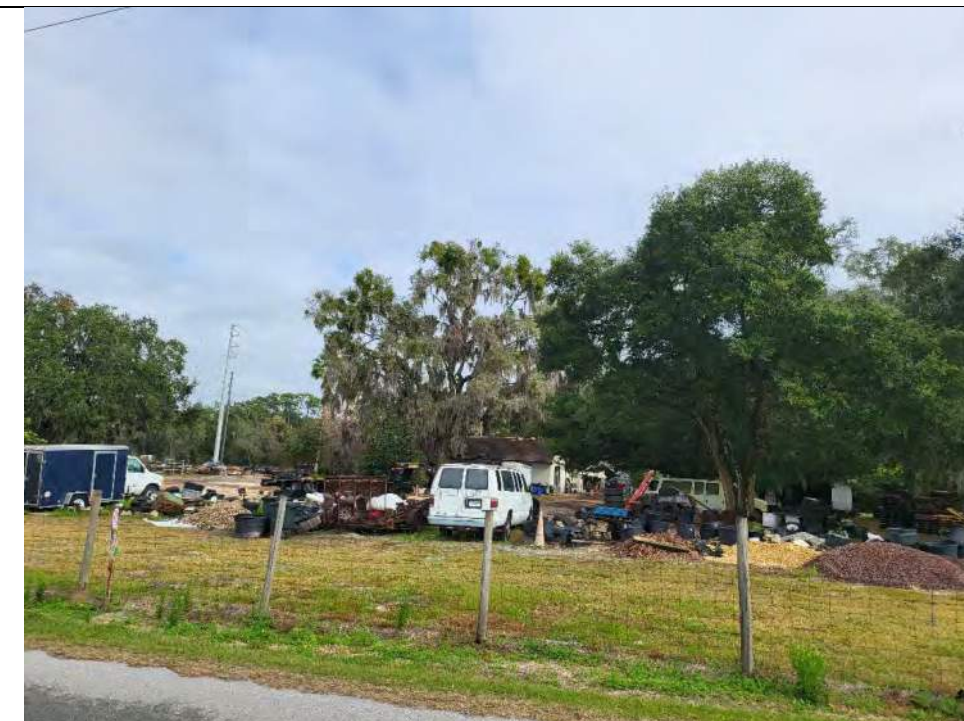
CONCLUSIONS: Due to the lack of recorded contamination impacts, this site has been assigned a CRR of **Low**.

Looking east at the material storage area.

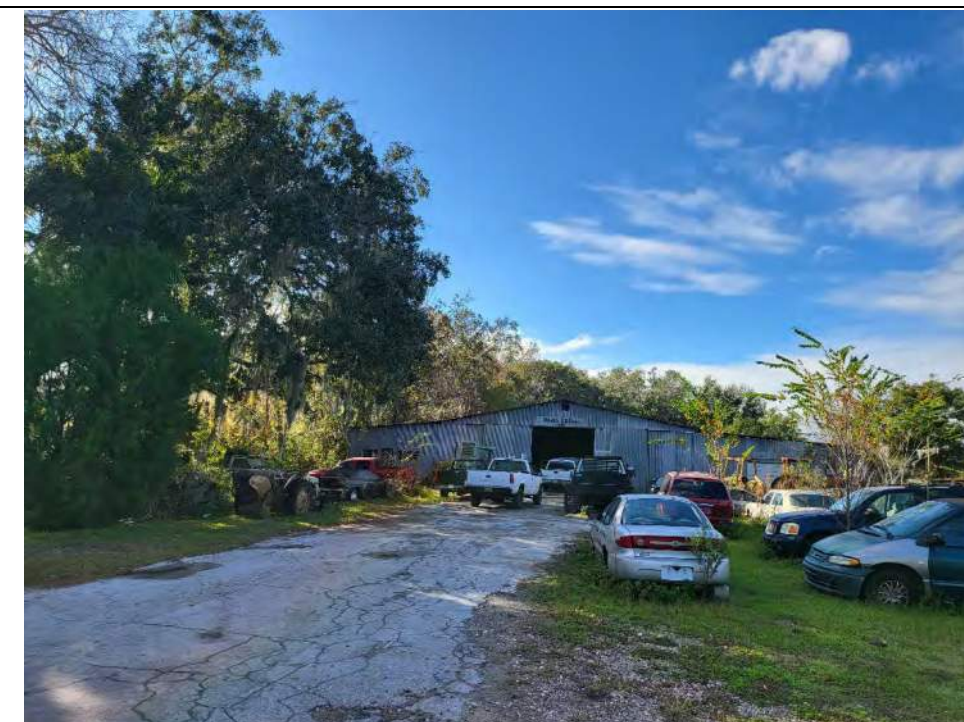
SITE OBSERVATIONS: The site is an auto repair garage. About 20 cars were observed to the east and north of the building.

CONCLUSIONS: Due to the possibility for petroleum impacts from an underground storage tank and historical auto repair use, this site has been assigned a CRR of **Medium**.

Looking west at the auto repair facility and parked vehicles.

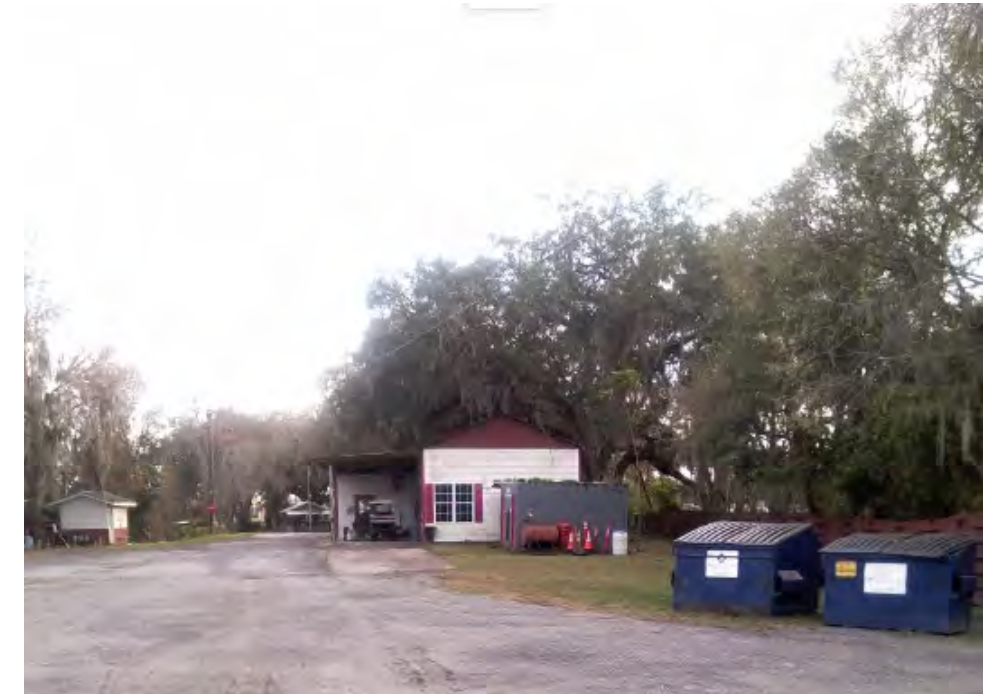
SITE OBSERVATIONS: The site contained parked tanker trucks, construction vehicles, and an apparent vehicle maintenance area with a 100-gallon aboveground storage tank.

Looking south at the office building and a ~100-gallon aboveground storage tank.

CONCLUSIONS: Due to the potential for petroleum impacts, this site has been assigned a CRR of **Medium**.

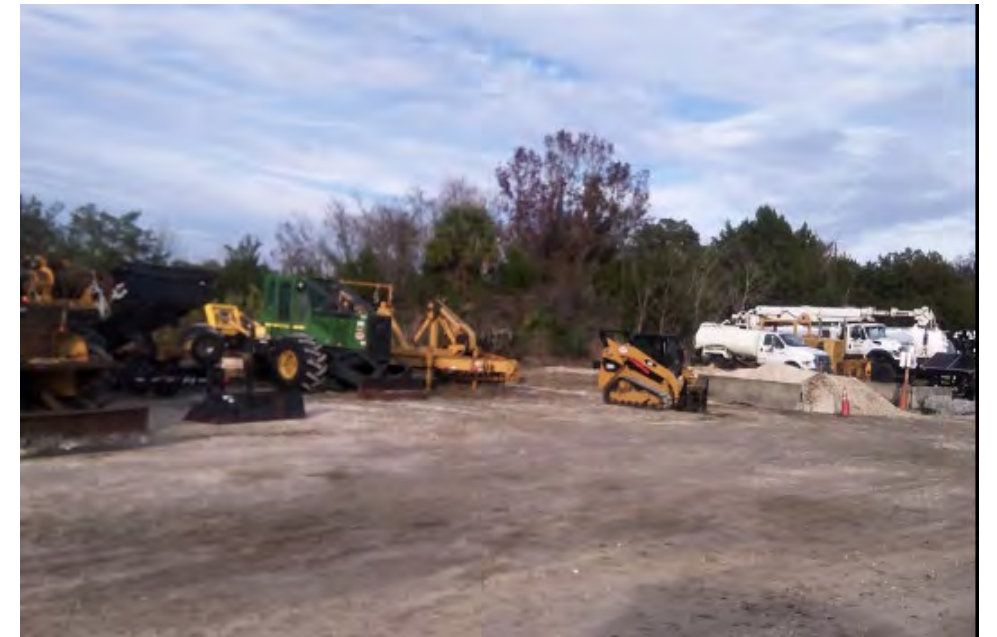
View of parked construction machinery.

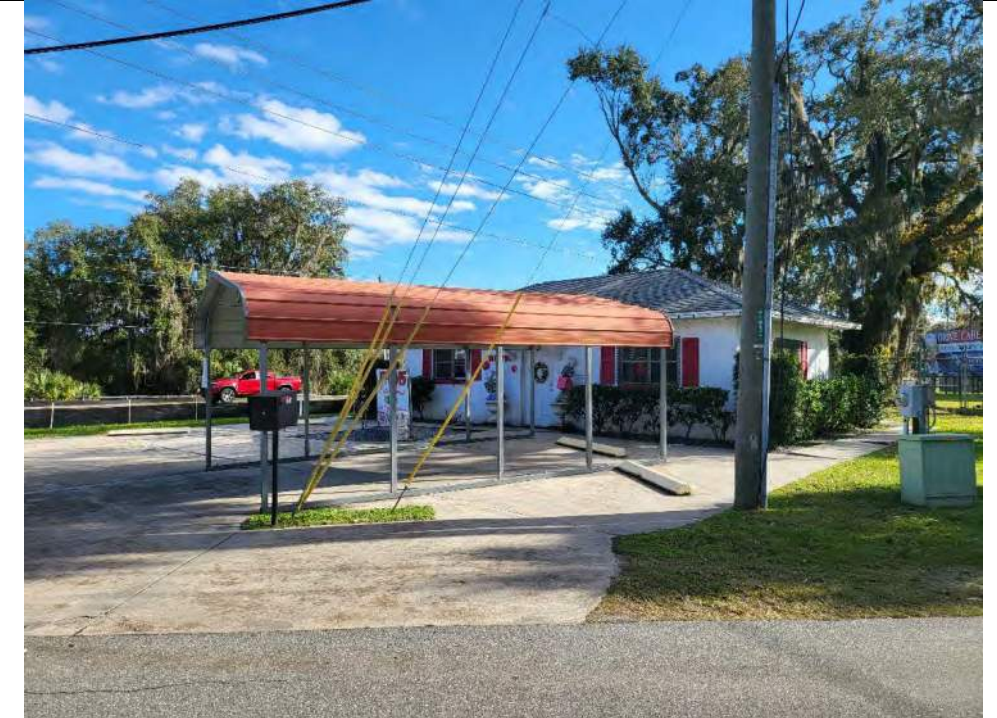
SITE OBSERVATIONS: The site is a vehicle towing company consisting of an office building, and a tow yard containing tow trucks and vehicles.

Looking south at the office building.

CONCLUSIONS: Due to the lack of recorded contamination impacts, this site has been assigned a CRR of **Low**.

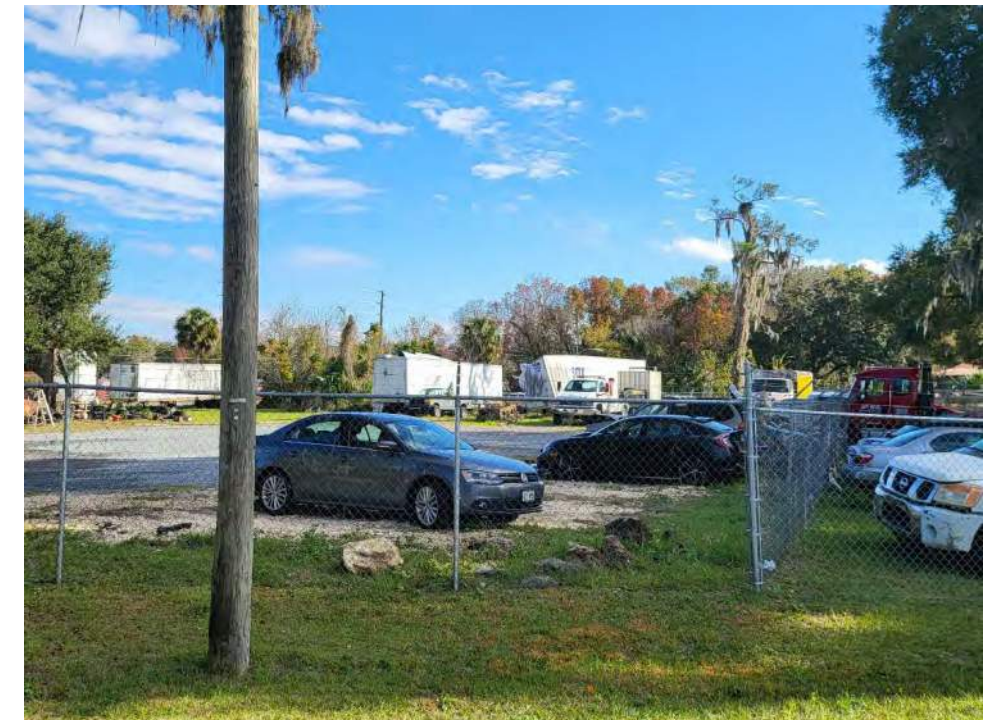
View of the tow yard and vehicles.

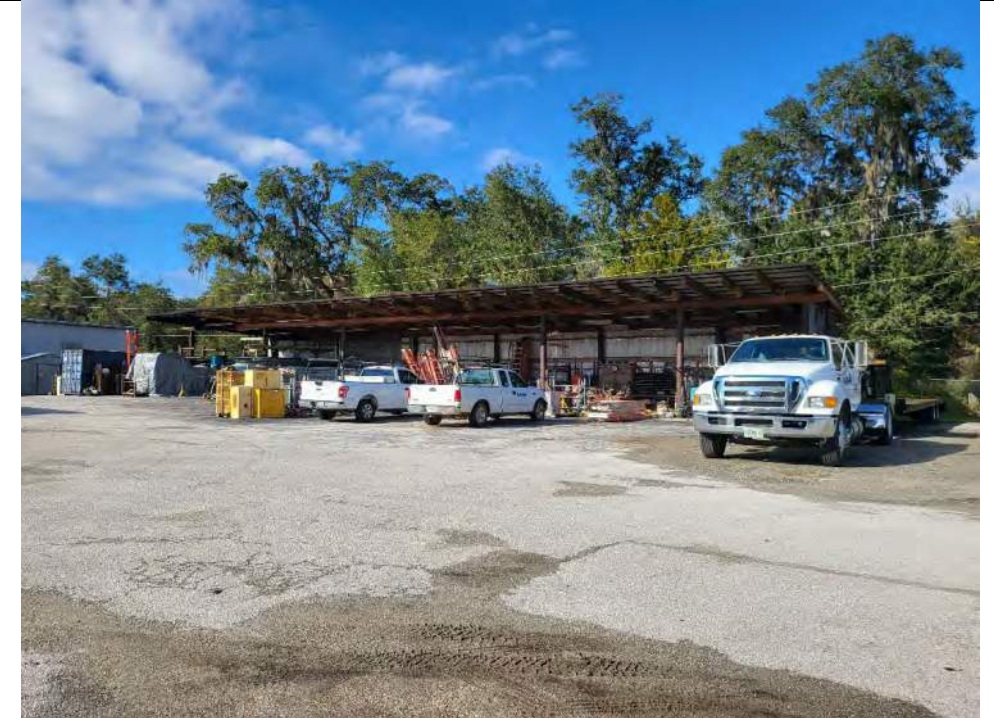
SITE OBSERVATIONS: The site contains a warehouse-type building and an apparent mechanical service area.

Looking northwest at a material storage area.

CONCLUSIONS: Due to the lack of recorded contamination impacts, this site has been assigned a CRR of **Low**.

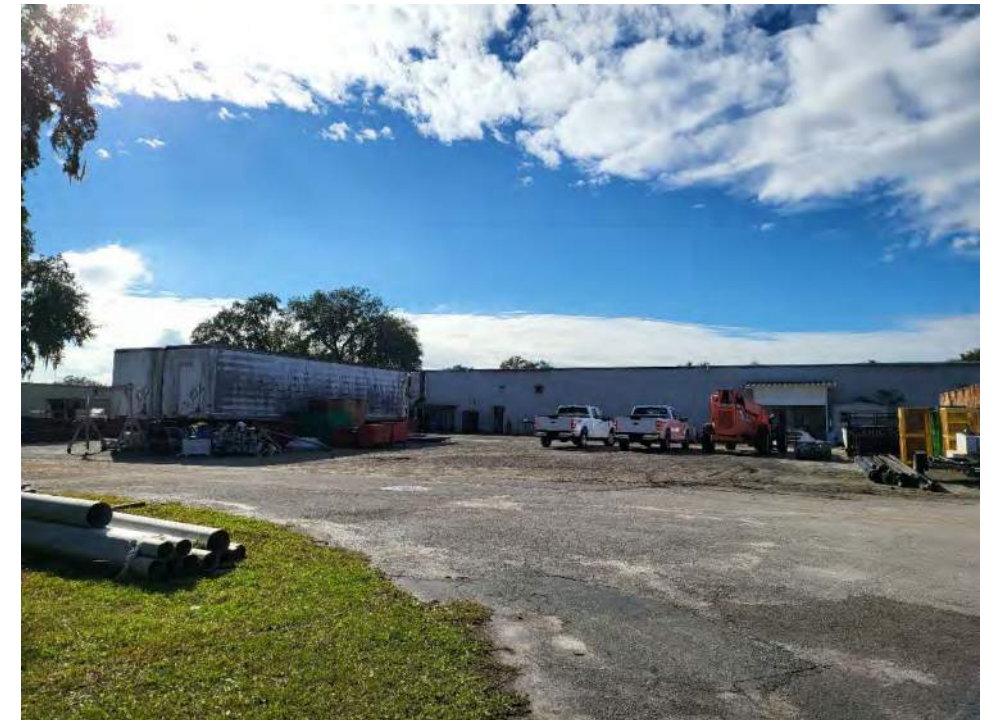
Looking west at the warehouse building.

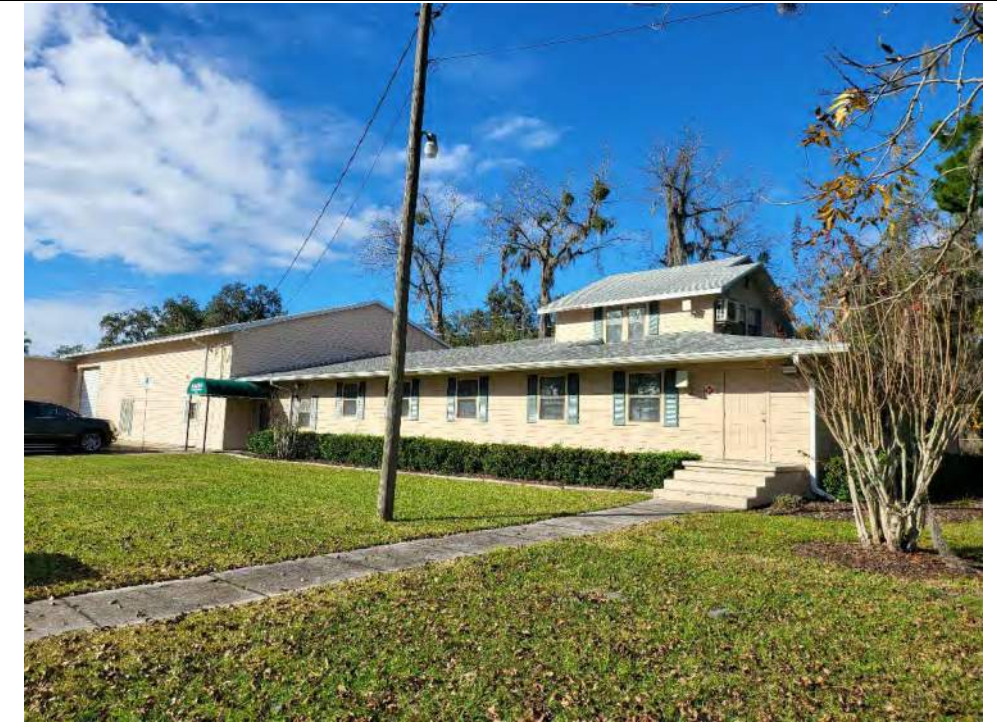
SITE OBSERVATIONS: The site is an office building with an attached warehouse-type building.

Looking northwest at the office building.

CONCLUSIONS: Due to the potential for contamination impacts from the former tank, this site has been assigned a CRR of **Medium**.

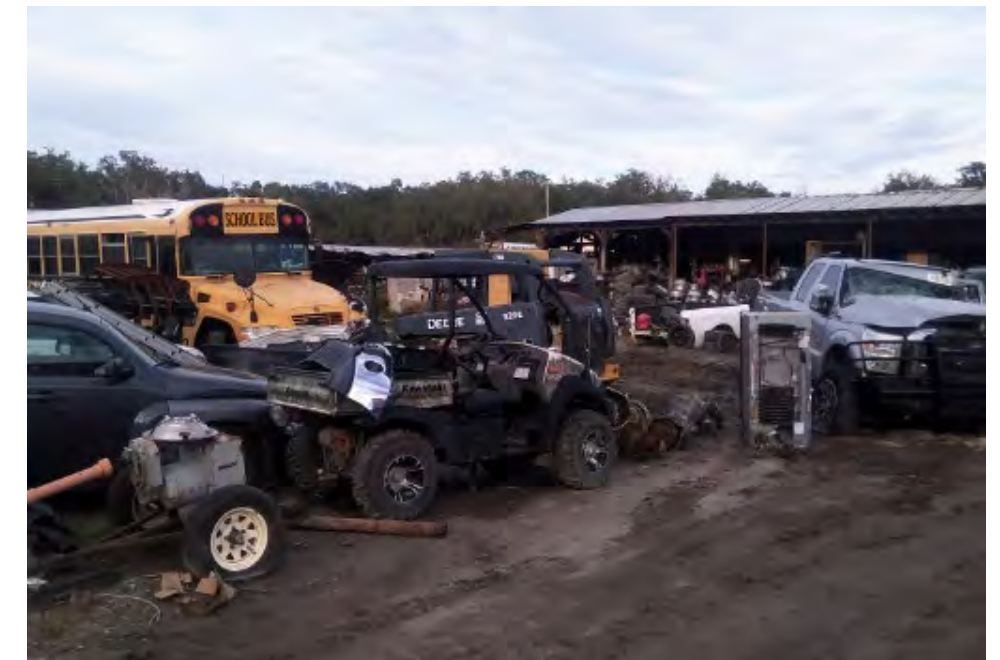
CONCLUSIONS: Due to the historical auto salvage yard usage, size of the auto salvage yard, and history of complaints and potential discharges, this site has been assigned a CRR of **High**.

Looking east at an area of salvage vehicles.

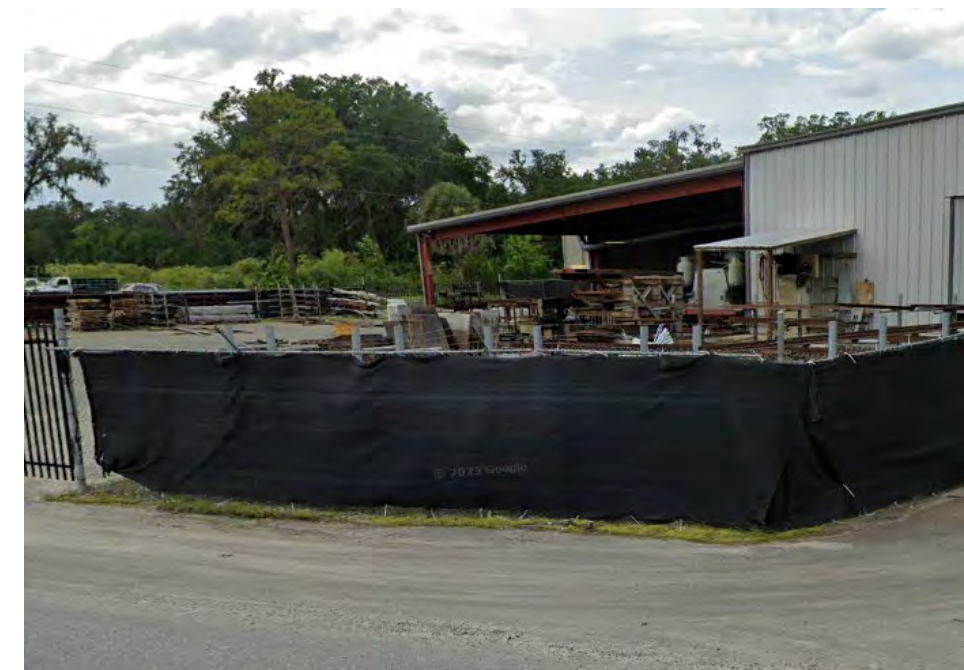
CONCLUSIONS: Due to the lack of recorded contamination impacts, this site has been assigned a CRR of **Low**.

Looking north at the building and material storage area.

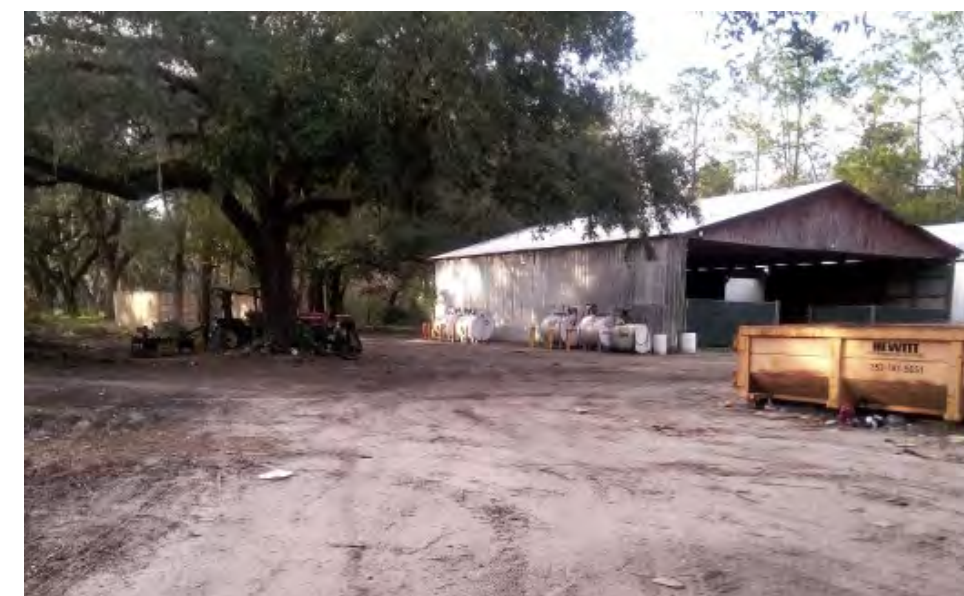
CONCLUSIONS: Due to the potential for petroleum impacts, this site has been assigned a CRR of **Medium**.

View of a maintenance garage and aboveground storage tanks.

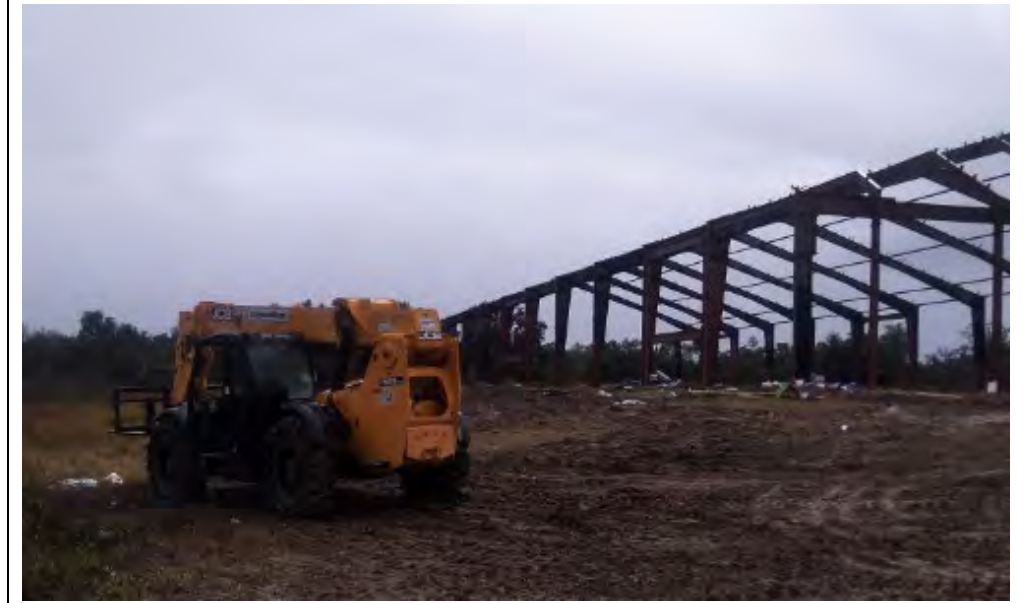
CONCLUSIONS: Due to the distance from the stormwater ponds, and potential for petroleum impacts, this site has been assigned a CRR of **Low**.

Looking southwest at the former building

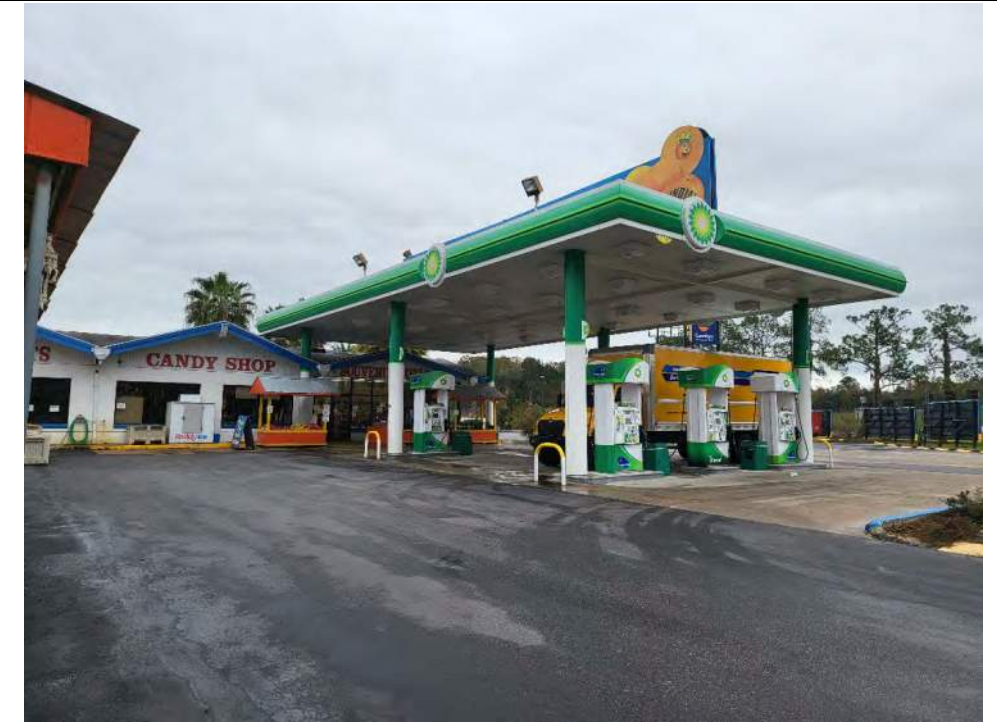
SITE OBSERVATIONS: The site is an operating gas station.

Looking east at the gas station and fueling pumps.

CONCLUSIONS: The discharges at this site received regulatory closure. Due to being an active gas station, this site has been assigned a CRR of **Medium**.

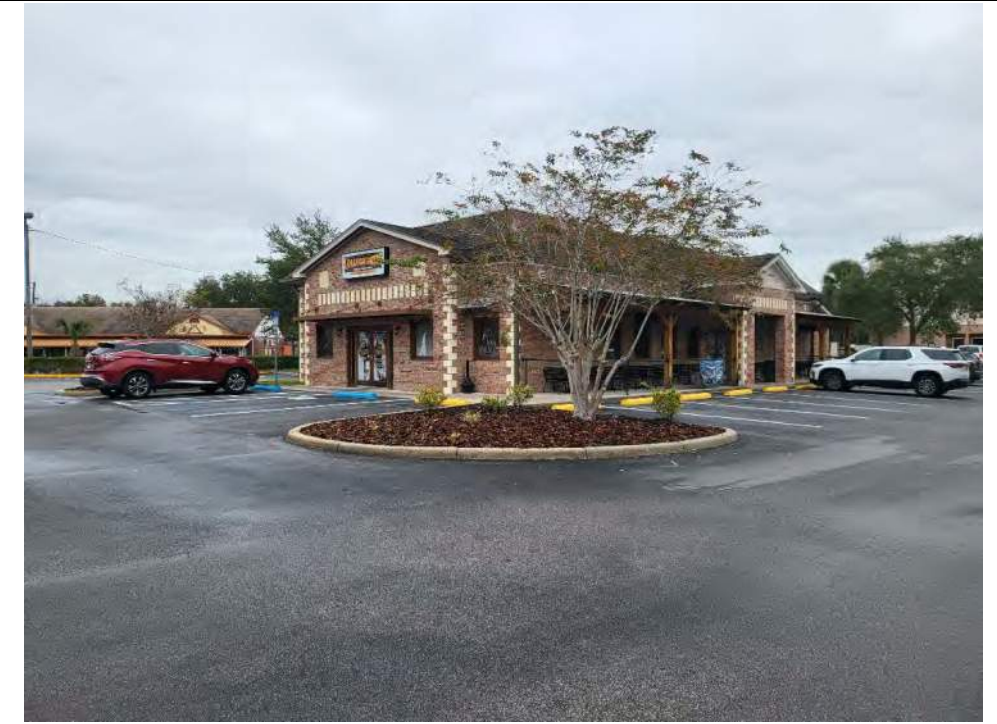
CONCLUSIONS: Due to achieving regulatory closure, this site has been assigned a CRR of **Low**.

Looking northeast at the area of the former gas station location.

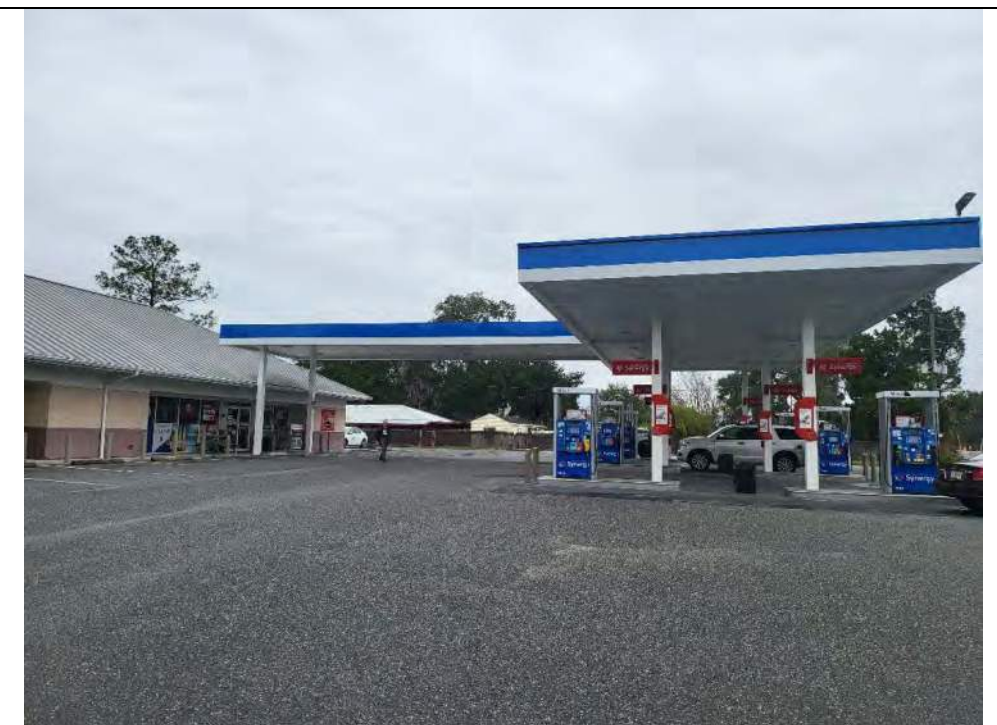
SITE OBSERVATIONS: The site is an operating gas station.

Looking north at the gas station and fueling pumps.

CONCLUSIONS: The site discharge achieved regulatory closure. Due to being an active gas station, this site has been assigned a CRR of **Medium**.

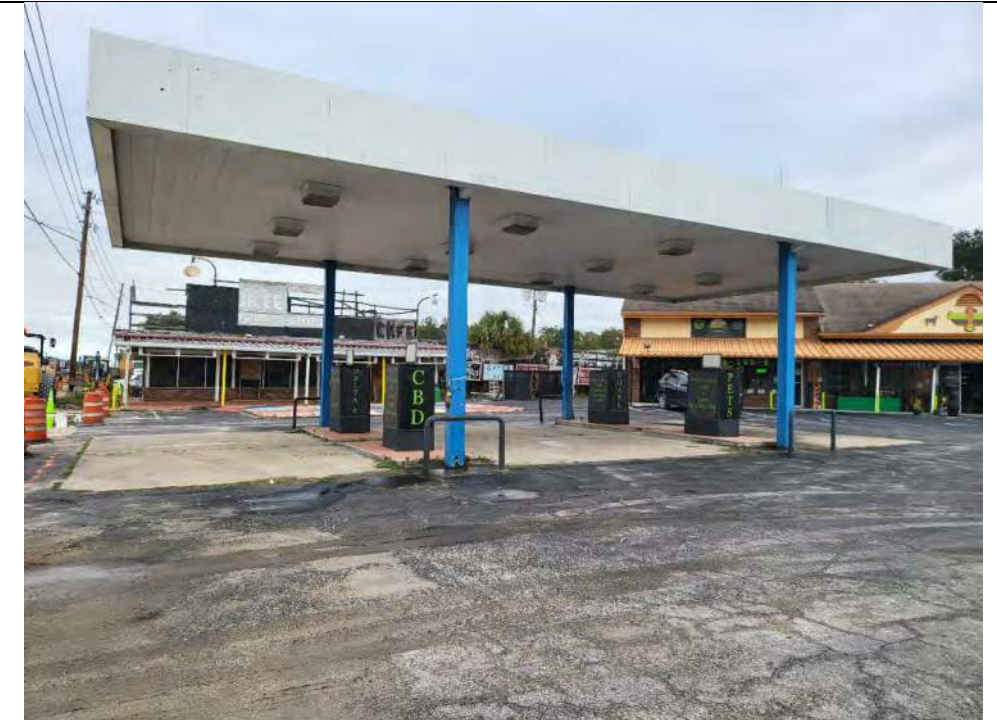
SITE OBSERVATIONS: The gas station is no longer in operation and is occupied by a retail store. The fueling canopy is located to the west of the building; however, the fueling pumps have been removed.

Looking north at the former fueling canopy.

CONCLUSIONS: Due to the lack of remaining contamination impacts, this site has been assigned a CRR of **Low**.

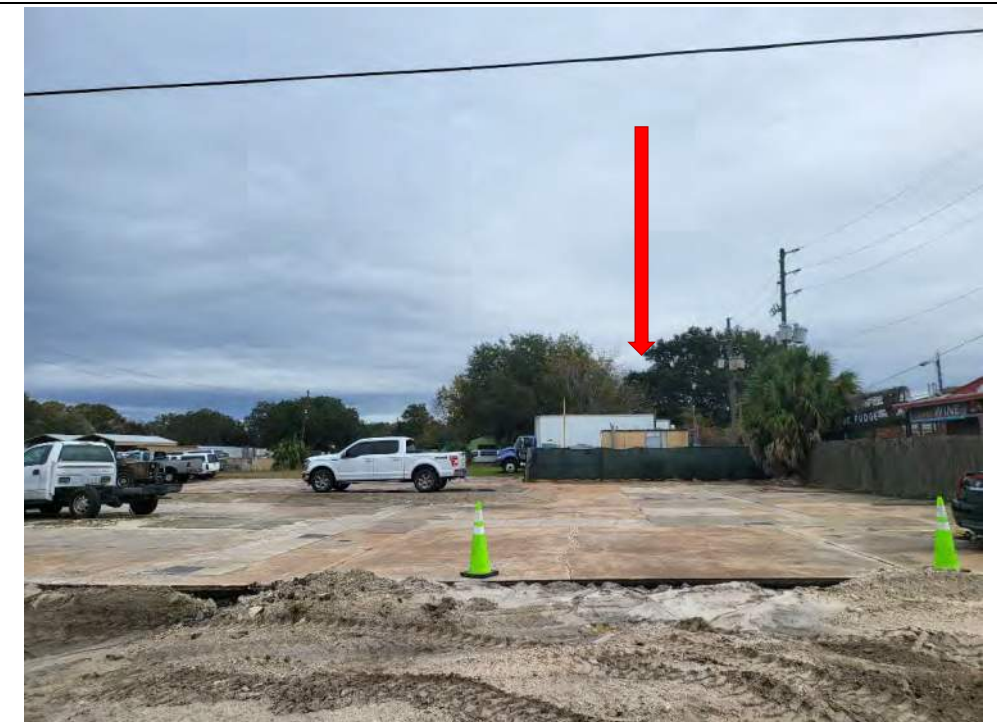
CONCLUSIONS: Due to the existing groundwater contaminant plume and its proximity to SR 35, this site has been assigned a CRR of **High**.

Looking east towards the area of the former gas station. The remediation system trailer is visible in the background.

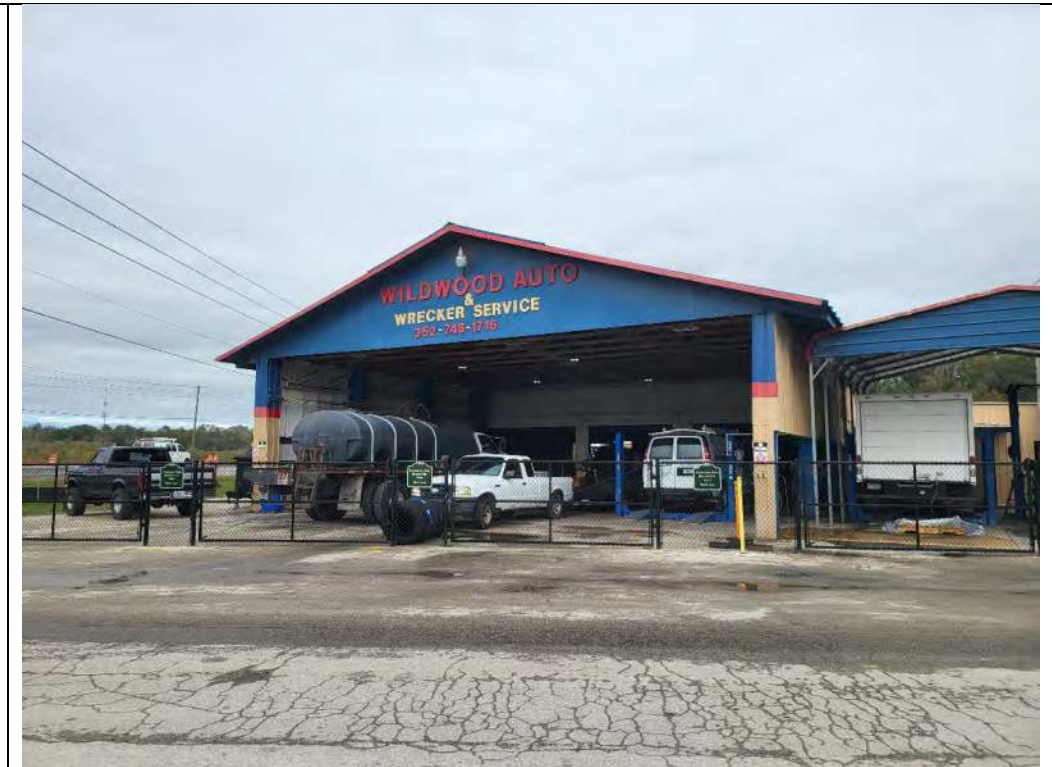
CONCLUSIONS: Due to the potential for petroleum impacts from historical auto repair and tow yard use, this site has been assigned a CRR of **Medium**.

Looking north at the auto repair building.

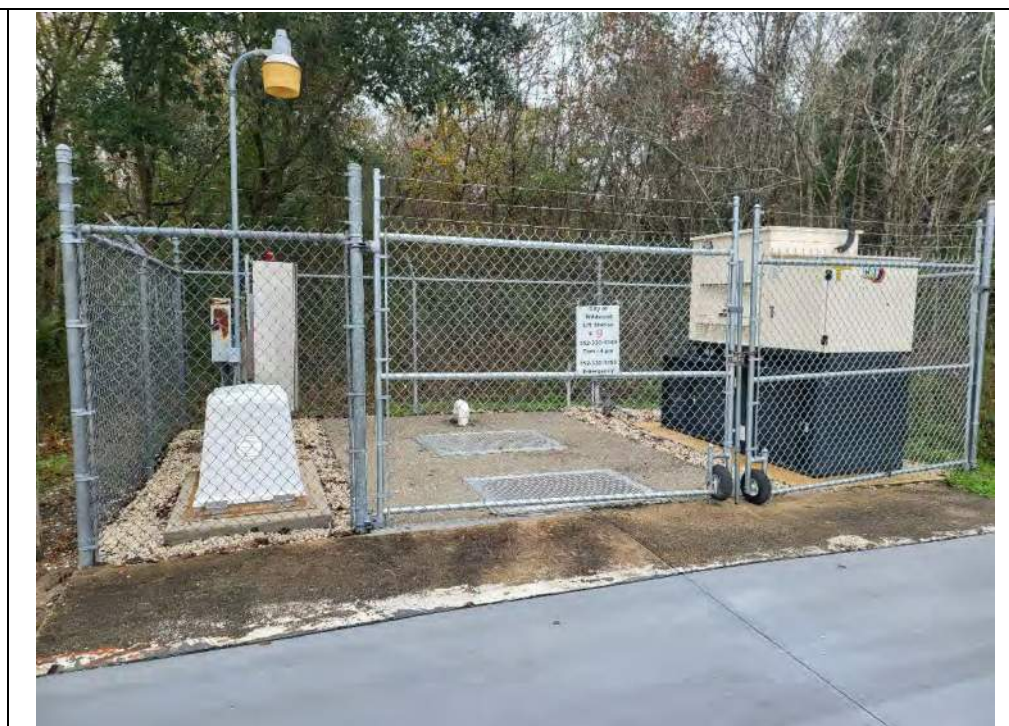
CONCLUSIONS: Due to the lack of recorded contamination impacts, this site has been assigned a CRR of **Low**.

Looking east at the lift station and emergency generator belly tank.

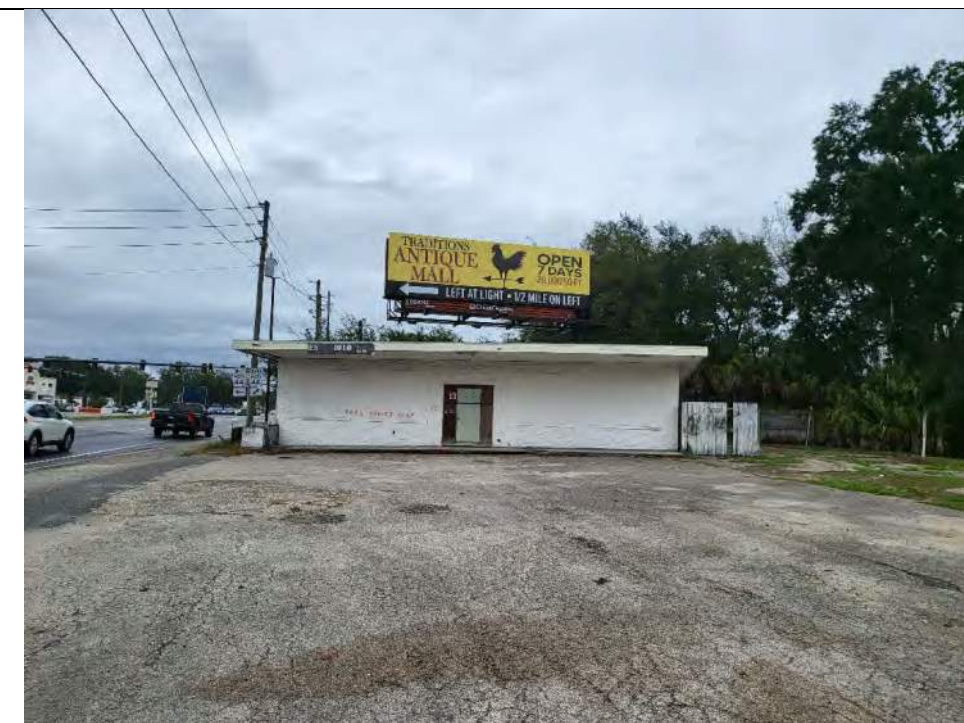
CONCLUSIONS: Due to the potential for petroleum impacts to remain on-site, this site has been assigned a CRR of **Medium**.

Looking north at the potential former gas station building.

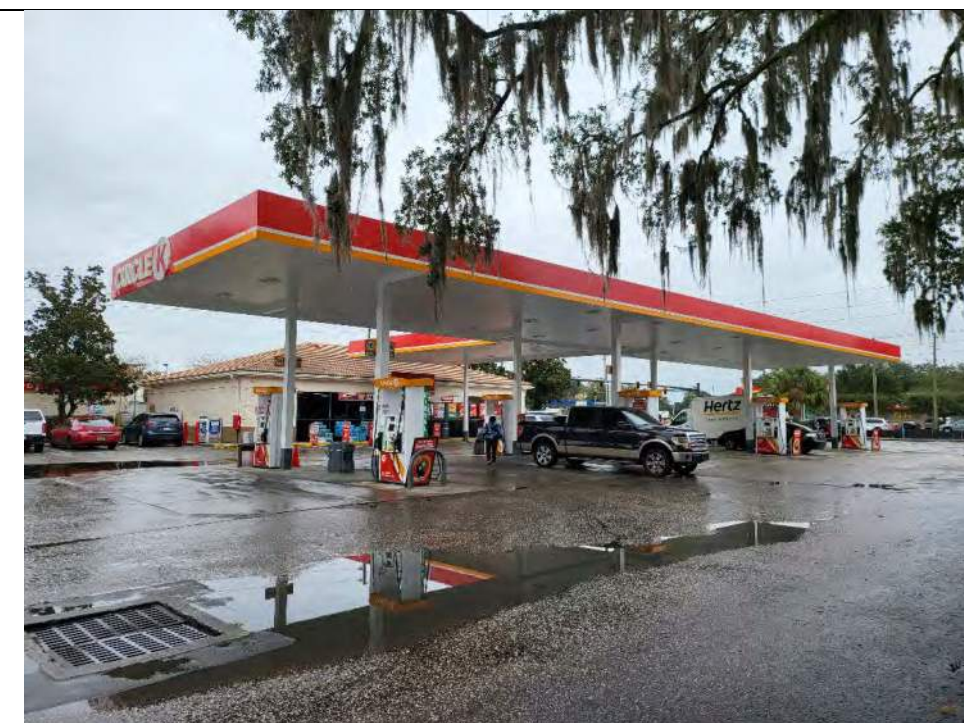
SITE OBSERVATIONS: The site is an operating gas station.

Looking northeast towards the gas station and fueling canopy.

CONCLUSIONS: Due to being an operating gas station, this site has been assigned a CRR of **Medium**.

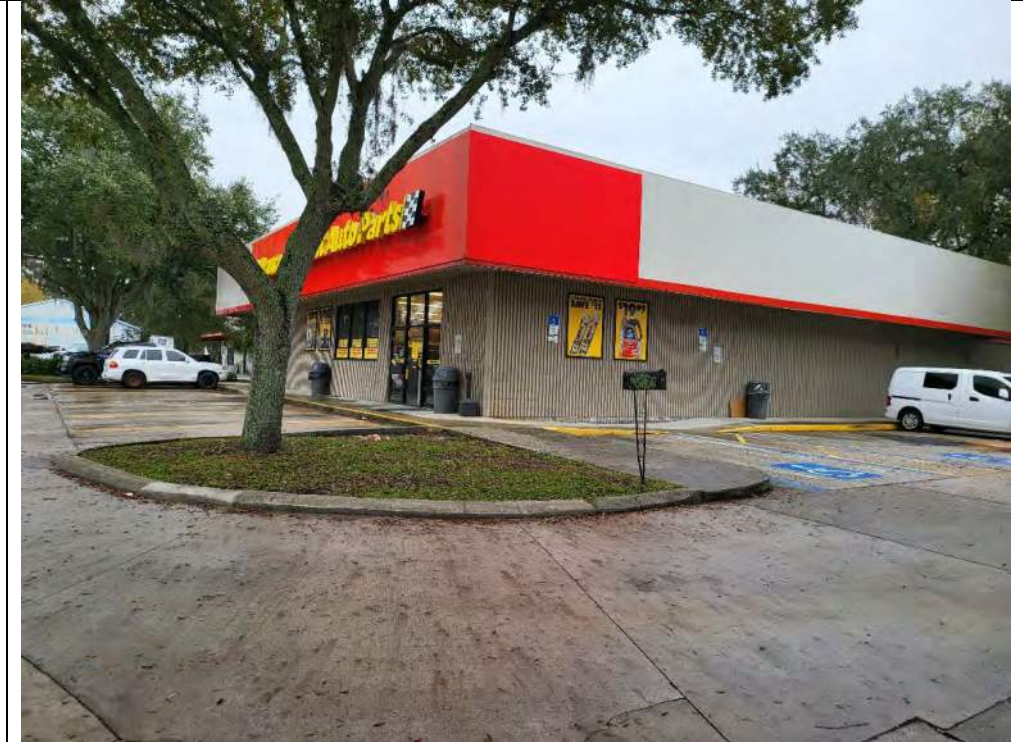
CONCLUSIONS: Due to the potential for petroleum impacts, this site has been assigned a CRR of **Medium**.

Looking southeast at the current retail building and area of the former gas station.

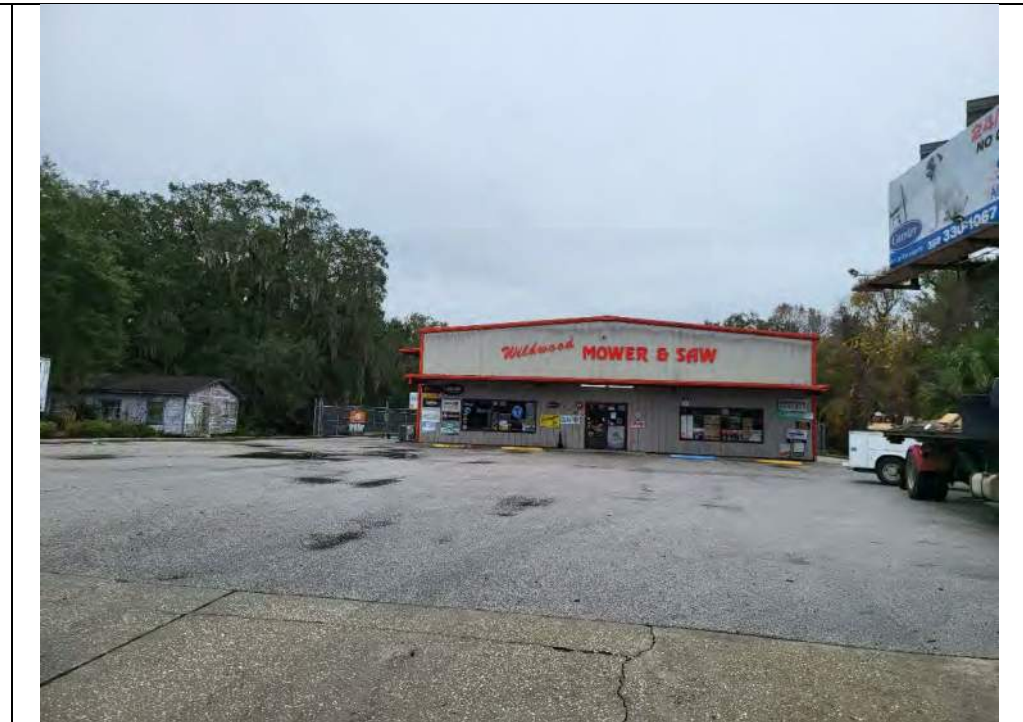
CONCLUSIONS: Due to the lack of recorded contamination impacts and the distance from SR 35, this site has been assigned a CRR of **Low**.

Looking south at the Wildwood Mower and Saw facility.
