CONTAMINATION SCREENING EVALUATION REPORT UPDATE

Florida Department of Transportation
District 5
SR 35 (US 301) FROM CR 470 TO SR 44
Sumter County, Florida
Financial Project ID No. 430132-1-32-01
GEC Project No. 5213E

June 2024

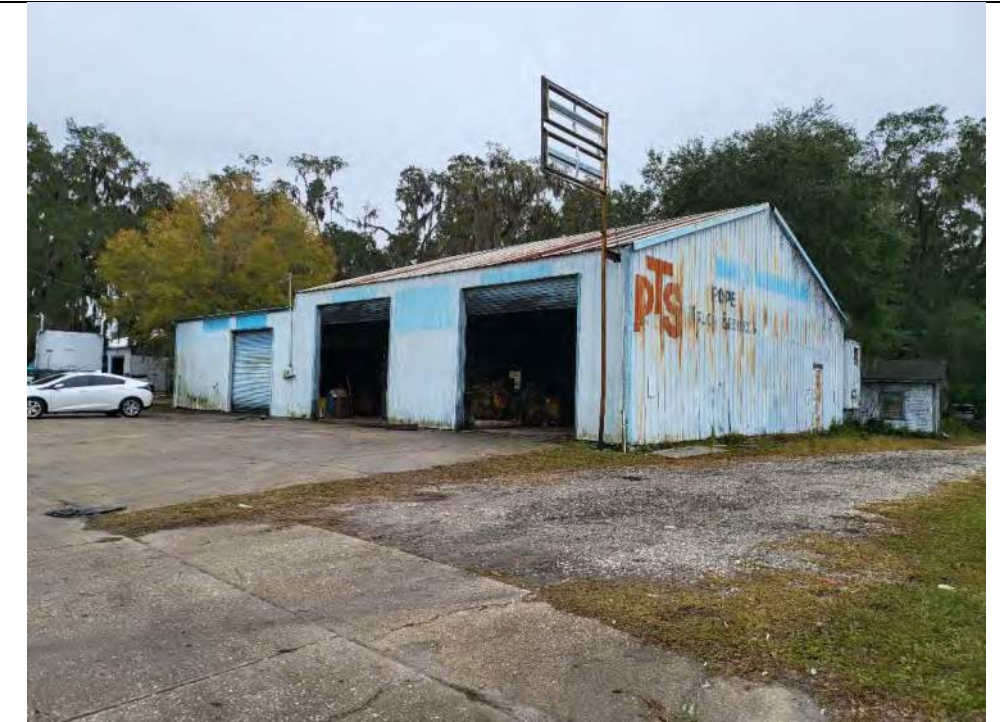
CONCLUSIONS: Due to historical auto repair use and potential historical gas station use, this site has been assigned a CRR of **Medium**.

Looking southeast at the auto repair shop and potential former gas station.

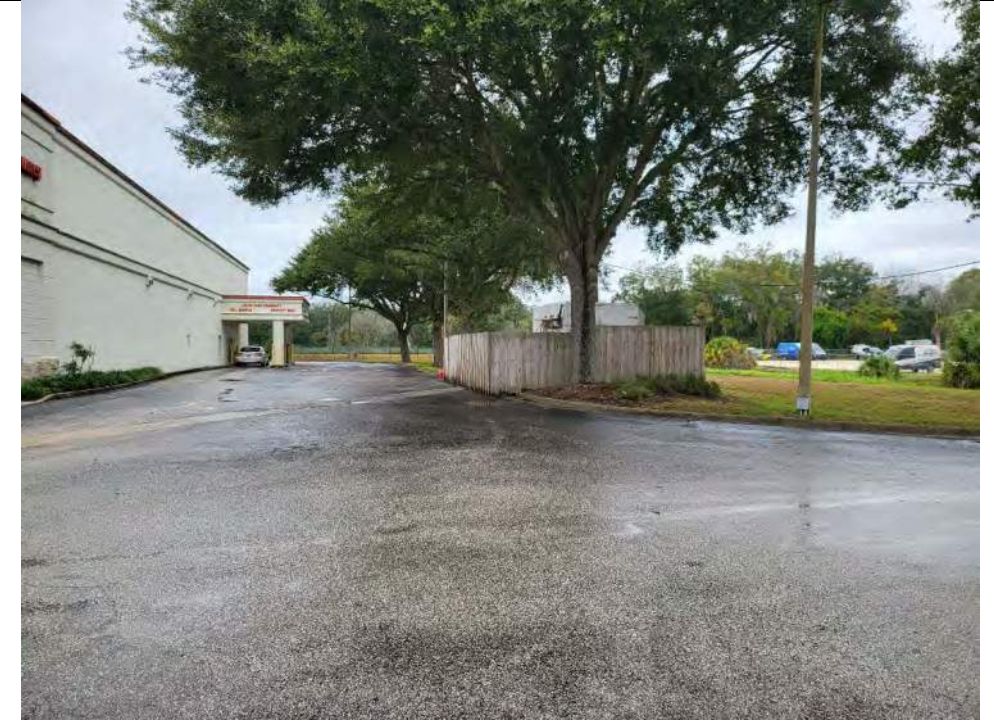
CONCLUSIONS: Due to the existing groundwater impacts, this site has been assigned a CRR of **Medium**.

Looking west at the remediation system trailer and area of the former gas station.

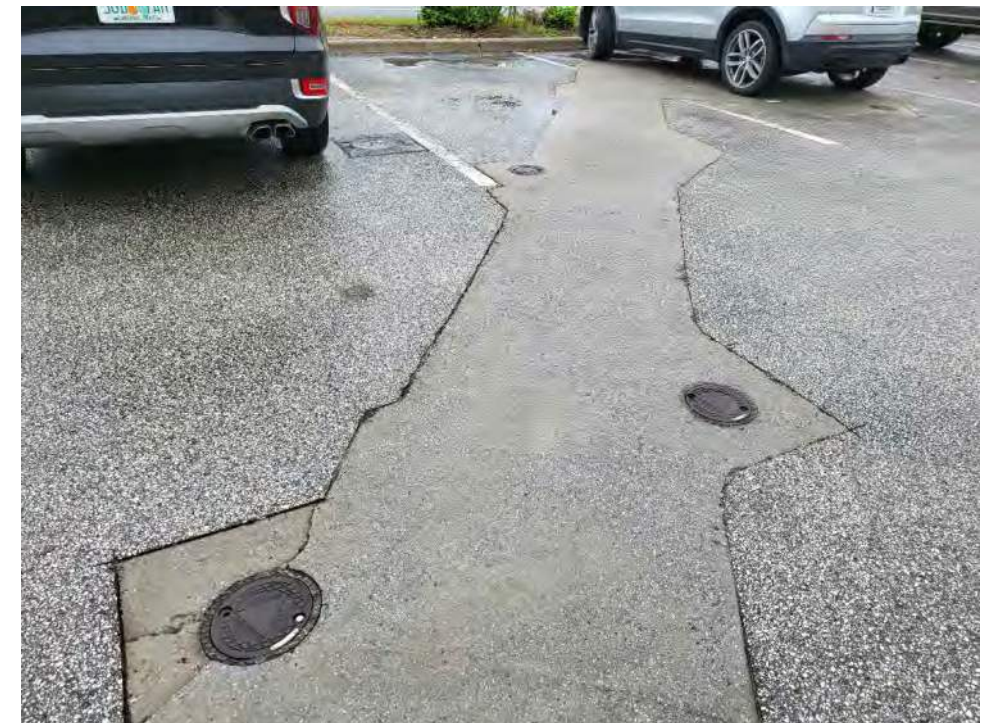
View of three remediation system wells in the eastern portion of the site.

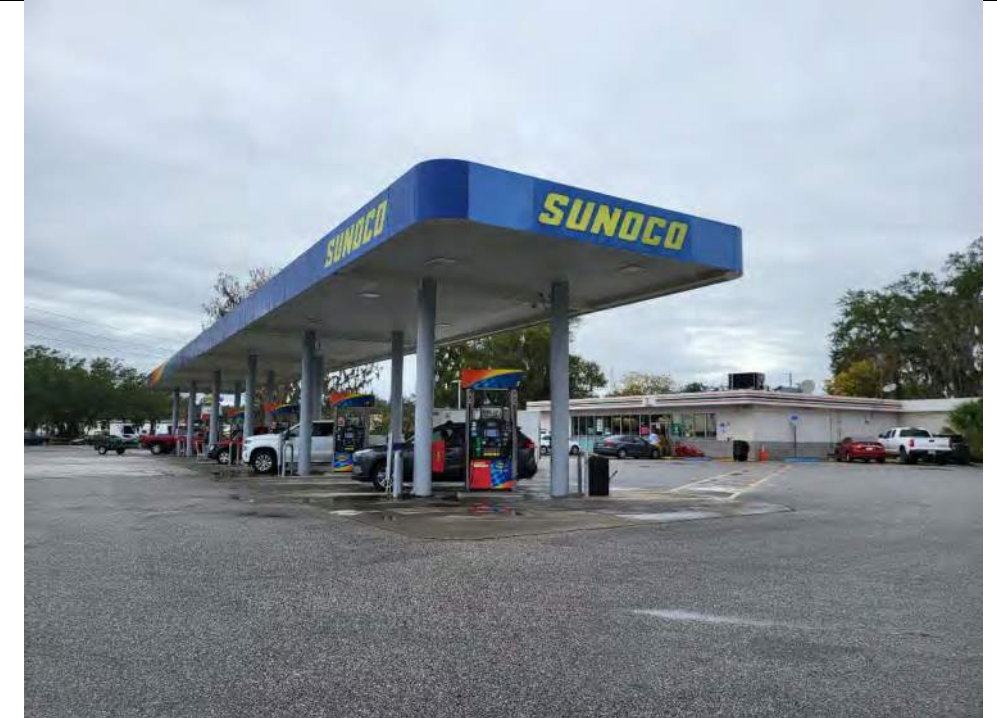
CONCLUSIONS: Due to the groundwater impacts being adjacent to, or under, SR 35, and the groundwater flow direction, this site has been assigned a CRR of **High**.

Looking northwest towards the gas station and fueling canopy.

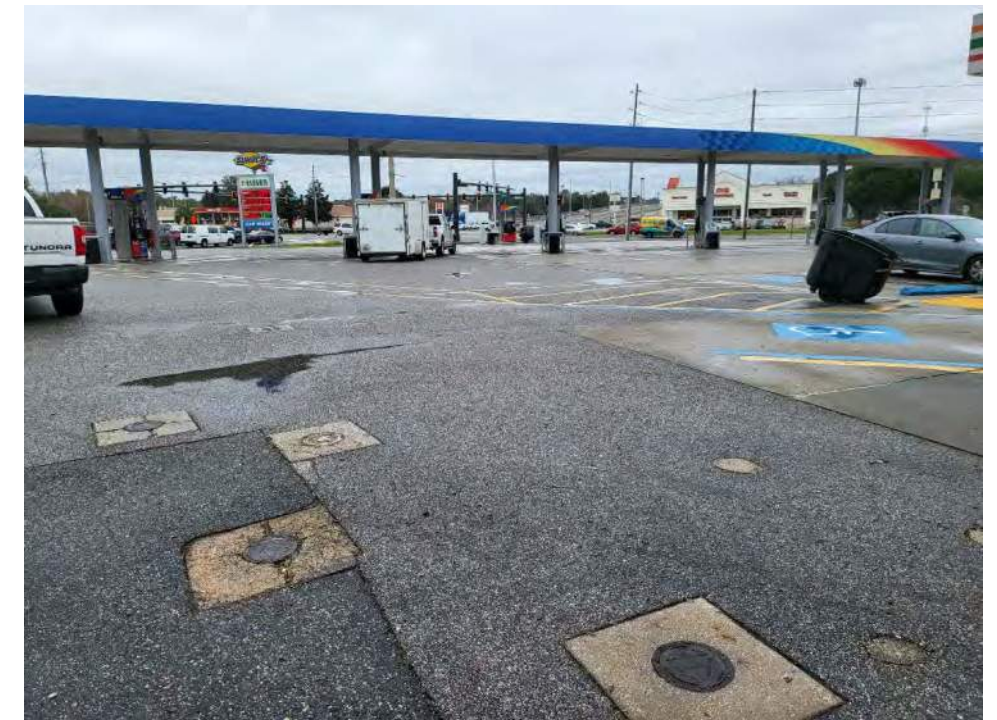
View of four monitoring wells in the northeast portion of the site.

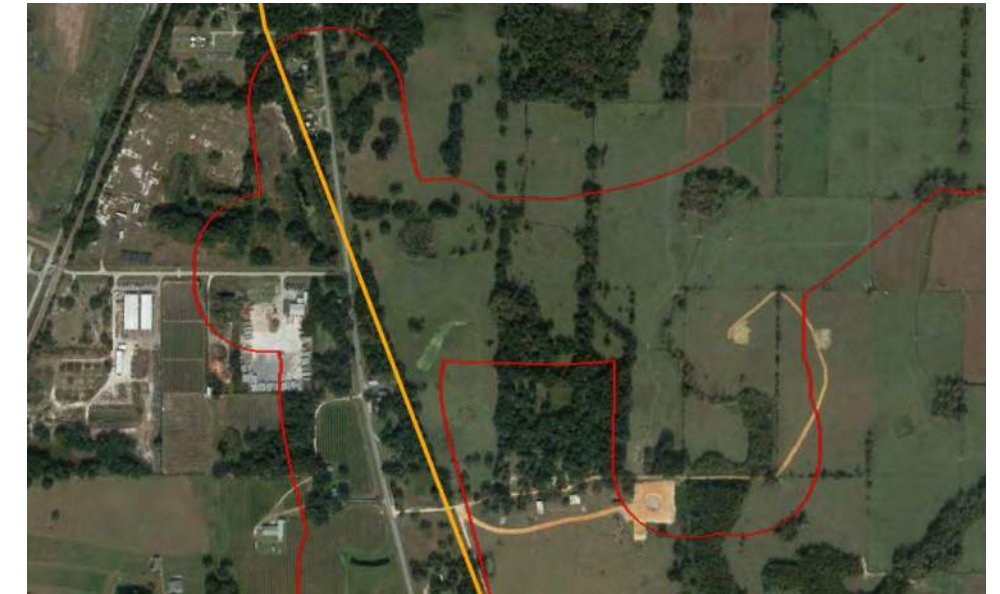
CONCLUSIONS: Based on the potential for contamination impacts to the site soils from historical railroad use, the former railroad corridor has been assigned a CRR of **Medium**.

View of the former railroad track, represented by the orange line, on the 2019 aerial photograph.

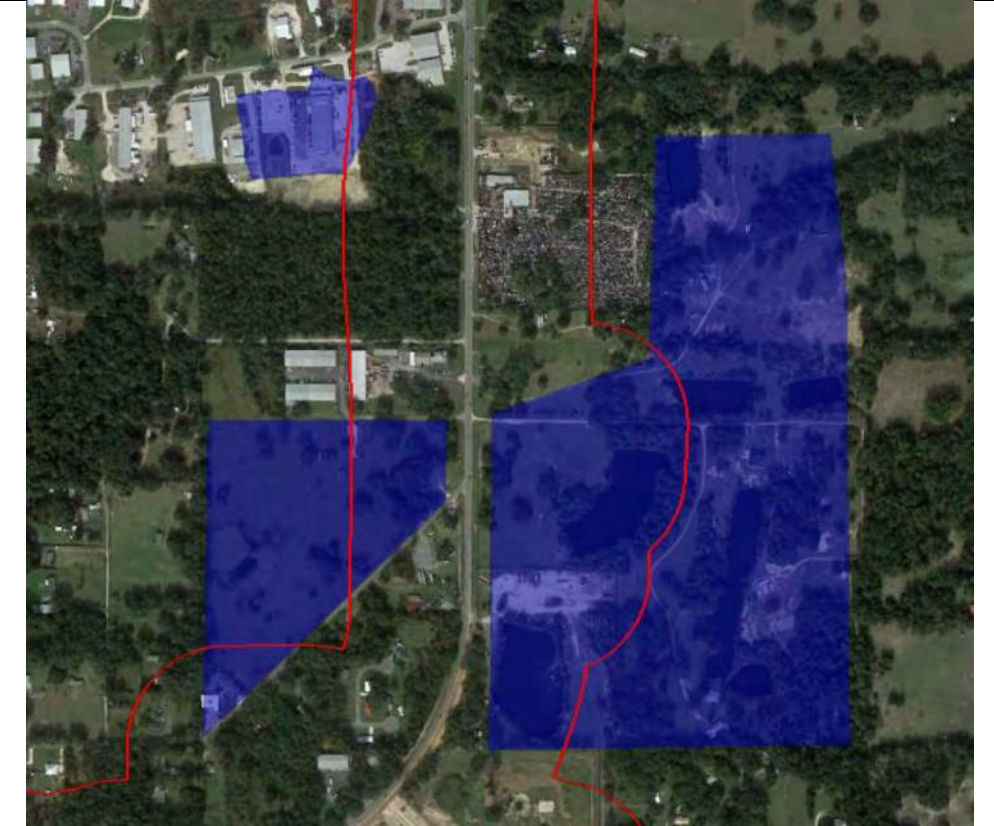
CONCLUSIONS: Due to its use as a quarry, lack of evidence of buried materials, and distance from SR 35, this site has been assigned a CRR of **Low** for the SR 35 improvements and a **Medium** CRR for Pond 13C-1.

View of the areas of Pits-Dumps complex, represented by blue, on the 2019 aerial photograph.

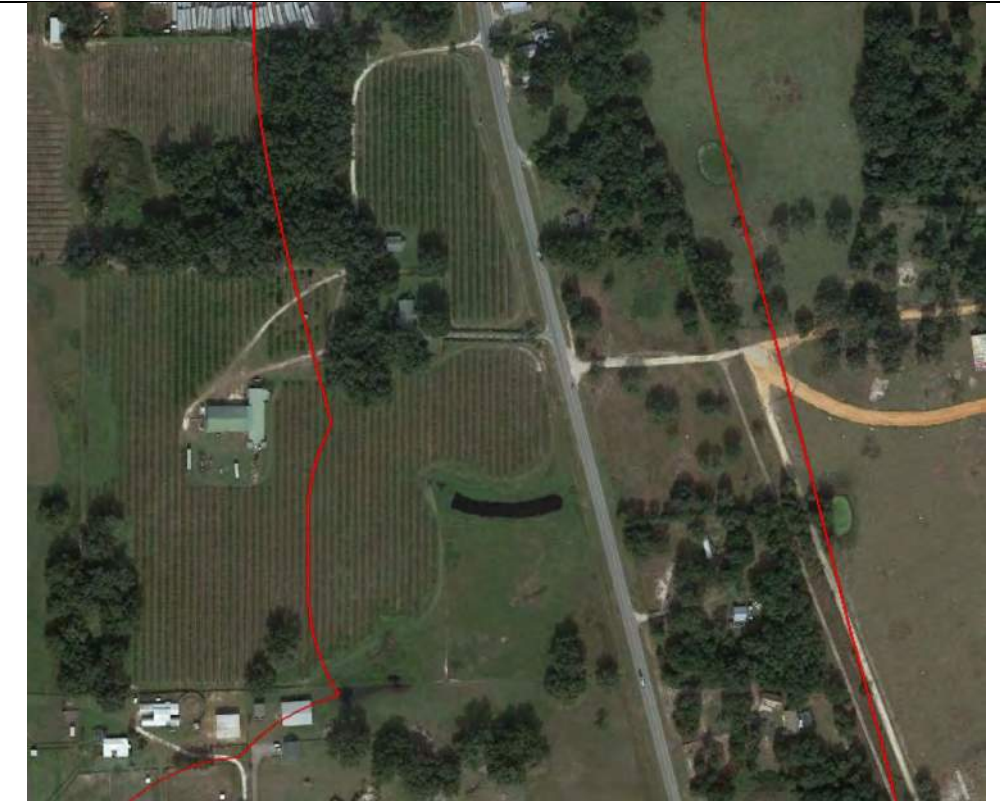
CONCLUSIONS: Due to the distance of the row crops to SR 35, the small size of the historical citrus groves, and the probable reworking of soils along the roadway, the agricultural land use has been assigned a CRR of **Low**.

View of an area of row crops to the west of SR 35 on the 2019 aerial photograph.

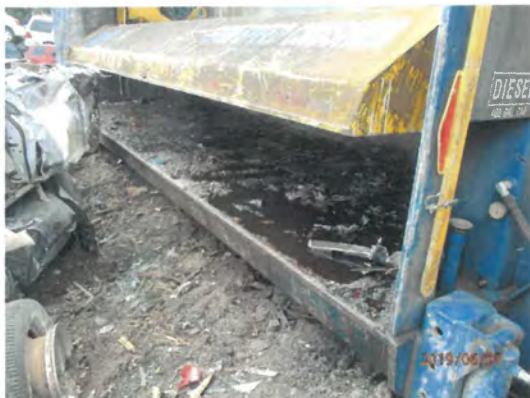
1. Vehicle Crusher

A vehicle crusher is located near the south side of the salvage yard operation. Although vehicle fluids are removed prior to crushing, some fluids remain in the vehicles. This fluid accumulates in tanks located within the crusher. If the internal tanks become clogged by dirt or debris, some fluid will be released [Figure 1]. Minor releases of petroleum were noted along the front of the crusher and need to be addressed [62-710.401(2), F.A.C.]. Crushed vehicles are shipped to Trademark Metals Recycling's Baldwin, Florida, facility.

Explanation: No person may discharge used oil into soils, sewers, drainage systems, septic tanks, surface or ground waters, watercourses, or marine waters. Specifically, minor discharges of petroleum products were found near the dismantling area and near the crusher.

Following the inspection, the facility sampled the petroleum contaminated media and, based on the sample results, arranged for disposal at a local non-hazardous waste landfill.

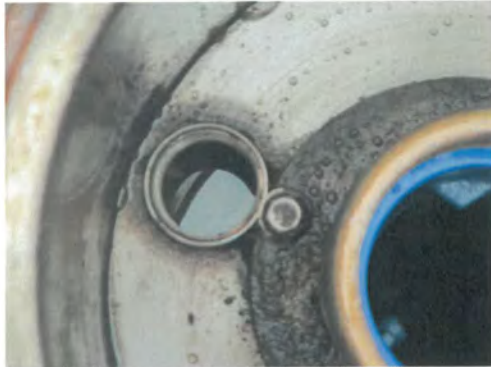
Diesel double walled spill bucket PCW in secondary

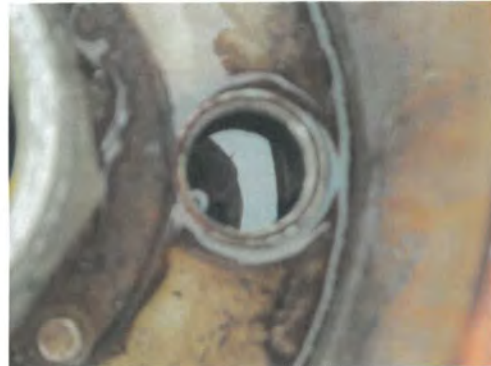
PUL double walled spill bucket PCW in secondary

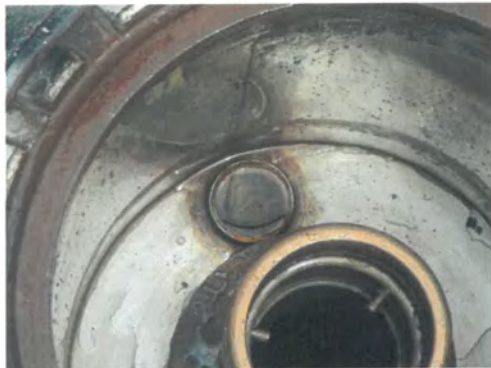
RUL double walled spill bucket PCW in secondary
